Thermal Analysis of an Installation Fault Concerning a Ripple Control Transformer

by Vassilios Chatziathanasiou, Georgios T. Andreou, Olga Gkaitatzi, Ozlem Otuzbir, and Dimitrios P. Labridis

Aristotle University of Thessaloniki, Thessaloniki, Greece

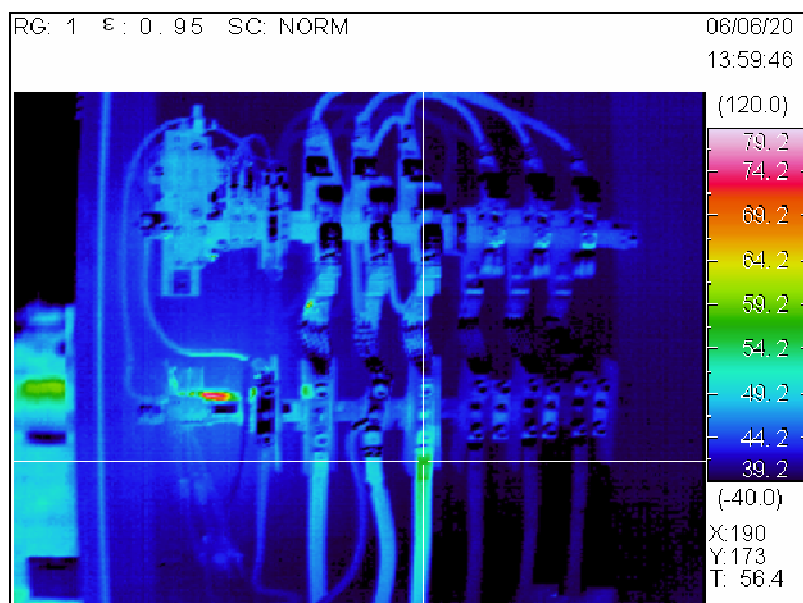
Fig. 1. Thermal image of Ripple Control Panel

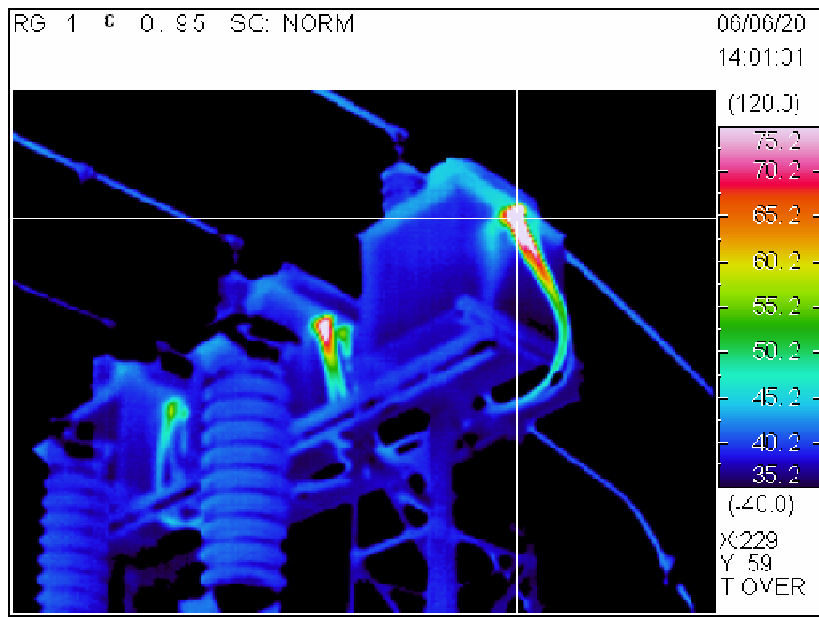
Fig. 2. Thermal image of infusion current transformers

As shown in the figure, the malfunctioning feeding cable exhibited at its joint with the transformer a temperature of about 120°C, whereas the respective temperature of the rest of the installation was less than 50°C, as would normally be expected. Further analysis of the incident indicated that the joint between the feeding cable and the transformer was made for aluminium cables, whereas the feeding cable itself was made of copper. Evidently the aluminium joint was overheated during its operation, the result being the destruction of the cable.

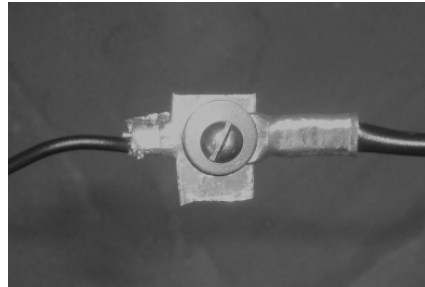
Fig. 4. Connection between copper cable and aluminium joint before the experiment

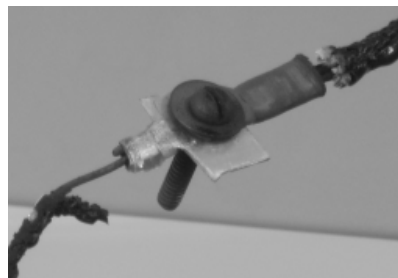
The configuration was powered, feeding the intermetallic joint with a current of about 35 A (well above the nominal rating of the NYA 1.5 mm² cable), and a Fluke Ti 35 Thermal Imager was used to observe the outcome of the experiment. After two days of experiment, the feeding cable blew as expected at the point of the intermetallic joint due to local excessive heating (Fig. 5).

Fig. 5. Connection between copper cable and aluminium joint only minutes before the joint destruction

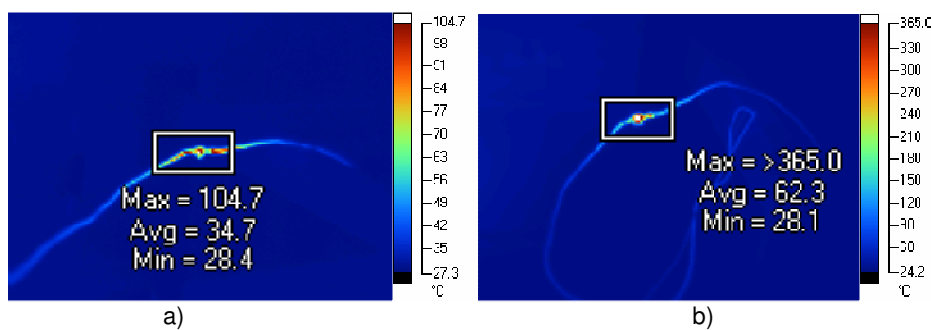
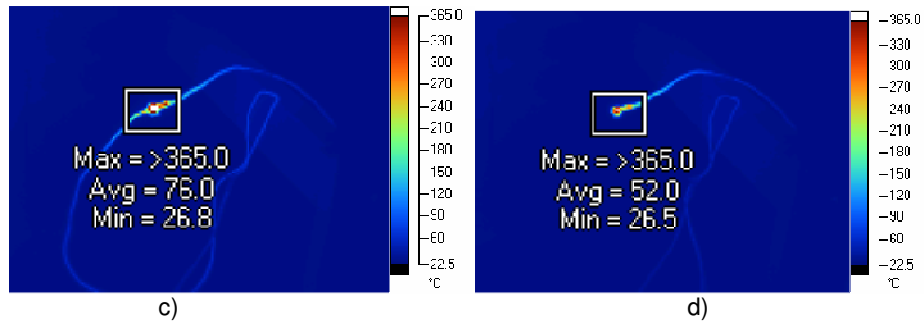
As can be seen in Fig. 6a-b, the joint maximum temperature increased until it exceeded the camera sensitivity, whereas for the rest of the experiment a constant rise in the joint average temperature can be observed (Fig. 6b-c) until the joint destruction. Fig. 6d depicts the thermal image of the joint moments after the joint failure.

Fig. 6. Thermal representation of the experiment progress

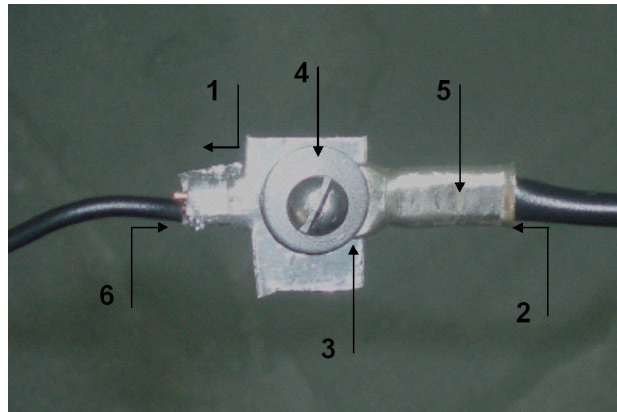
Fig. 7. Sample areas of joint for the microscopic analysis

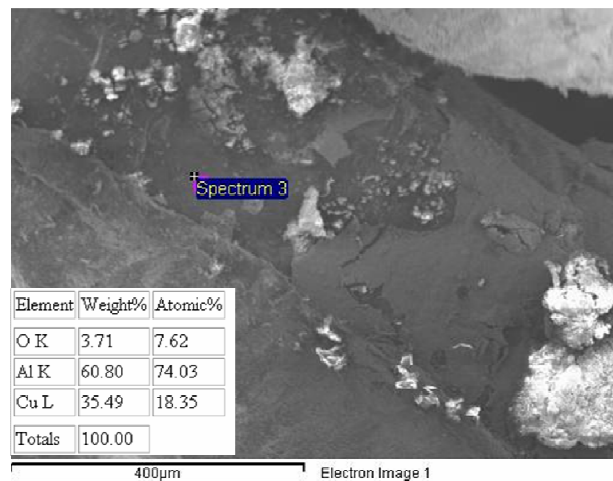
Fig. 8. Results of the microscopic analysis concerning sample area 1

The composition of the samples analyzed by the electronic microscope included basically Cu and Al oxides, whereas some points studied indicated the presence of IMC. However, the experiment results show that the growth of the oxides on the Cu/Al joint surface along with the respective increase in the joint electrical resistance and temperature was sufficient for the joint destruction, whereas IMC development did not appear to influence the experiment outcome significantly. This suggestion is also supported by the fact that the joint destruction did not occur due to a mechanical failure that would suggest IMC development, but only due to excessive temperature rise of the joint.

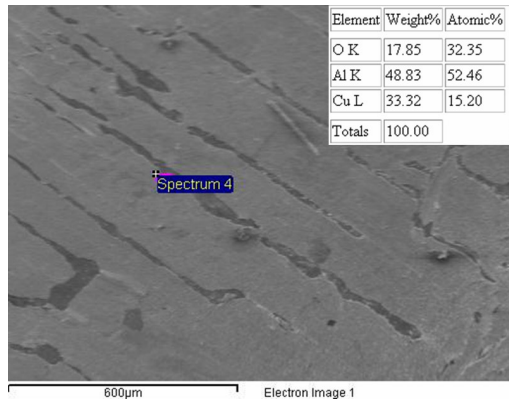
Fig. 9. Results of the microscopic analysis concerning sample area 3

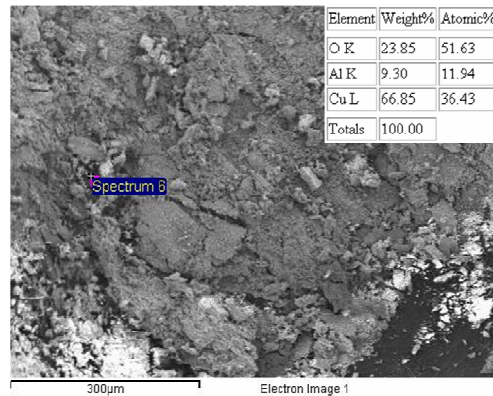
Fig. 10. Results of the microscopic analysis concerning sample area 6
