IRT survey for the quality control of FRP reinforced r.c. structures

by P. Corvaglia*, A. Largo*

Abstract

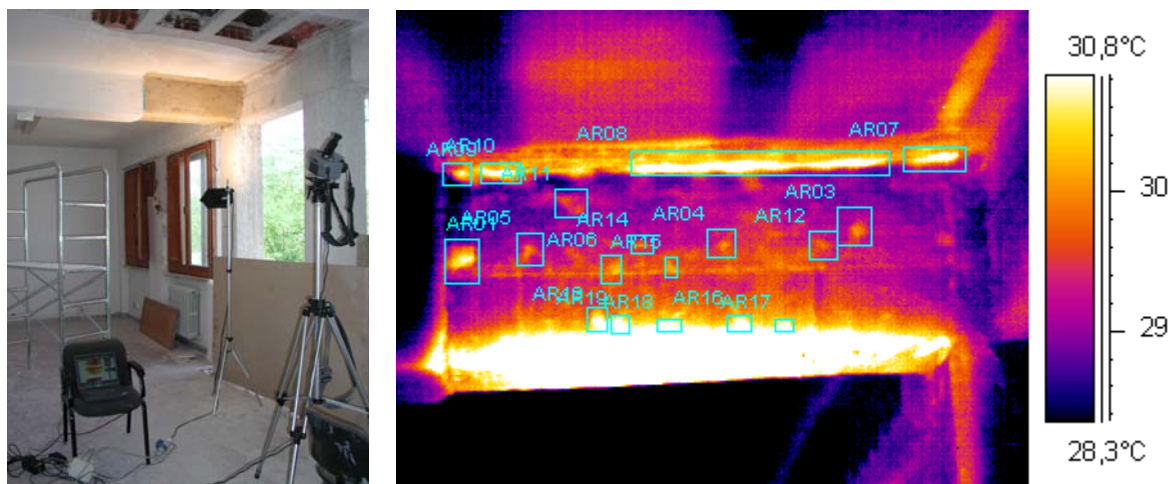
In the following (Fig. 5, indoor and Fig. 6, outdoor) two examples of thermograms of the GFRP reinforced structure are presented; especially in Fig. 5 a lot of defects of different shapes and dimensions were identified.

This was probably caused by an improper use, during the placement of the FRP sheets, of the stiff rubber roller (which should help the adhesive to completely penetrate through the fibres of the fabric) and of the aluminium roller with a worm screw (which should help to completely eliminate air bubbles formed during application). All the defects were classified as Type 3.

Fig. 5 Indoor IRT survey of an r.c. structure reinforced with GFRP sheets

However, in this case, considering the number and distribution of defectiveness all along the reinforced area, even if every single defect could be separately repaired, it was considered advisable to completely remove and reapply the entire FRP system.

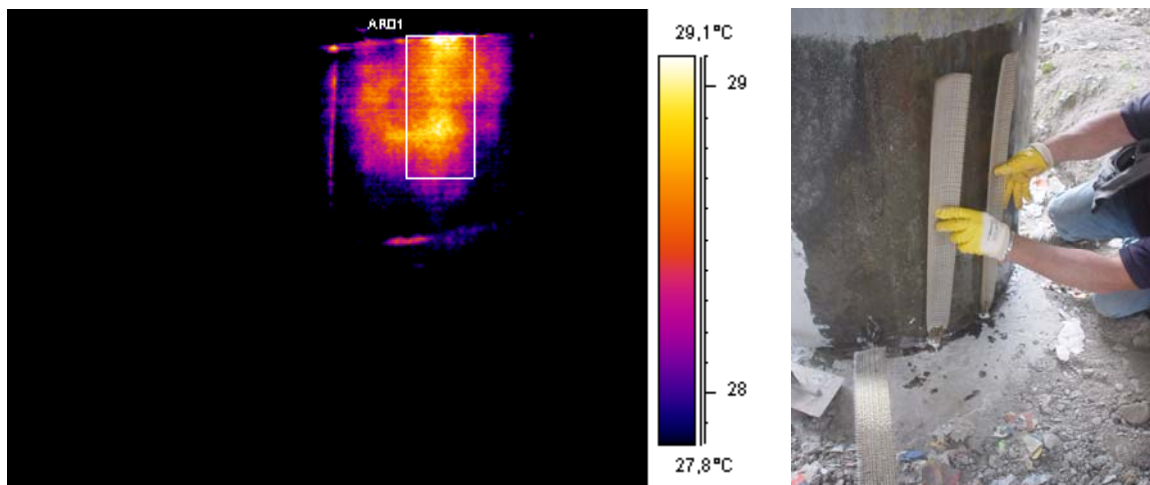
Fig. 9 Application of SRP reinforcement

The second type of defect (evidenced in the red circle in Fig. 7 and in the white rectangle in Fig. 9, left) is most probably due to the presence of the SRP reinforcement (applied between the concrete and the CFRP sheet, as described in Fig. 9, right) and can be classified as a Type 4 defect. However, considering that the debonded zone is located in a reinforced area designed as “witness panel” (i.e. not resulting from the design of the reinforcement but strengthened only to perform other tests, like direct pull – off test), it can be easily repaired with low – pressure epoxy injection.

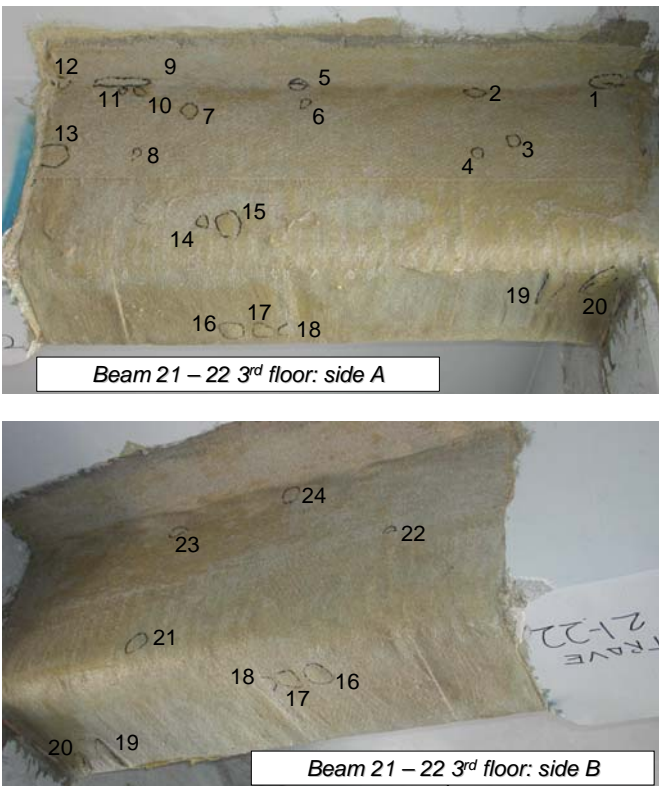
Table 1. QC survey summarizing table and repairing indications

<p>Beam 21 – 22 3rd floor: side A</p> <p>Beam 21 – 22 3rd floor: side B</p>		Def. #	T₁	T₂	T₃	T₄	Repairing method	
		1			✓			Method 2
		2			✓			Method 2
		3		✓				Method 1
		4		✓				Method 1
		5		✓				Method 1
		6		✓				Method 1
		7		✓				Method 1
		8		✓				Method 1
		9			✓			Method 2
		10		✓				Method 1
		11		✓				Method 1
		12		✓				Method 1
		13			✓			Method 2
		14		✓				Method 1
		15			✓			Method 2
		16			✓			Method 1 ²
		17			✓			Method 1 (note 2)
		18		✓				Method 1 (note 2)
		19			✓			Method 1 (note 2)
		20			✓			Method 1 (note 2)
		21			✓			Method 2
		22		✓				Method 1
		23		✓				Method 1
24		✓				Method 1		
INDICAZIONI								
Considering the number and distribution of defectiveness all along the reinforced area, it may be advisable to completely remove and reapply the entire FRP system. However, the reparation of every single defect could be also accepted.
