## Inspection of the Leakage for the Closure Plug of Heavy Water Reactor using Infrared Thermography in Nuclear On-site Application

by S. G. Lee\* and W. T. Kim\*\*†

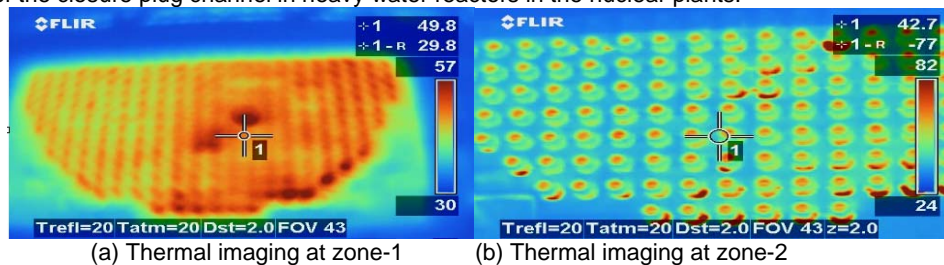
**Fig. 3.** Infrared imaging from zone 1 of closure plug ( $\epsilon=0.96$ )

All figures of Fig. 3 showed imaging's for zone-1 and zone-2, respectively, of infrared thermography for detecting the leakage in the front of the closure plug channel in heavy water reactors in the nuclear plants.

From infrared thermography, the thermal imaging for detecting the leakage of heavy water from the closure plug in the nuclear plants was evaluated on-site. Since there were much radioactivity, condition monitoring using thermography was very useful to observe the temperature distributions without risks and concluded as one enough efficient to monitor.
