Inspection of HVOF-coated Pelton wheels using active thermography

by J. Délémontez*, M.Taglione**, A. Rivière***, E. Martin****

Abstract

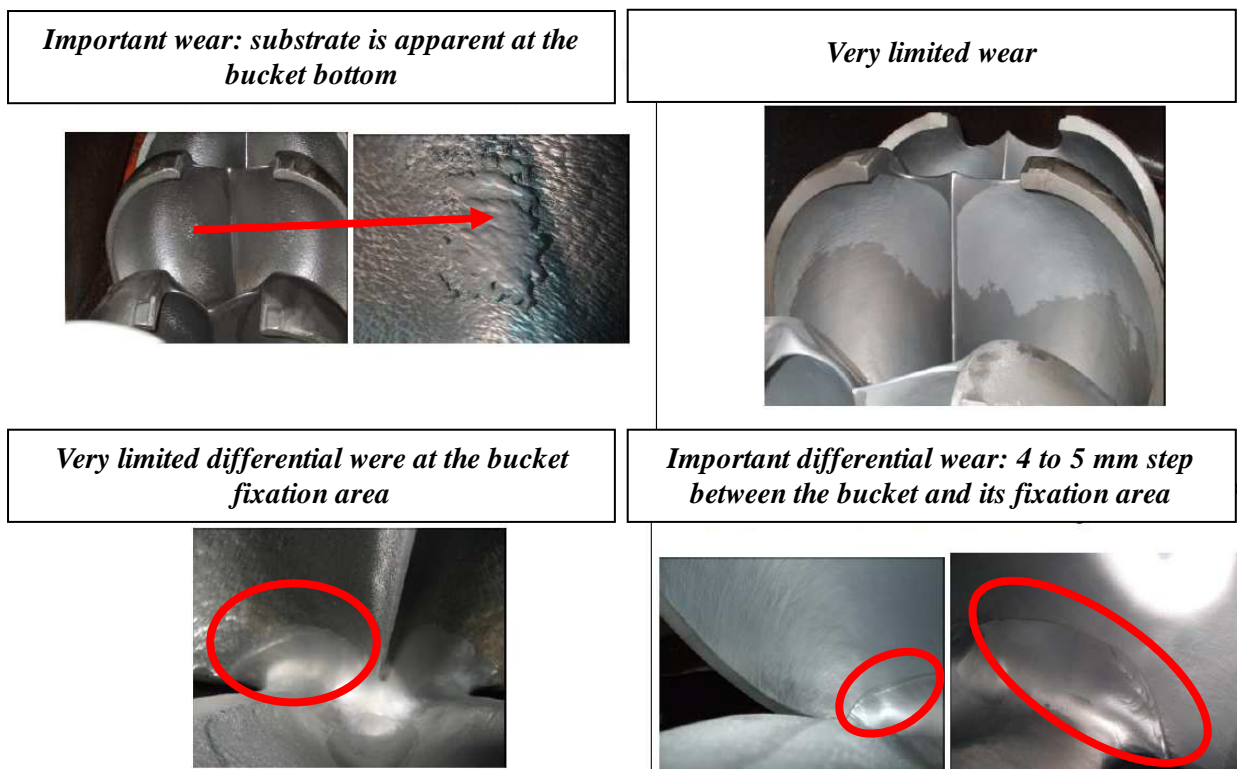
- HVOF-coated buckets have a very smooth surface with hardly any wear marks ;

- the coating is still present in practically all functional areas with little loss of thickness ;
- some spalling of the coating can be seen, particularly on the median edges and in the cutouts but there was little noticeable change between inspections.

Figure 1: Comparison of wear state of the two types of coating tested (left: arc-welding TAFAs, right: HVOF)

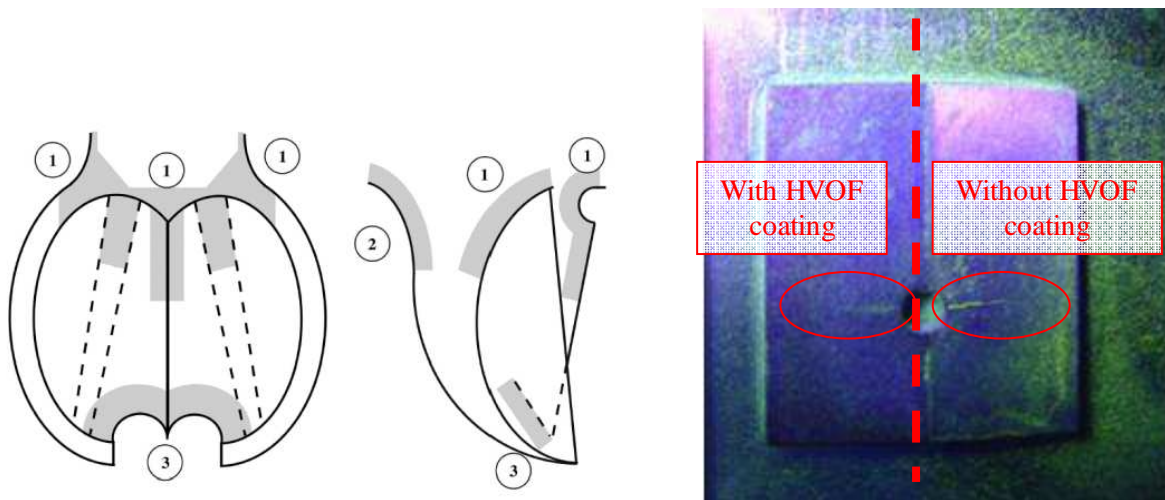
The only negative point is the transition area between the coated part and the substrate in the area where the bucket is attached, which could cause premature differential wear in this area. The attachment area was deliberately left uncoated in order to be able to carry out periodic Non Destructive Examinations (NDE) by magnetic particle inspection (MT) to detect the presence of cracks in this area subject to heavy fatigue, in accordance with the EDF maintenance doctrine.

NDE by magnetic particle testing (MT) carried out by the EDF maintenance teams is based on the search for the indication of a crack caused by a phenomenon of flux leakage from the bucket that has been magnetised and sprayed with a developer containing fine ferro-magnetic particles. The HVOF anti-wear coating acts as a barrier against the phenomenon of flux leakage. The main consequence of this is a strong reduction in the sensitivity of detection as illustrated in figure 2, which is unacceptable in areas subject to high strain from fatigue. Failure to detect a crack several millimetres long during a periodic inspection could in fact lead to breakage and ejection of a bucket in service, which is unacceptable in terms of risk to property and people.

Figure 2: Areas sensitive to cracking in Pelton buckets - Effect of the presence of the HVOF coating on the detection sensitivity of the NDE by MT

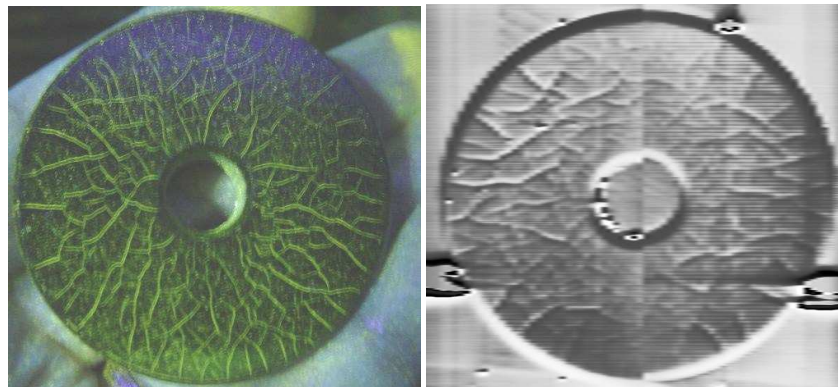
The comparison of thermographic inspection using the PTC prototype and magnetic particle testing can be realized using the calibration samples from the existing EDF procedure. This calibration sample is designed according to EN 9934-2. It comprises surface breaking fatigue cracks, as can be seen on Figure 4.

Using laser thermography, we can see that the crack networks can be detected the same way they are with magnetic particle testing. This concurs with the experience AREVA NDE Solutions has with this technique, which shows that its sensitivity is in the same range as MT for both surface breaking and underlying cracks on steel components.

Figure 4: Comparison of MT (left) vs. PTC prototype (right)

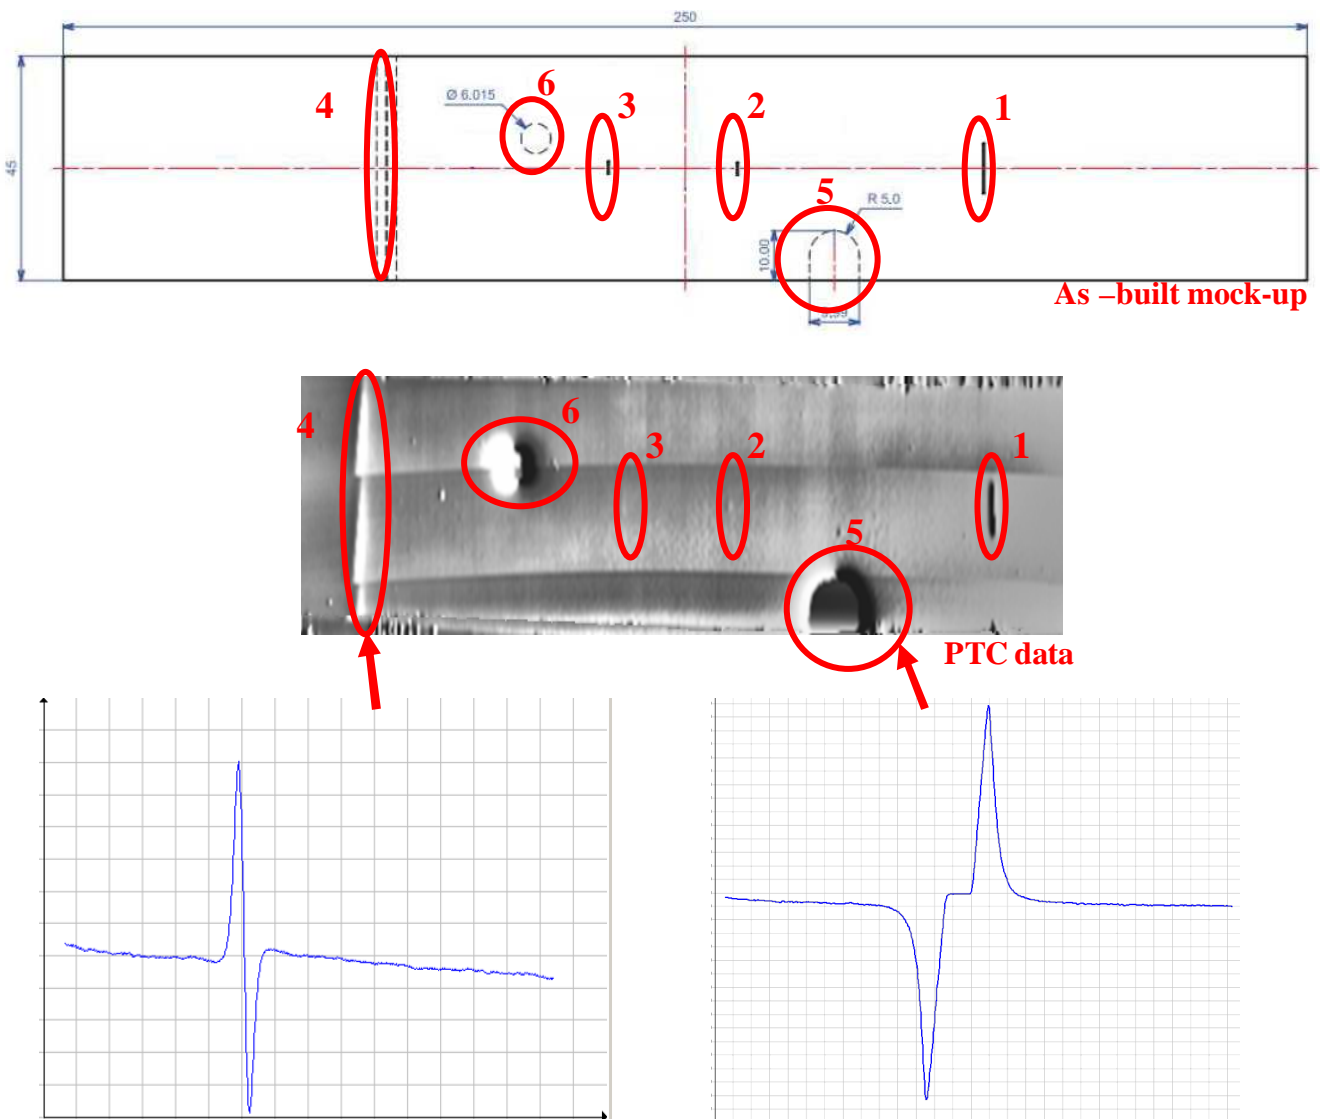
Inspection of this mock-up showed that under proper operating conditions, all the defects embedded into the mock-up are detected using thermographic inspection. Discontinuities perpendicular to the surface stand for cracks and are detected thanks to the typical signal they provide, as explained above. Discontinuities parallel to the surface stand for disbonds and are detected because of the important heat elevation at their location: heat cannot dissipate into the bulk of the part, and stays in the coating thereby generating a temperature rise.

The indications linked to defects 2 and 3 are extremely small, but could be detected by the inspection system provided the right experimental conditions are used. For this particular application, the inspection system is able to detect **cracks with length down to 2.0 mm**.

The smallest disbond that was present on the mock-up was seen: for this particular application, **the inspection system is able to detect disbonds with diameter down to at least 6.0 mm**.

Figure 5: Results of the preliminary tests led at AREVA NDE Solution Technical Centre (arbitrary units)
Top : mock-up drawing and associated indications
Bottom left: indication of a discontinuity
Bottom right: indication of a disbond

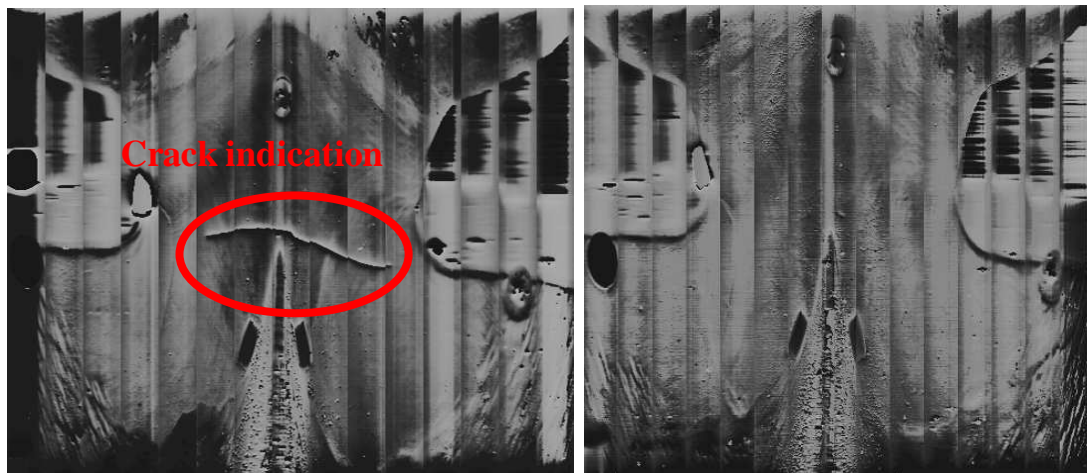
During a periodic inspection, a fatigue crack was found on the bucket fixation area of an uncoated Pelton wheel from the Passy dam. The wheel was dismissed and made available for NDE training and testing. The defect area, as well as a sound bucket-fixation area on a nearby bucket, were coated with HVOF. The PTC prototype was placed in front of the wheel as can be seen on Figure 6, and both areas were inspected in blind-test conditions from this position at a 1 m distance. The results obtained and shown on Figure 7 clearly indicate a discontinuity in one of the HVOF-coated bucket

fixation areas, while the other is sound: this corresponds to what had been found using MT *before coating*. The crack dimensions and localisation were measured from the thermography data, and were found to be within 10% of the MT results. Those tests were led in Albertville, at an EDF maintenance facility; the next step planned was conducting tests in a real hydropower plant.

Figure 7: Passy wheel inspection using the PTC prototype
Left: cracked bucket fixation area
Right: sound bucket fixation area

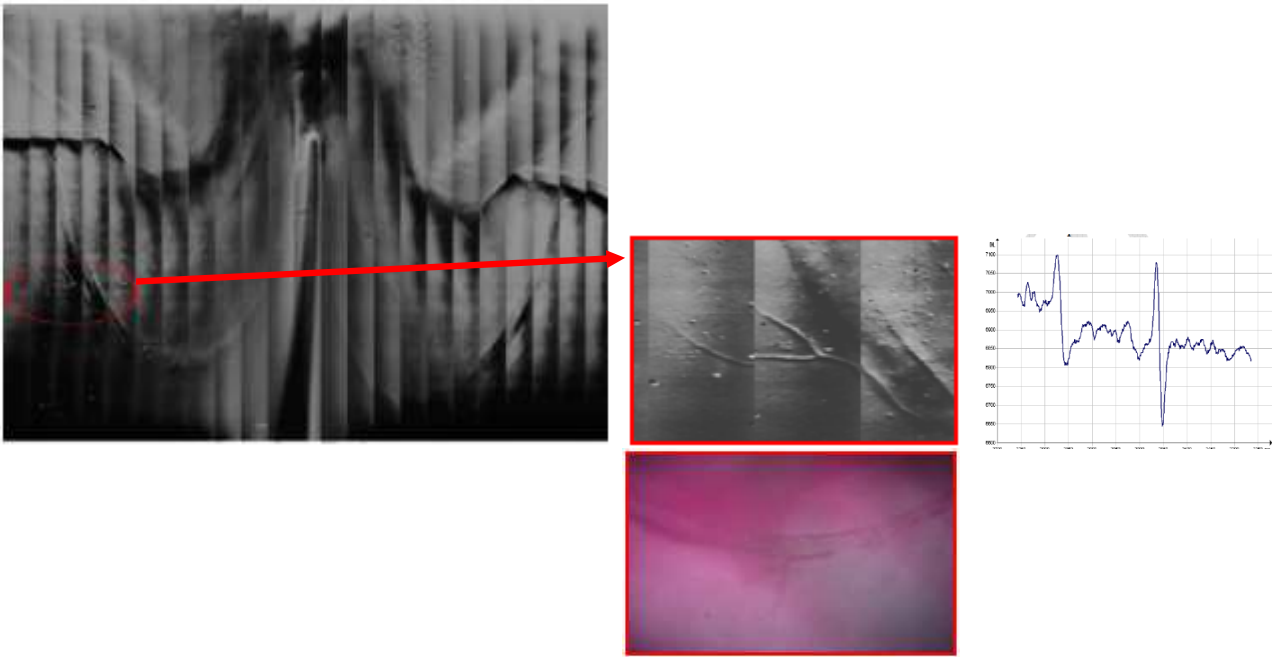
Another example was the PTC inspection of a new Pelton Wheel from Les Bois power plant which buckets were coated in two steps with HVOF. Results showed some crack indications with a clear thermal barrier signature at the interface of the two HVOF layers. A PT examination was performed and confirmed the presence of surface breaking cracks but with a weak contrast because of the surface condition of the coating, as illustrated on Figure 8.

Figure 8: Les Bois wheel inspection using the PTC prototype
Top : thermal barrier indication at the interface between two layers of coating
Bottom : surface breaking crack indication with PT examination

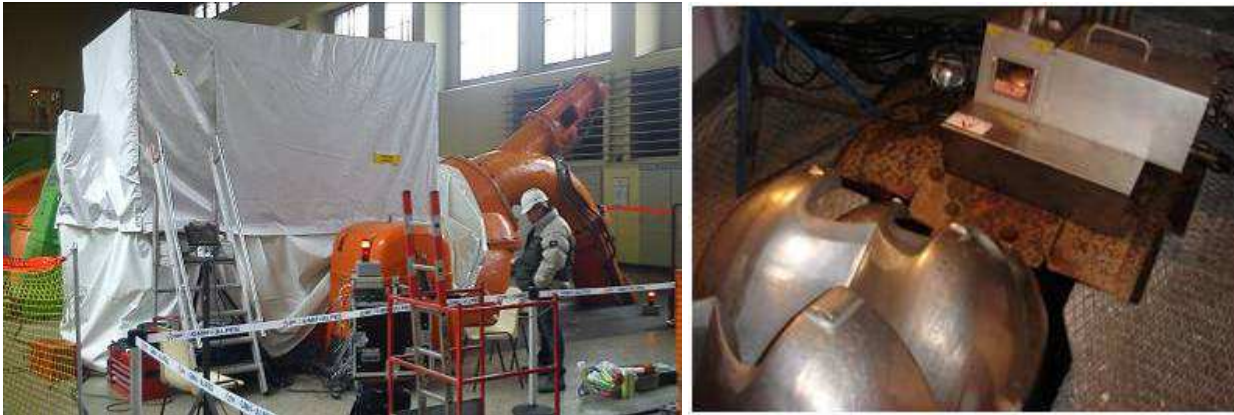
The positioning of the camera for inspecting the areas described on Figure 2 requires a wide working range because of the various geometries that are at stake. Because laser heating is afocal, and because the PTC is designed to work from 10 cm up to 200 cm of the inspected surface, all required areas could be easily accessed, see Figure 9.

Last but not least, the laser used for performing the heating being a class IV laser its use requires to protect the users from its rays. A safety tarp was set around the acquisition area, and providing an efficient safety light barrier exclusion zone. Another team was working very close to the inspected wheel (see white barrier on Figure 9), and presented no issue during the whole inspection duration.

Figure 9: prototype PTC under laser protection tarp during Pelton wheel inspection at Passy

The inspection rate of the demonstration system used was rather slow (30 minutes per inspected area), as it is designed to inspect over a 25 mm width. In the present case here, it would be advisable to use a larger laser line: for example a 100 mm line would reduce the inspection time by a factor of four.
