Lock-in Thermography Inspection for Characterizing and Quantifying Material Defects Resulting from Parameter Deviations within the Manufacturing Process Chain of CFRP Composites

by T. Ullmann¹, T. Schmidt² and S. Dutta²

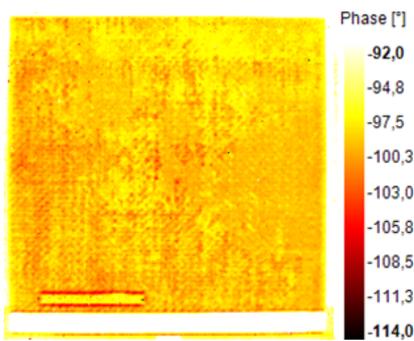
Fig. 1: OLT phase image at $f = 0.3$ Hz attenuation frequency

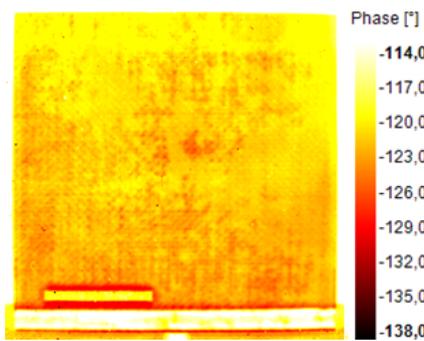
Fig. 2: OLT phase image at $f = 0.06$ Hz attenuation frequency

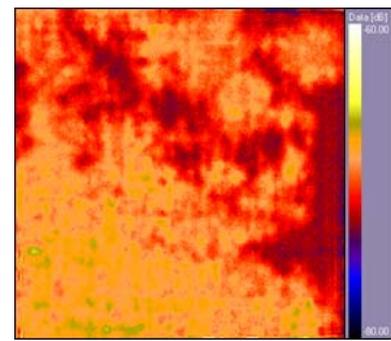
Fig. 3: C-mode image of air coupled ultrasound inspection
