Induction thermography as an alternative to conventional NDT methods for forged parts

by P. BOUTEILLE*, G. LEGROS*

* CETIM, NDT Division, 52 avenue Félix Louat, 60300 Senlis, France, patrick.bouteille@cetim.fr

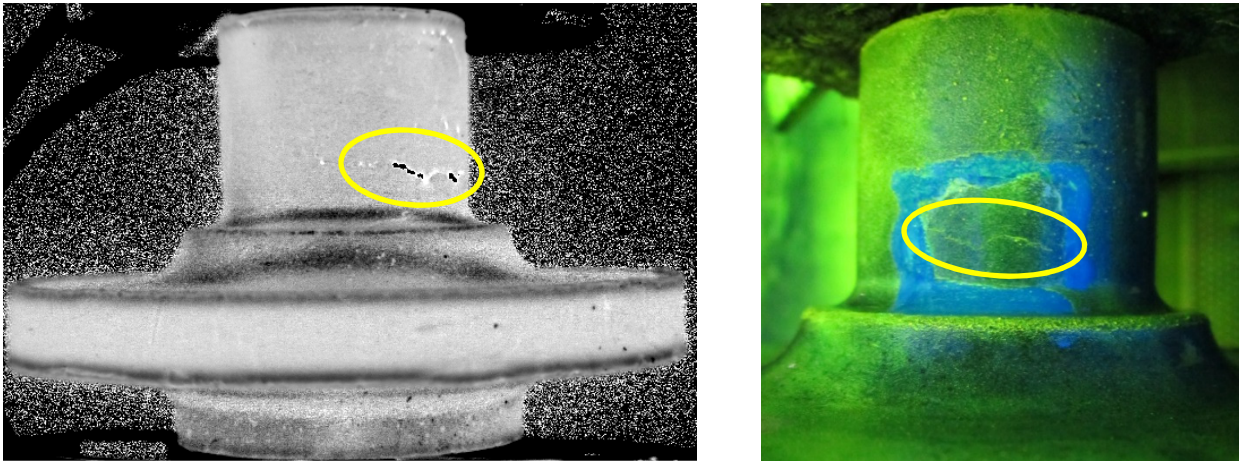
An indication on the bushing of the hub below is detected by magnetic particle inspection (Figure 3, right-hand side) as well as by thermography with a side view (Figure 3, left-hand side).

Figure 3: Circumferential indication detected by thermography (left) and by magnetic particle inspection (right)

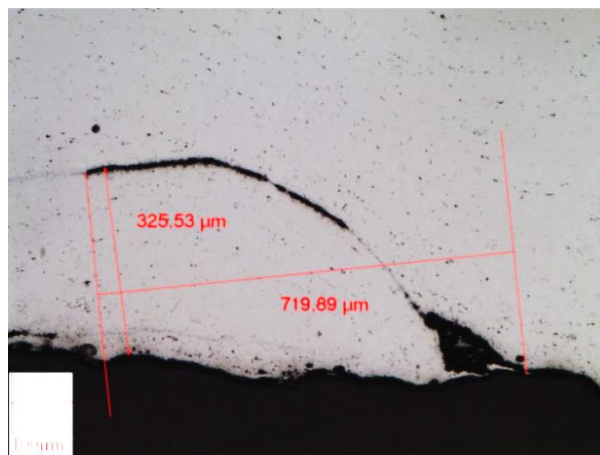
A metallographic section made on this indication confirms the presence of a rather deep cold shut.

Figure 4: Metallographic analysis on the indication detected by thermography and magnetic particle inspection

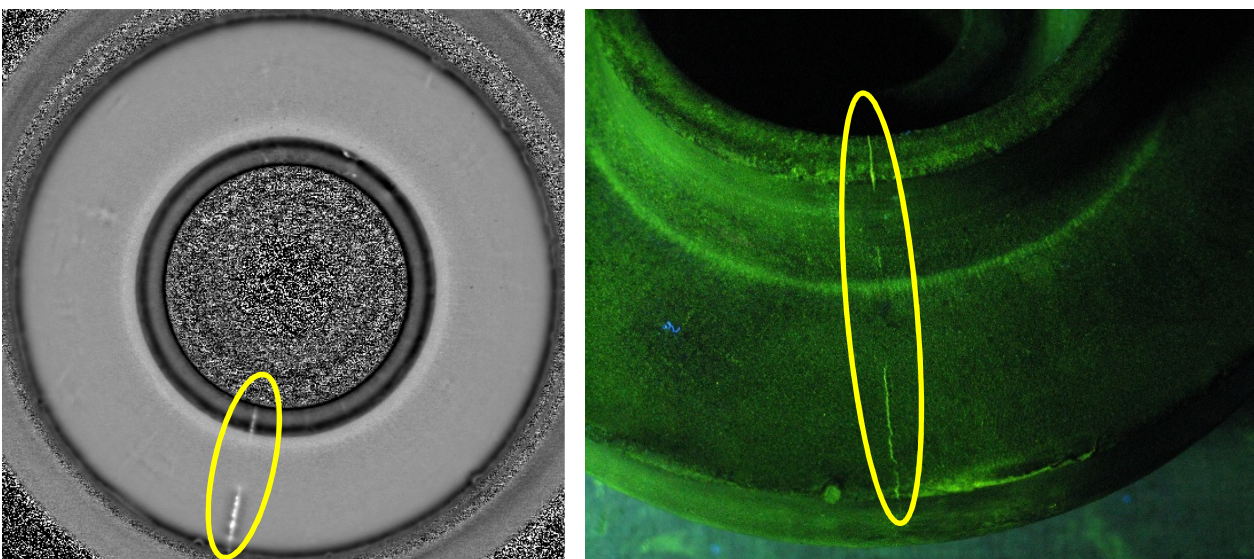
Figures 5 show a radial defect detected both by infrared thermography (left) and magnetic particle inspection (right) on wheel centering side.

Figure 5: Radial indication detected by thermography (left) and by magnetic particle inspection (right)

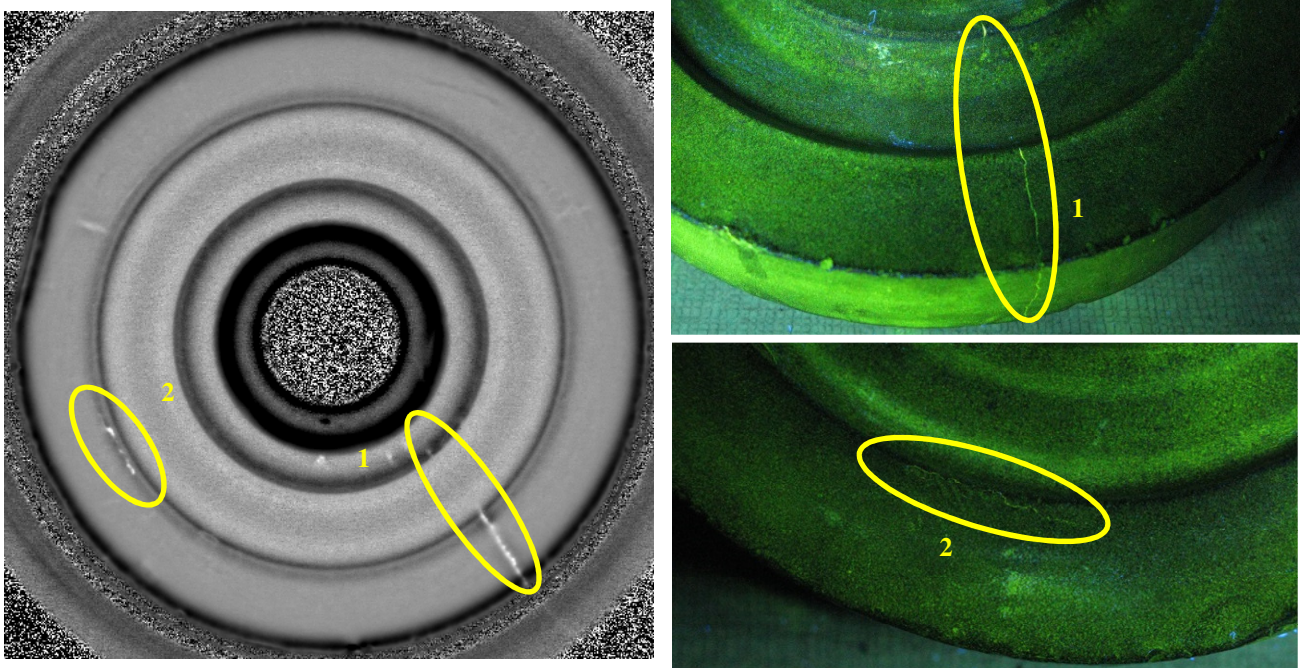
The same coil and the same infrared thermography configuration simultaneously evidenced the radial and circumferential indications. This is confirmed on the following phase image obtained during the thermography inspection of a hub with radial and circumferential defects. The circumferential defect (number 2) is hardly detected by magnetic particle inspection, in spite of the choice of a testing configuration conducive to its detection.

Figure 6: Inspection on bushing side by thermography (left) and magnetic particle inspection (right)

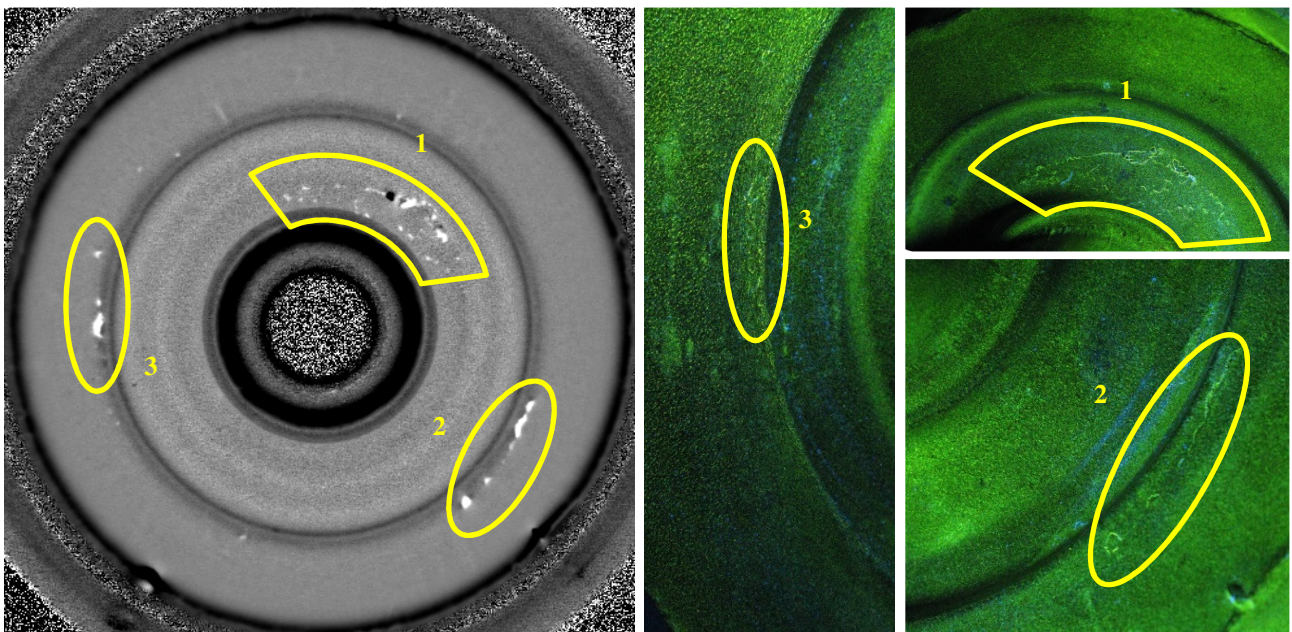
On Figure 7, induction thermography revealed three circumferential indications on bushing side. The circumferential indication numbered 3 is barely detected by magnetic particle inspection although it is well detected by induction thermography.

Figure 7: Inspection on bushing side by thermography (left) and by magnetic particle inspection (right)

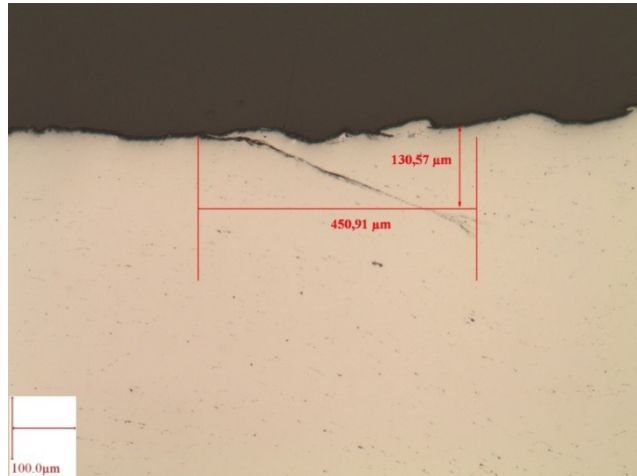
A metallographic section was made on this indication which was very hardly detected by magnetic particle inspection. This section confirmed the presence of a cold shut at the indication detected by thermography (Figure 8).

Figure 8: Metallographic analysis on an indication detected by thermography but not detected by magnetic particle inspection

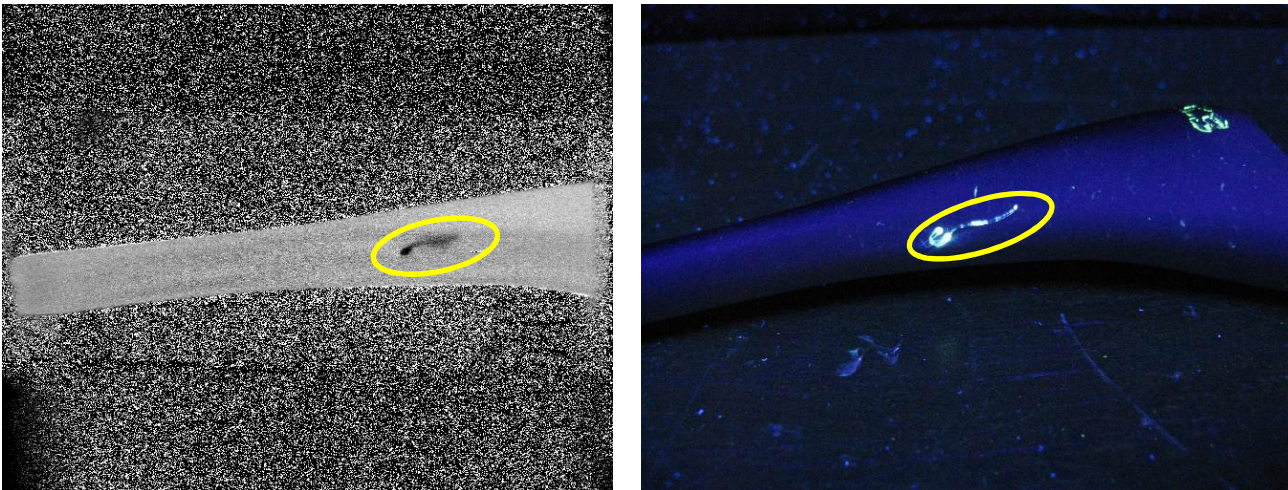
Figures 10 show a phase image corresponding to the thermography testing (left) of a smooth stainless steel prosthesis and the result of the penetrant testing (right) carried out on this same prosthesis.

Figure 10: Inspection of a stainless steel artificial hip joint by thermography testing (left) and penetrant testing (right)

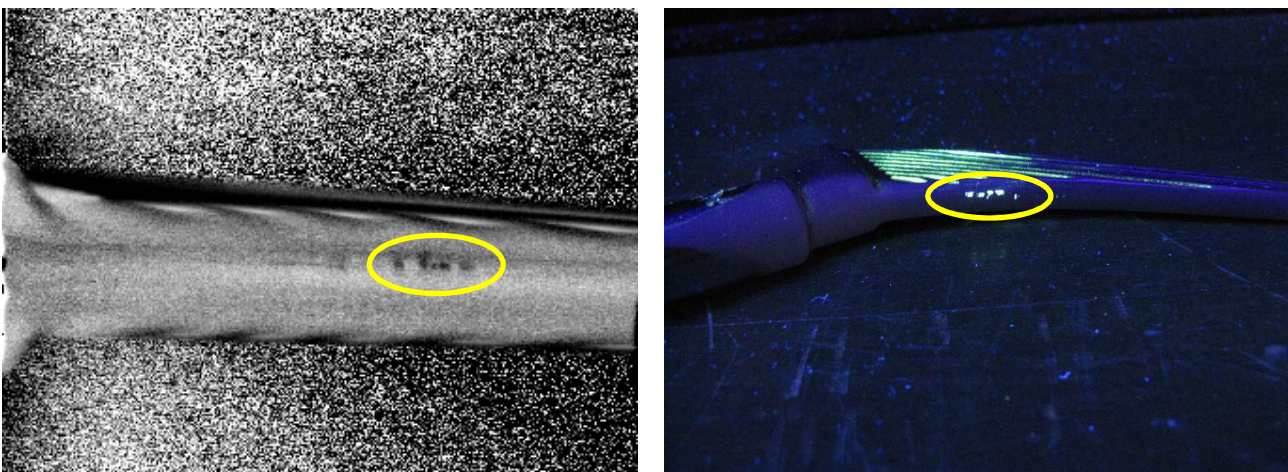
The figures below show the comparison between thermography testing and penetrant testing in order to detect a defect on the smooth portion of a cobalt-chromium alloy prosthesis.

Figure 11: Inspection of a cobalt-chromium alloy prosthesis by thermography testing (left) and penetrant testing (right)

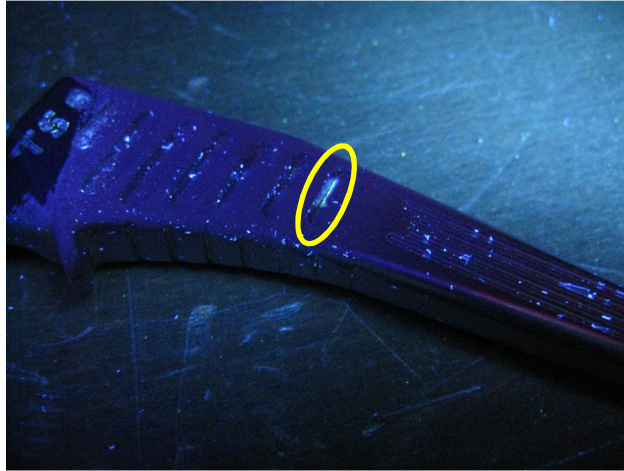
Forging defects located inside a groove on titanium prostheses aren't detected by this thermography configuration, although they are detected by penetrant testing (Figure 12).

Figure 12: Inspection of a titanium prosthesis by penetrant testing

The position of the defect (at the bottom of a groove) or its depth, are certainly the reasons why it was not detected. In fact, detecting defects on titanium parts is possible. In particular, this is the case in the example below (Figure 13) on a titanium plate with defects created artificially by forging.

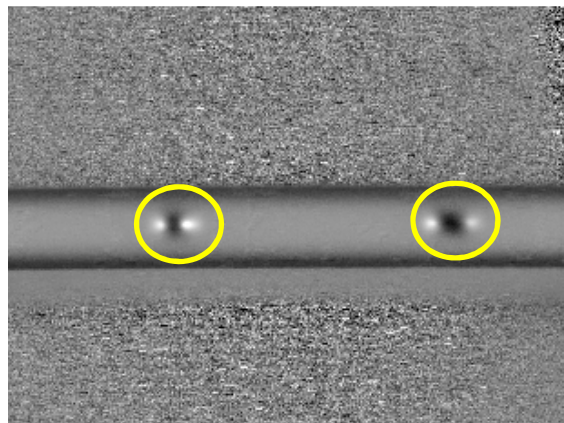
Figure 13: Inspection of a titanium plate by thermography testing (TT)
