Thermography in the Investigation of Gilding on Historical Wall Paintings

Keywords: infrared thermography, historical architecture, wall paintings

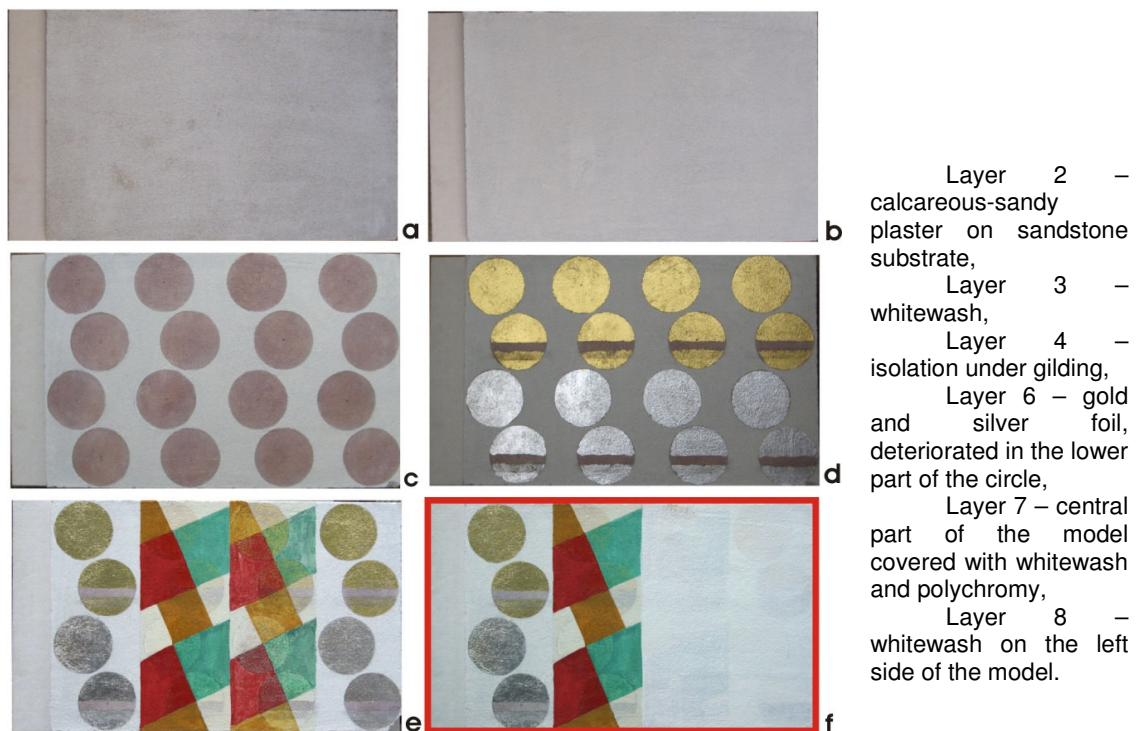
Fig. 2. The stages of model construction, layers marked as on model cross-section

Further research with the use of the third laboratory model, Fig. 1, concerned the evaluation of the state of preservation and the range of gilding under whitewash and polychromy. Taking into account previous experiences, a model on sandstone substrate was constructed, Fig. 2a and gilding was applied in separate circles (which imitated nimbuses of saints from Gothic paintings). Only two types of foil were used: gold and silver. Circles of intact and mechanically deteriorated foil (gold or silver) were applied in pairs Fig.2d. Next the gilded areas were covered with whitewash and polychromy (glazing and covering paint)

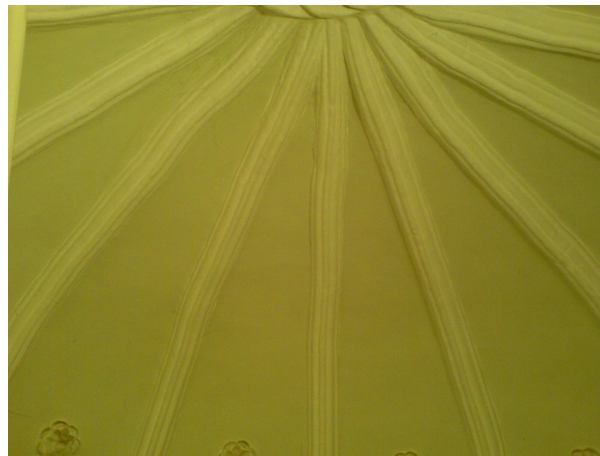
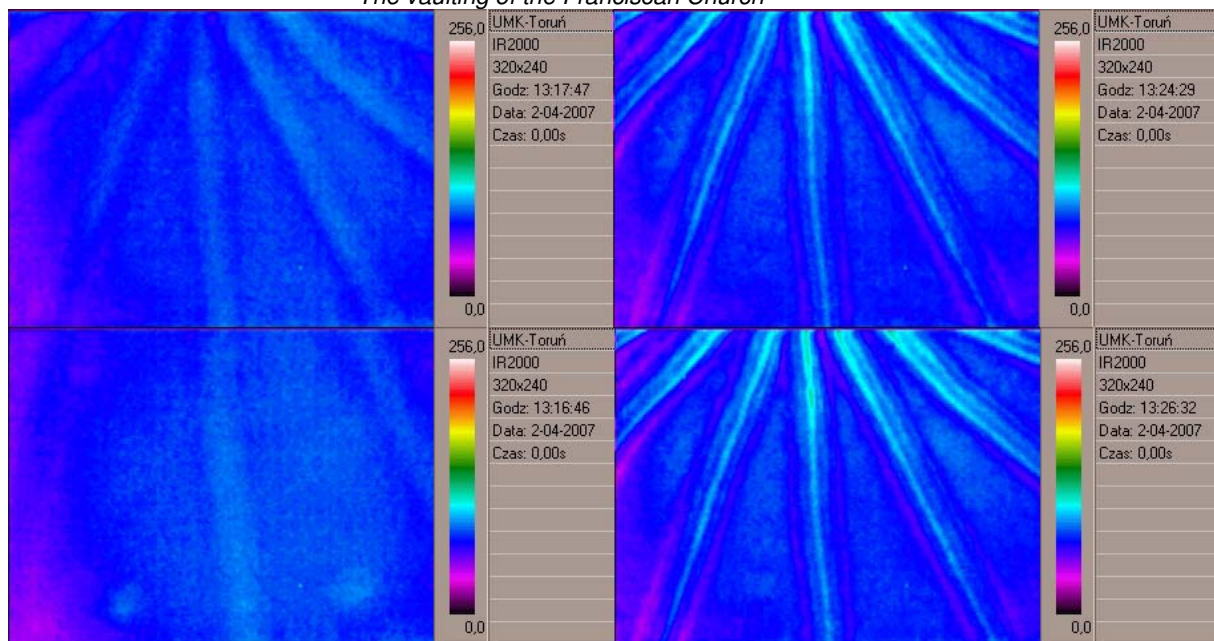
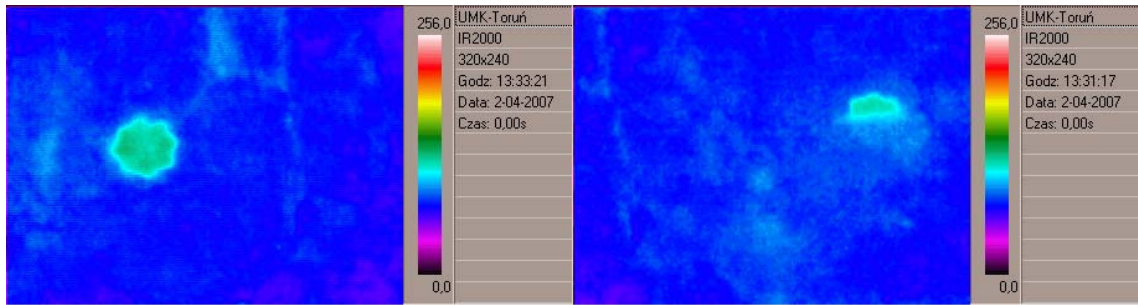
The vaulting of the Franciscan Church

Fig. 4. Thermographic measurements on the vaulting of the Franciscan Church in Włocławek (Poland). Images of the ribs recorded with no heating provision (a, b) and after heating (c,d). The two latter pictures revealed the presence of stars under whitewash (a, b)

Thermography showed to be a satisfactory method in searching for polychromy and gilding under a layer of whitewash , which can be seen from the following figures Fig 4, 5, 6.

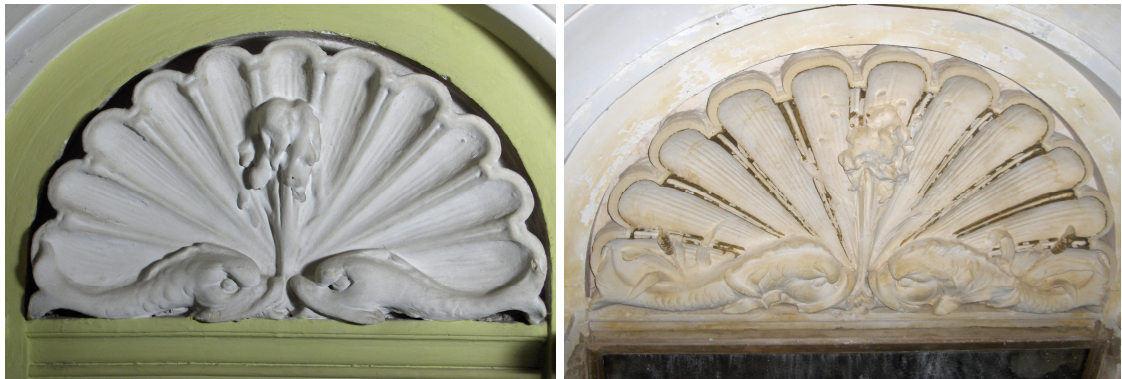
Fig. 5. Stuccowork in Ciechocinek (Poland). On the left side picture a fragment covered with white wash, on the right side – gilding uncovered after cleaning
