DEFBETIR: Detection by infrared thermography of the heat signature of diseases and defects in concrete structures of civil engineering.

by M. Nahant*, S. Paez** and J. Van Leeuwen***.

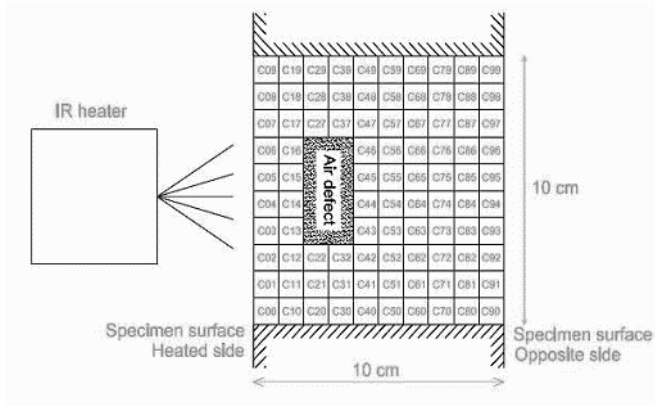
Fig. 1. Cross section of the model, showing a defect constituted of air.

A tri-dimensional finite elements computer model has been developed in order to simulate the heat flow progression in a concrete material. It represents a cube of concrete of 10 centimetres of edge, which is part of a semi-infinite concrete wall. The cells of the model are cubes of 1 cm edge, so there are in all 1000 cells.

The model takes into account physical principles of conduction, convection and radiation. The attributes of each cell can be modified, so it is possible to put virtual defects anywhere in the model. The aim of this program is to simulate various configurations, like different defect depths, heating power or heating time, to check the value of the superficial thermal contrast.

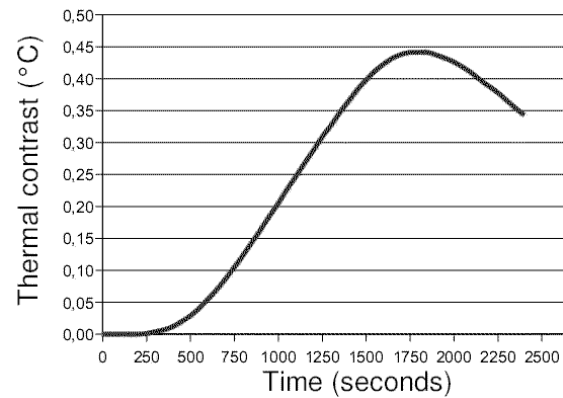
Fig. 2. Evolution of thermal contrast in front of a defect (in °C) versus time (in seconds)

The information which can be drawn from this analysis is :

- Maximal thermal contrast is directly proportional to heating power,
- Maximal thermal contrast is also directly proportional to heating duration,
- Time of apparition of maximal thermal contrast is nearly independent of heating power, and doesn't vary very much with heating duration.
- Steel reinforcing bars have nearly no impact on the detection of defects,
- The maximal depth allowing the detection of defects is about 5 cm,
- For a rock-pocket-like defect, at 4 cm depth, the maximal thermal contrast is about 15 % of the temperature elevation of the surface of sound concrete at the same time.
- The effect of the wind is very important : a 20 km/h wind divides by two the thermal contrast of a subsurface defect.

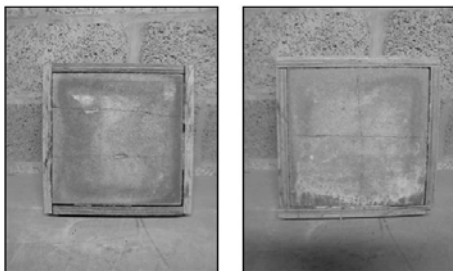
Fig. 3. Concrete slabs used for studying the detectability of cracks

Some concrete elements have been broken and then re-assembled, in order to try to discover if infrared thermography is appropriate to detect cracks. The slabs were heated in a single point with a hot air heater. Tests have shown that the cracks slow the heat flow going from the heated point to the surroundings, showing the crack lines on the thermographs.

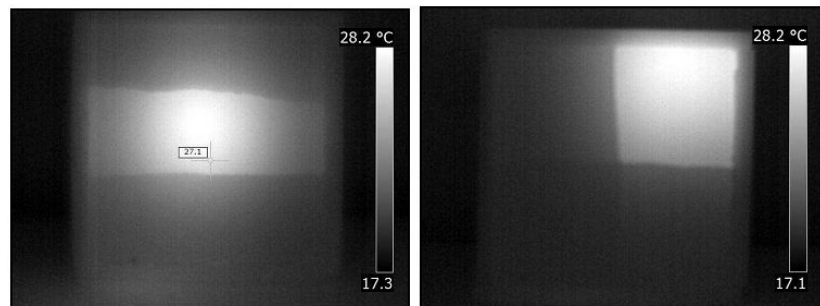
Fig. 4. Infrared pictures of the slabs after local heating

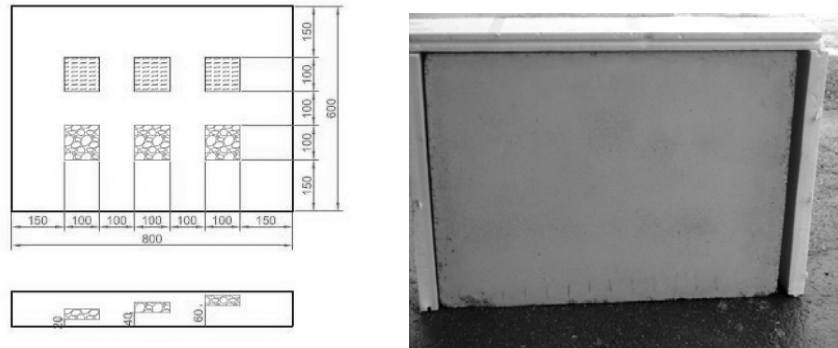
Fig. 5. Layout and picture of the concrete slab, containing polystyrene blocks (on top) and gravel packets (at the bottom)

Some concrete slabs, containing gravel packets made to simulate rock pockets, have been realized. They have been studied using two different heating methods : static and moving. The heating, performed with an infrared heater, is not uniform enough with the static configuration, which adds an important difficulty to the detection of internal defects.

Further PPT results are obtained on a test slab (fig 5) with defects at 2, 4 and 6 cm depth from the surface. The heating is artificial and uniform (fig 11 a,b,c) or non-uniform (fig 11 d,e,f). The slab is heated during twenty minutes, then one infrared picture is taken per minute during a cooling time of 90 minutes. Like with the numerical simulations, best results are obtained with phase images which reveal all the defects in both conditions of heating.

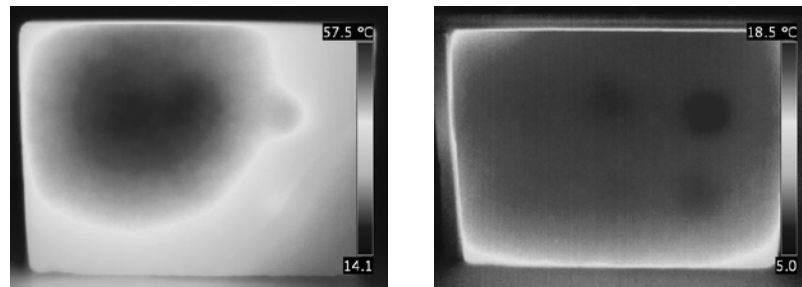
Fig. 6. Infrared pictures of the same slab. Comparison of both heating techniques : static heating (on the left) and moving heating (on the right). The second one gives a better uniformity and allows a better defect detection.

Consequently, it appears that the heating must be as even as possible to make reliable measures. For this purpose, moving is better than static heating. Moreover, when the test is carried out outside during a cold and windy day, it is much harder to detect the defects, due to the influence of wind and edge effects. It is thus better to protect the studied surface from the influence of the wind.

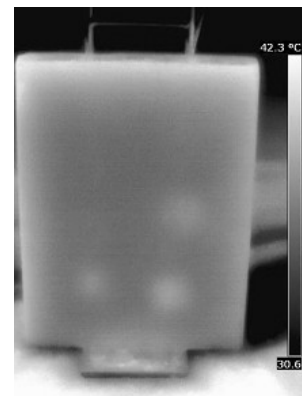
Fig. 7. Infrared picture of the slab : passive thermography (the only source of heating is the sun)

The slab on the next thermogram has been exposed to sunlight for two hours, around noon time, a very sunny September day. On the infrared picture, the near-surface defects appear very clearly. Passive thermography can be used to locate rock pockets in concrete structures.

The main advantage of passive thermography is that it is both a cheap and an environment-friendly technique which provides a perfectly even heating. Disadvantages are the relatively low available heating power and the dependance to weather conditions, to surface orientation, and to the colour of the concrete, as the sun mainly heats in visible light.

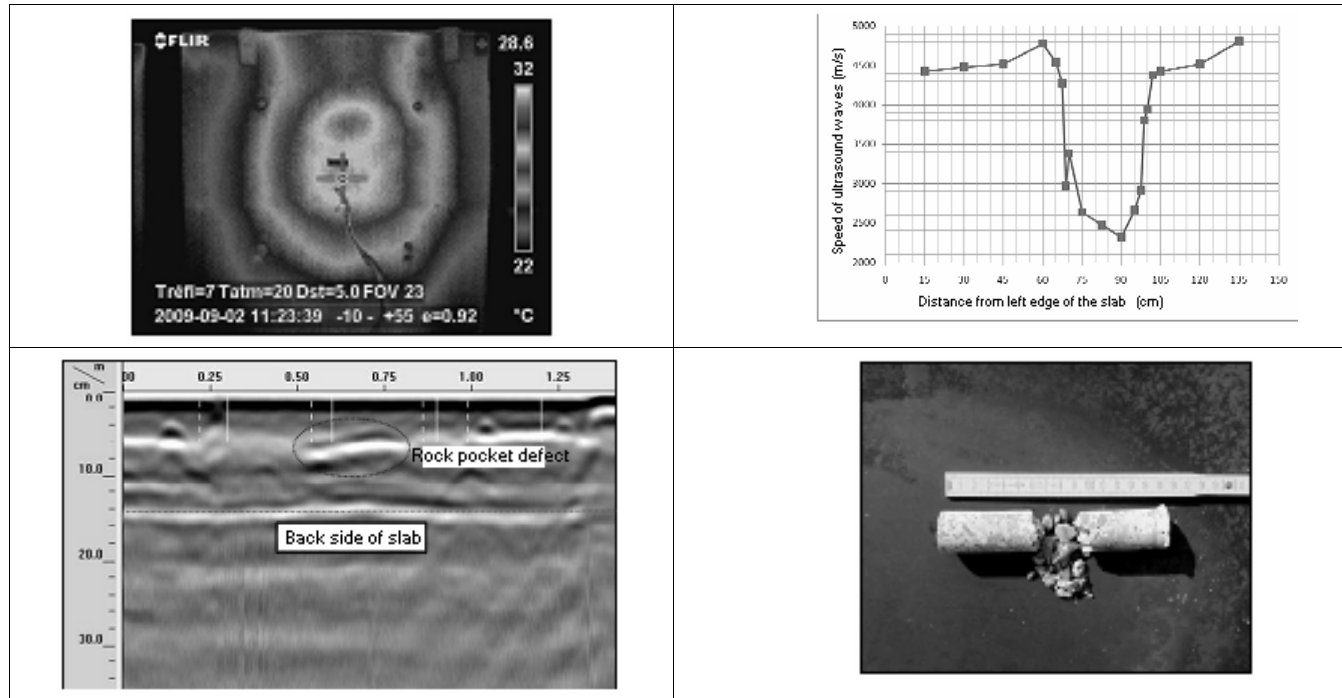
Fig. 8. Results of the four scanings. From top left to bottom right : active thermography, ultrasound, ground penetrating radar and coring.

A very large concrete slab, containing a rock-pocket defect, has been studied by infrared thermography and three other techniques (ultrasounds, ground penetrating radar and coring), to check if the four results are matching.

The results of the four techniques match perfectly and locate the defect on the same spot. This shows that infrared thermography works as well as other proven techniques for detecting subsurface defects in concrete elements, and can be used on construction sites.

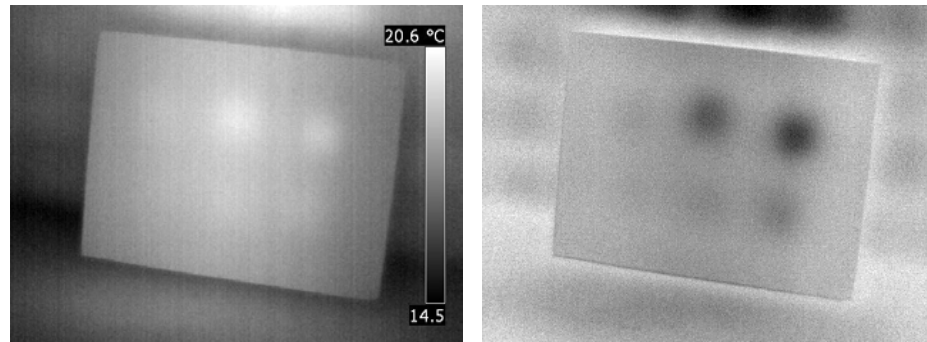
Fig. 9. Derivative method : the defects appear better on the derivative image (on the right) than on the original thermal image (on the left)

This technique, developed recently by Shepard's group [4], consists in smoothing the surface temperatures cooling curve of each pixel of the image. Then the first and second derivatives are calculated, and images are reconstructed from those, identifying defects in a better way. The pictures below show the usefulness of this technique to decrease the importance of non-homogeneity of the heating.

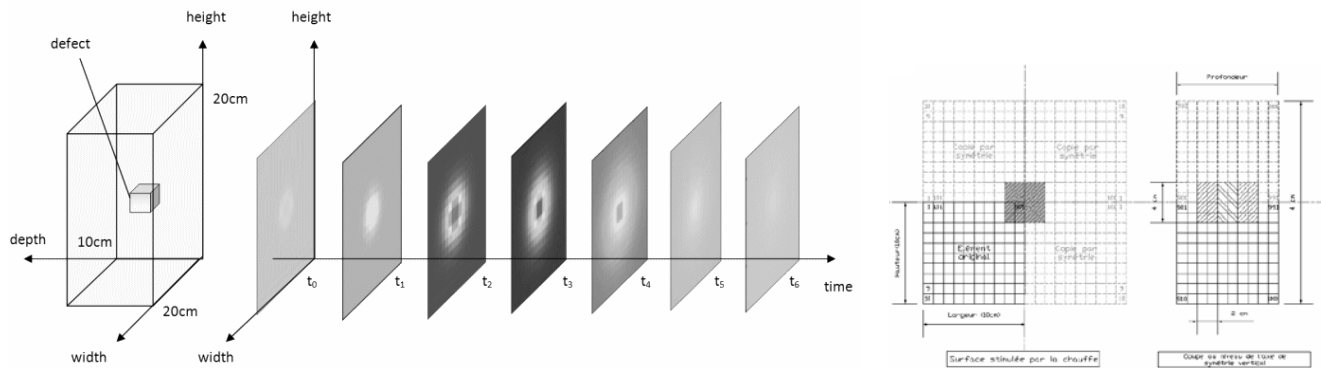
Fig 10 : Evolution of the surface temperature of a concrete element where a defect is inserted. (This defect consists of 50% of air and 50% of concrete)

First results are obtained by numerical simulation. After a heating phase the PPT is applied to the cooling phase. It appears that the phase images strongly reduce the non-uniformity of the heating, allowing a much better detectability. On the other hand the amplitude images do not improve the detectability.

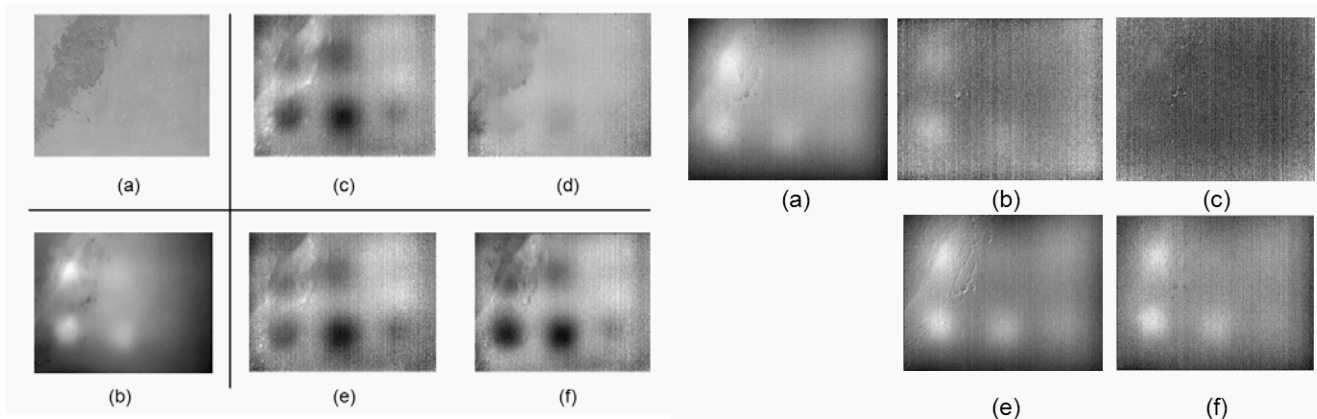
Fig. 12: Artificial heating. (a): photograph of the test slab; (b): infrared picture; (c) and (d): phase images at $1,85 \cdot 10^{-4}$ Hz and $3,7 \cdot 10^{-4}$ Hz; (e) and (f): phase images at $1,85 \cdot 10^{-4}$ Hz and $3,7 \cdot 10^{-4}$ Hz with smoothing.

Outdoor tests are performed on the same slab, still with artificial heating but under real climatic conditions disturbing the detection : the variations of sun power and wind speed during the experiment create disturbances in the cooling curve. Moreover, the slab has zones where the surface colours are different. The darker zones receive more solar energy, they become thus hotter and the infrared pictures are strongly disturbed by this phenomenon. Information on phase images is thus reduced. The defects are clearly visible on the first image of phase (fig 12 c). On the following images of phase, they are no more detectable (fig 12 d). To improve the images of phase, the cooling curve of each pixel is smoothed. This operation allows to obtain a better detectability on several images of phase (fig 12 (e), (f)).

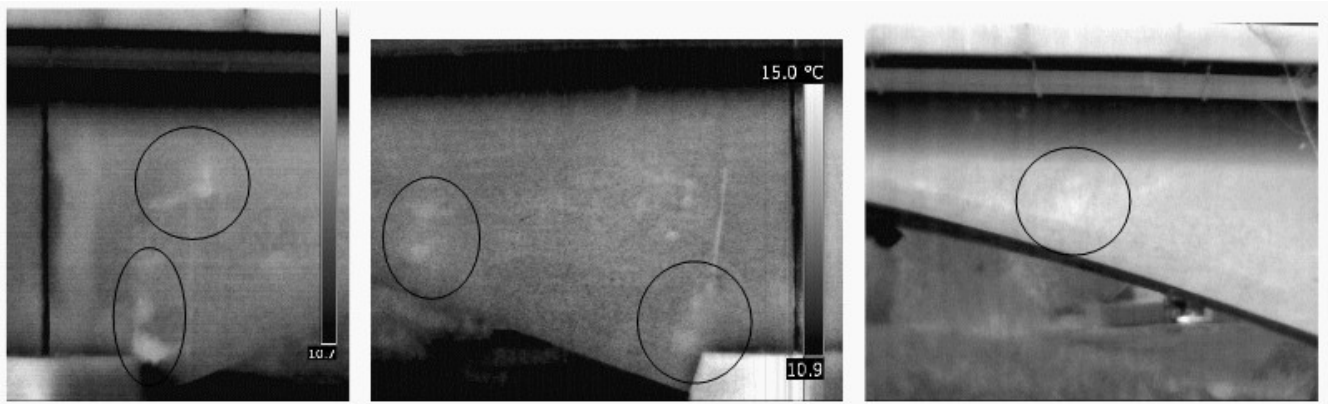
Fig. 14. Infrared pictures taken at the bridge of Moyen with passive thermography. Rock pockets appear as warmer zones.

This reinforced concrete bridge is known for containing many rock-pocket defects. A passive thermography survey has been carried out to locate them. Here are the most significant pictures where subsurface defects are circled.

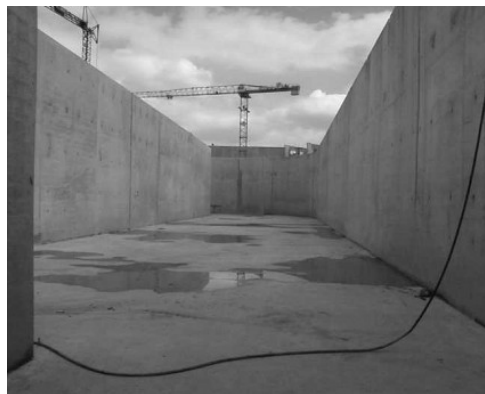
Fig. 15. The biological tank of a wastewater treatment plant

Special constraints for the present project are the dimensions of the purification pools : the surfaces that need to be analyzed by thermography vary from a hundred square meters to several thousands. The walls of those tanks are made of high quality reinforced concrete, and they are sometimes thicker than thirty centimetres.

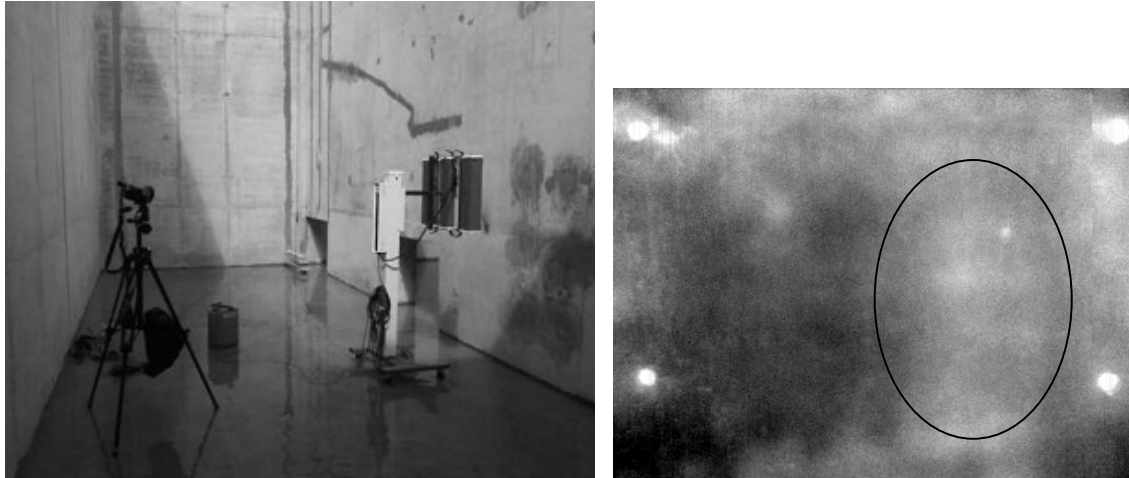
Fig. 16. A warmer zone appears on the thermographic picture, probably showing up the presence of a internal defect.

An active thermography auscultation has been carried out, and an alleged defect appeared on the pictures.
