THERMOGRAPHIC INVESTIGATIONS SUPPORTING DIAGNOSIS FOR FONDATIONAL AND CONSERVATIVE ISSUES: the case study of Anime Sante del Purgatorio Church in Caccamo, Sicily-Italy

by A. Bianco

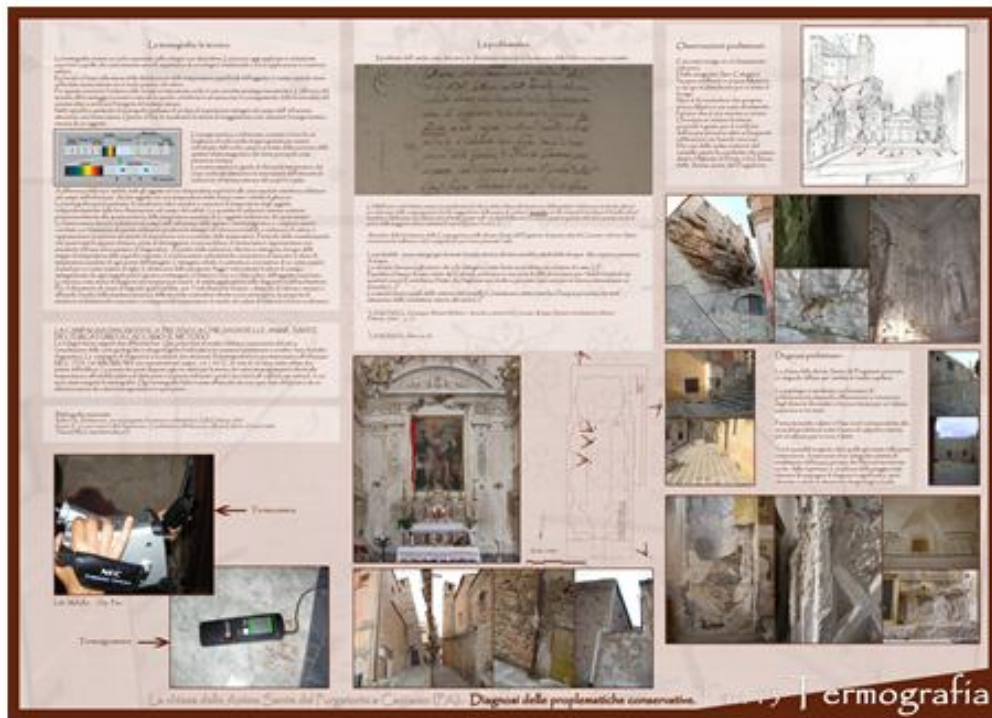
For this reason was projected and realized a diagnostic investigative campaign, aimed to monitor the Church inside (where were most evident degradation and structural cracks) and outside (where we supposed a presence of canals); this monitoring was conducted realizing at same time an extensive thermographic mapping and a thermohigrometric recording, made comparing the results obtained in sunny and rainy days. The repetition of the same investigative protocol in different climatic conditions permitted to verify the incidence of rain flow and to have a confirmation of presence of supposed canals with the individualization of others (figure 1).

Fig. 1. The Anime Sante del Purgatorio Church , TI investigation

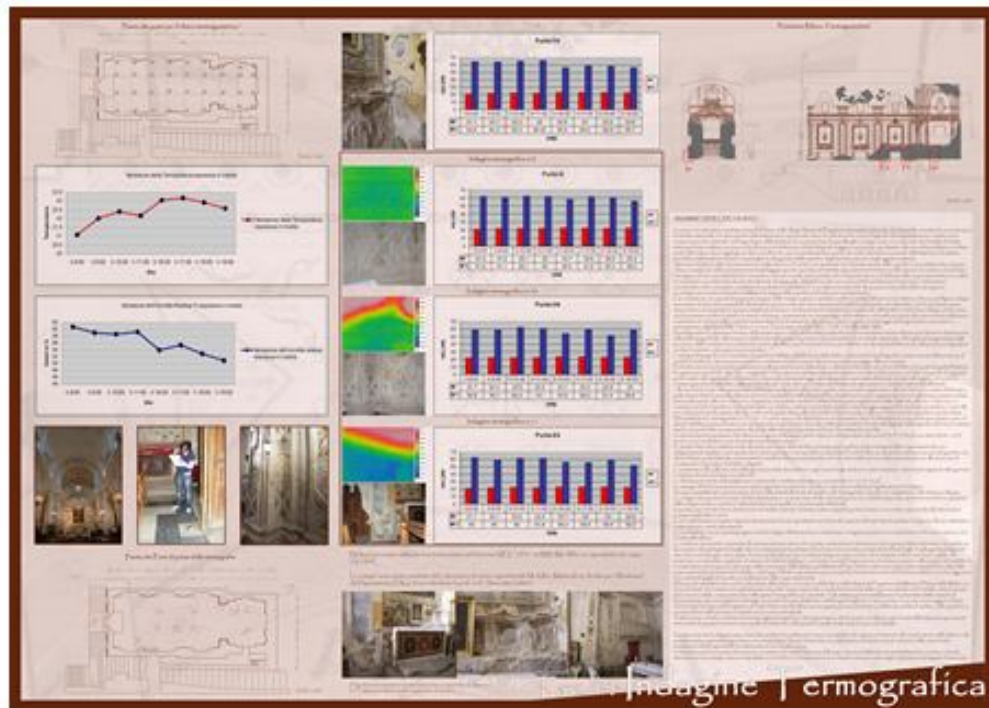
The capability of this investigative methodology to individualize the area more exposed to this peculiar conservative vulnerability permitted also to define a simple intervention project, which contains realization of an alternative system of underground canals, to intervene on the causes, and little works of cracks repair and foundation isolation with a aerating trench and material consolidation of decorations, to intervene on the degradation. Finally capability to repeat the same investigative protocol after realization of intervention gives an opportunity to value, in qualitative and quantitative terms, its efficacy, on a short time, and its efficiency on a long time (figure 2).

Fig. 2. The Anime Sante del Purgatorio Church , TI results
