Coupling infrared thermography and acoustic emission for damage study in CFRP composites

by V. Munoz *, B. Vales*, M. Perrin**, M.L. Pastor**, H. Weleman*, A. Cantarel** and M. Karama*

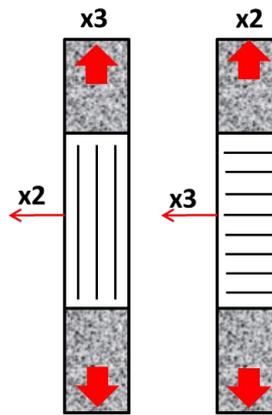
Fig. 1. Fibre direction for each kind of specimen

A carbon fibre reinforced laminate is considered for this study. The composite is made of 14 unidirectional plies of prepreg Hexply M10R/38%/UD150/CHS leading to a 2 mm thickness composite with fibre volume f_v of 62%. The reference of the fibre is TORAY T700S. Sample fabrication is carried out using the manual lay up technique. Then the sample is cured at 125°C during 90 minutes at a pressure of 2 bars. This sample is representative of a transversely isotropic composite. To obtain the tensile samples, the cured plate is cut according to the standard ISO 527-5 [12]. Two composite directions are obtained after cutting the plate (0° and 90°). Figure 1 shows the axis fibre direction (direction x3) for each category of specimen.

The tensile tests are made at ambient temperature. These tests are performed with an electromechanical testing machine INSTRON 5500. 2 tests are carried out according to the fibre direction, 0° (axial load along the direction x3) and 90° (axial load along direction x2) (figure1). To check the reproducibility of the response, three specimens are considered for each loading direction.

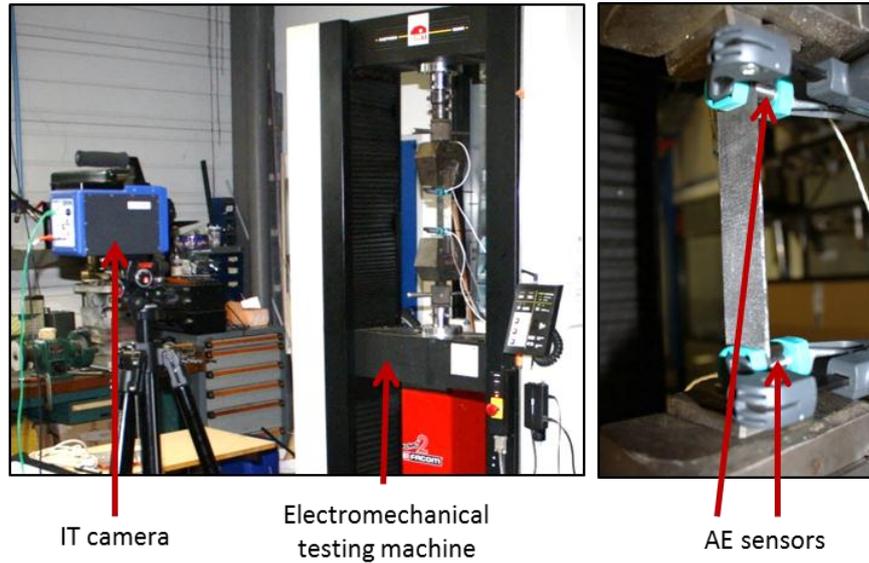
Fig. 2. Experimental setup

The thermal acquisition is done with a FLIR Titanium SC7000 retrofitted camera. Automatic calibration, control of the camera and data recording are done by Altair software. Acquisition frequency is 150 Hz. So as to limit surrounding influences, a data processing after the acquisition phase has provided the temperature variations fields $\Delta T = T - T_0$ over the sample, with T the temperature field at time t and T_0 the temperature field in the initial state $t = 0$. Such relative analysis avoids the most disturbing effects, including environmental ones, and highlights the thermal events induced in the material.

The acoustic emission activity is recorded during the tensile test using AEwin for SAMOS software. The data acquisition system is composed by a PCI8 board in which two channels are used. The AE monitoring is conducted using two piezoelectric sensors mounted on one side of the specimen. The sensors are attached using mechanical support while supplying the necessary acoustic coupling agent. The WD sensors are wideband with frequency band-width between 100 kHz and 1 MHz. In view of environmental noise in the laboratory, the acquisition threshold is set to 32-35

dB. The acquired signals are amplified by 40 dB. Two sensors have been positioned at the top and bottom of the specimen in order to derive the location of the AE events. The full experimental setup is shown in figure 2.

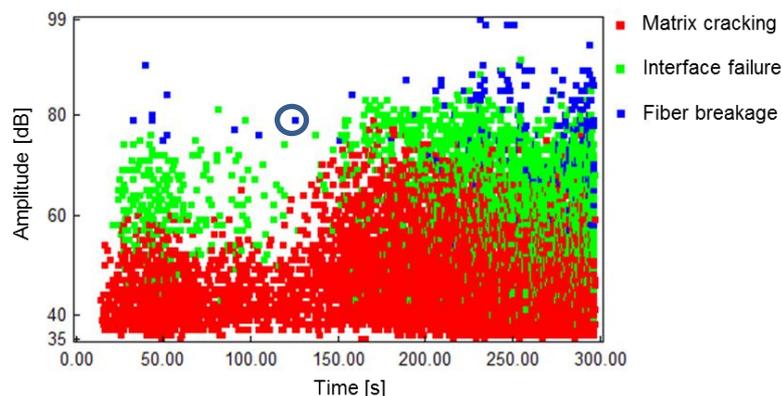
Fig. 3. Cluster results of acoustic emission for 0° tensile test

Figure 3 shows on the amplitude versus time graph the classes of AE data obtained after the application of the pattern recognition method. Three groups are clearly distinguished. The red group with the lowers amplitudes corresponds to the matrix cracking, the green group refers to the debonding and interphase failure and the last blue group corresponds to the fibre breaking. We can see that the fibre breaking generates AE at high amplitudes in regards to the others damage mechanisms.

Correlations between AE and TI measurements have been done between several heat sources and acoustic events of high amplitude and high energy. As an illustration of the analysis, the procedure and results are explained here on the case of the one specific AE event selected on figure 3. Figure 4 shows the thermogram (figure 4a), the heat source (figure 4b) and the located amplitude (figure 4c) for this damage that appeared at 128.428 seconds after the beginning of the tensile test. According to the figure 3, this damage (at this specific time) corresponds to a fibre breaking. We can see that the amplitude of the analyzed acoustic event is around 79 dB (figure 4c). To correlate that specific AE to

Regarding the specific event highlighted in figures 3 and 4b, we can see that the location of the heat source and acoustic event stand in the same zone of the specimen (lower part) near the sensor number 2 (indicated by the green number 2 in figure 4c). The error of the AE location in regards to the heat source is 25%. However, it is important to note here that the location in AE is done by measuring the velocity of the wave for each specimen in the initial state. The slight difference in location may thus be explained by velocity change induced by the damage and load applied.

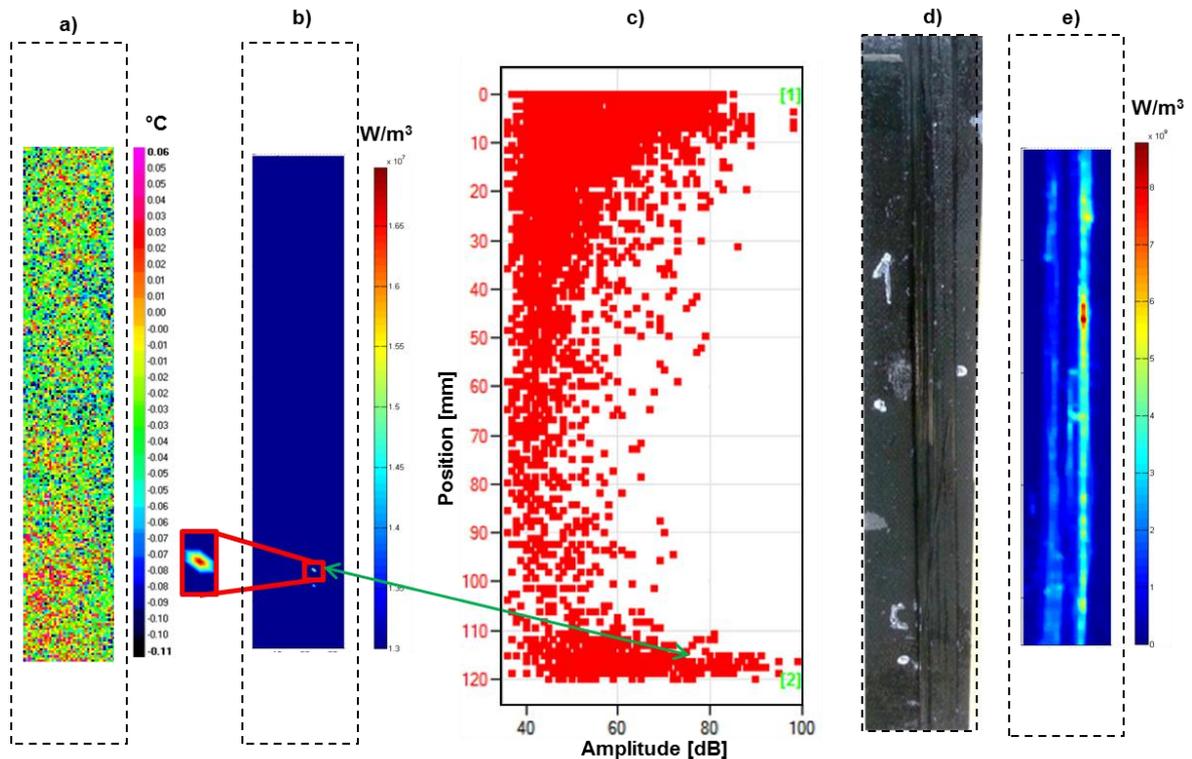
Fig. 4. Correlation between heat source and acoustic emission amplitude for the 0° specimen

the heat source, it is needed to analyse the maximum of heat source at a specific timespan. We have considered an interval of 1 s around the AE event (128.428 ± 0.5 s) which includes 150 thermal frames. During this timespan the maximal heat source is obtained at 128.407 s. (error of 0.02%) for the pixel highlighted in figure 4b. Figure 5 shows that for such analyzed pixel, the heat source gets indeed its maximal value at the AE event time.

Figure 4c provides the location of AE events during the test. Events take place all along the specimen length, which stands in agreement with the post-mortem observation shown in figure 4d and its heat source (breaking time) (figure 4e). We can clearly see that the final breaking of 0° specimens results from macroscopic debonding in the fibre direction.

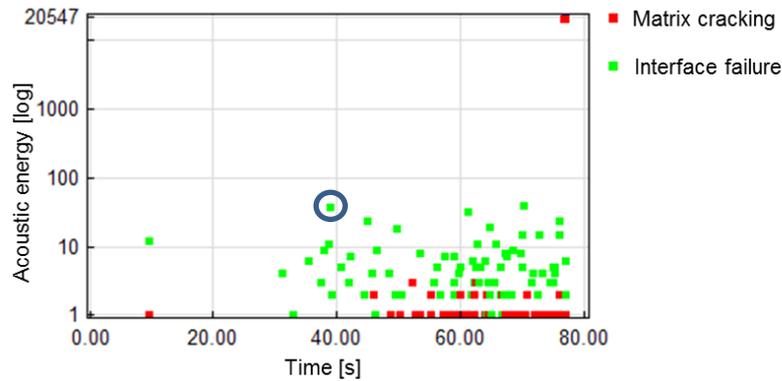
Fig. 6. Cluster results of acoustic emission for 90° tensile test

Figure 6 shows the classes of AE for the 90° specimen. As explained before, only two groups are needed according to the damage mechanisms for this fibre direction: the red group represents the matrix cracking and the green group refers to debonding. The AE corresponding to the matrix cracking have the lowest energy and amplitude. In this case the analyzed AE corresponds to a debonding (selected AE event in figure 6). This allows observing that debonding or delamination also create heat sources as important as the fibre breaking.

In the same way, a specific timespan is selected for the analysis. Figure 7 shows the thermogram (figure 7a), the heat source (figure 7b) and the located acoustic energy (figure 7c) for the selected damage at 42.220 seconds after beginning the tensile test. As explained above and according to figure 6, this damage (at this specific time) corresponds to an internal debonding. The acoustic energy for this specific damage is 38 aJ (figure 7c) which is high in regards to the others AE. For the analysis we have considered an interval of 1 s (42.220 ± 0.5 s) which leads to 148 thermal frames to be analyzed. During this timespan the maximal heat source is founded at 42.216 s. (error of 0.01%) (Figure 7b). Again, figure 8 shows the correspondence between AE event and maximal value of the heat source for the analyzed pixel. Some high heat sources can be seen some milliseconds before and after the analyzed instant but should be considered as parasite events generated by some thermal noise since they do not correspond to any AE.

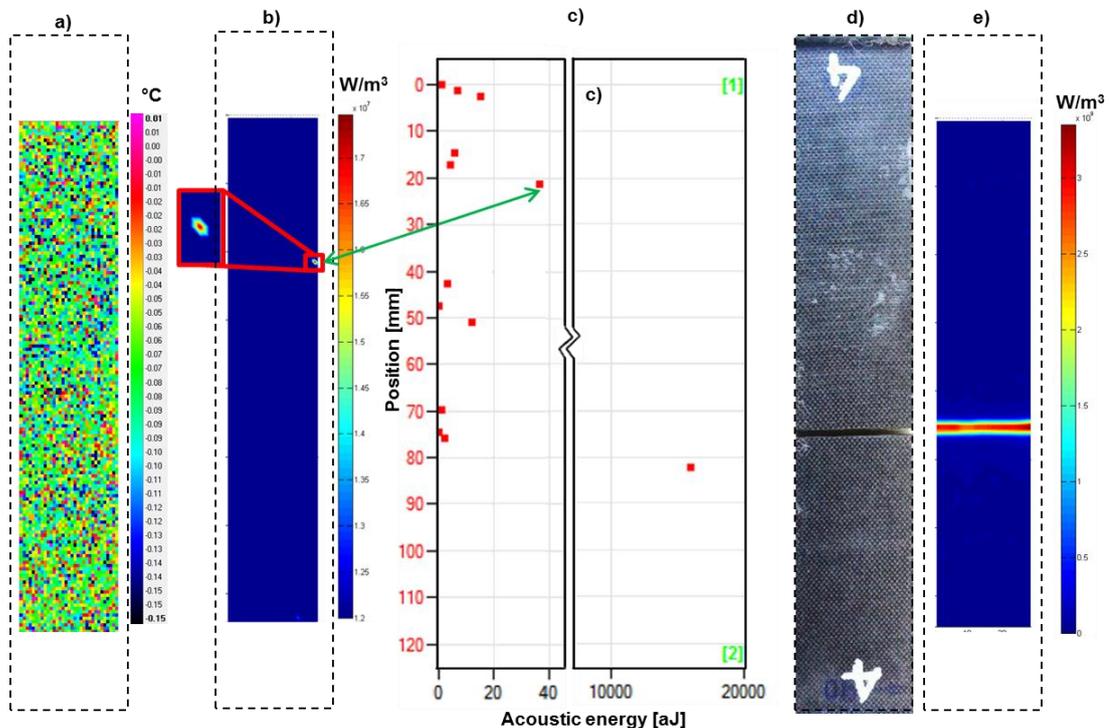
Fig. 7. Correlation between heat source and acoustic emission energy for the 90° specimen

In this case, the location of the heat source and the acoustic event are also in the same zone of the sample (near sensor number 1) with an error of 21%. In addition to the changes in velocity, such difference may be related to much more brittle character, and therefore instable of the failure in that case. Indeed, it is shown in figures 7d and 7e the final failure breakdown occurs in the fibre axis, induced by the failure of the weakest point of the epoxy matrix (the breakdown is transversal to the load axis). The full load of the tensile test is supported by the matrix (epoxy) and so the break takes place transversally to the load axis.
