Evaluation about Detection of Defects in the Nuclear Piping Loop System Using Lock-in Infrared Thermography

Abstract

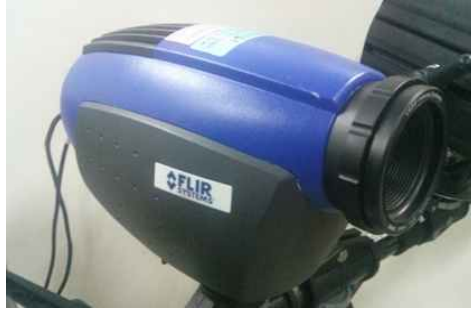
Figure 1. Infrared Camera

The camera used for this study is as shown in Fig.1, and its specifications are listed in Table 1. Infrared thermography is a technique that calculates phase and amplitude through digital signal processing with a high resolution (0.02°C) in order to measure minute changes in temperature in a mechanical structure. In this study, preceding experiments were performed in two conditions: First one was to assume that the nuclear power plant was shut down due to regular inspection and the other one was to assume that it was operating normally. In these two conditions, the state of pipes at normal temperature was inspected outside through heat flow of silicon oil inside the pipes. However, in this study, the insulation was not taken into consideration.

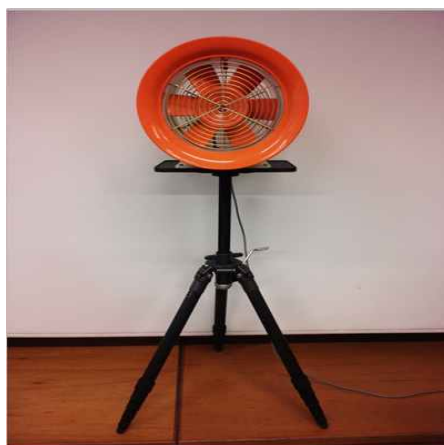
Figure 2. Cooling device

Fan cooler with better directionality and high speed is used for the study. Wind blower can cool the corresponding specimen via forced convection using the difference between fan inlet and outlet. Also, better directionality can ensure cooling in 2 ~ 3 m away. Fan cooler features aluminum die casting blade, and weight is reduced to 11 kg. Maximum wind speed is 16.5 m/sec, and blade length is 270 mm to ensure uniform cooling on pipe specimen. Fig. 2 shows the picture of fan cooler with high speed blower. According to the distance between pipe and 2 cooling units and the one between pipe and IR thermography camera, the analysis results are reviewed. 70% of rated power is applied on halogen lamp, and cooling lock-in IRT is used for image collection. Cooling cycle is set to 0.1 Hz.

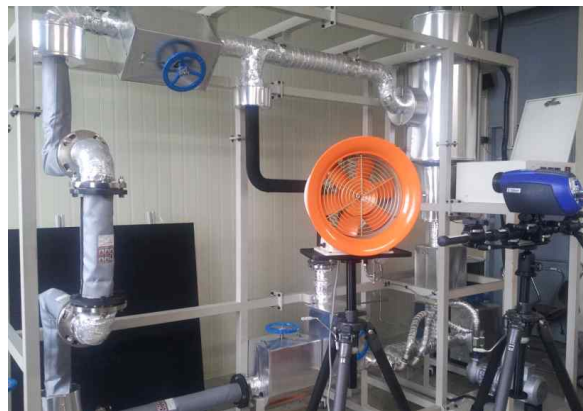
Figure 3. Loop system and infrared thermography

For this study, a loop system as shown in Fig. 3 was made using 2.5-inch pipes of ASTM A106 Gr.B carbon steel, and its specifications are shown in Table 2. In order to simulate a high-temperature pipe system of a normally operating nuclear power plant, the temperature inside the pipes was maintained at 250 using silicon oil. Distance between the cooling device and the pipe was set to 1.5m. Thermal properties of the ASTM A106 Gr.B carbon steel pipe used for this study are shown in Table 2.

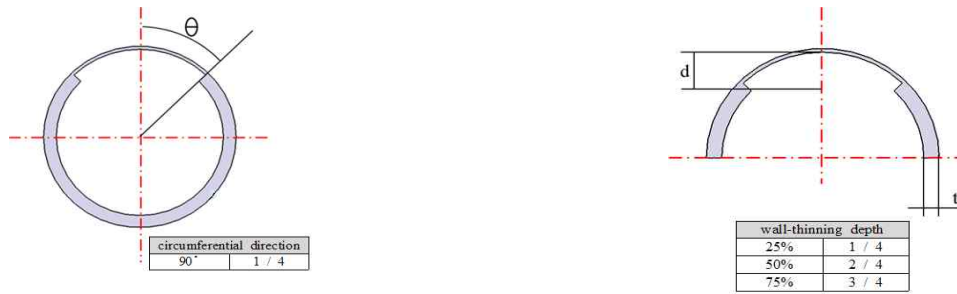
Figure 4. Dimensions of defects in pipe

In order to perform this experiment, the pipes made with the materials actually used in a nuclear power plant were used and defects with the following conditions were processed inside the pipes. The 2.5-inch pipe with the thickness (t) of 7.5mm, the length (L) of 350mm and 700mm, and the outer diameter (Do) of 113mm was processed to have defects with $L/Do=0.5$ (56.5mm) for straight pipes and ones with $L/Do=0.25$ (28.5mm) for complex pipes, as shown in Fig.4. In addition, the part where the transverse center line of the defect in the circumferential direction was horizontal to the infrared camera was changed to 0° as shown in Fig.4 (b), and the defect depth was regularly changed according to the pipe thickness, as shown in Table 4 below.

(a) pipe according to circumferential direction

(b) pipe according to wall-thinning depth

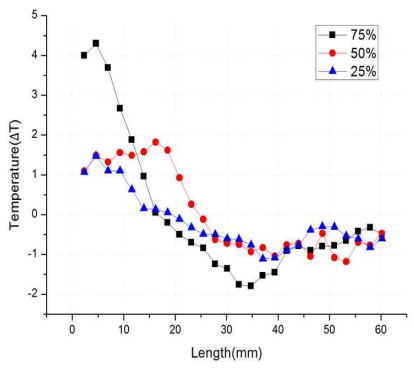
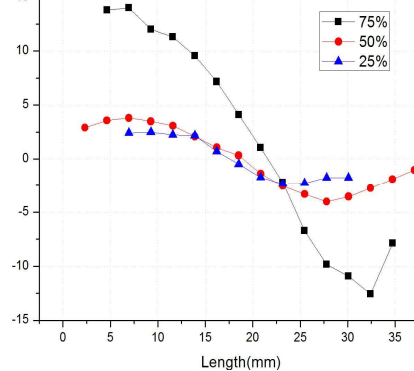
Specimen	Pipe Type	Thermography Image	Lock-in Thermography Image
700mm	straight(a)

Table 7. Thermography and lock-in thermography differential graph
