# Examination of heat insulation features of thermal resistant paints with use of IR camera

by T. Kruczek\*, I. Szczygieł\*, G. Kruczek\* and P. Kowalczyk\*

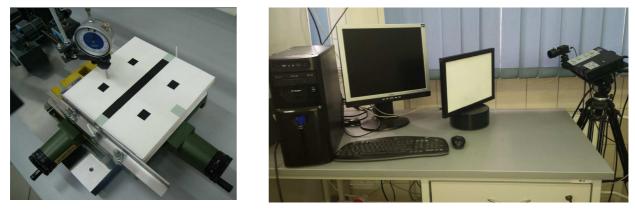
Fig. 5. Measuring equipment for measurement of the thickness of paint layers, dial thickness gauge (on the left) and 3D scanner (on the right)

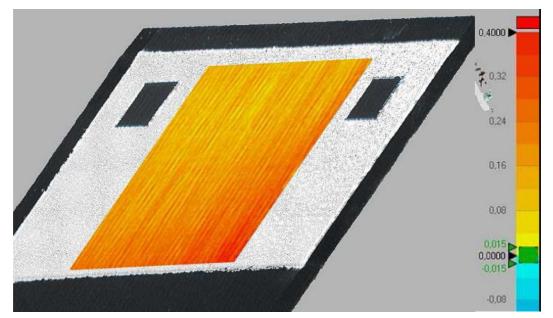
Fig. 13. Visual image example of the surface structure of the tested coating obtained by means of 3D scanner

In the measurements of the thickness of paint coatings also a 3D scanner was used. In Fig. 13 an example of high resolution image of the tested coating surface obtained with the use of such scanner is presented.
