## Inspection of HVOF-coated Pelton wheels using laser thermography

by J. Délémontez\*, Y. Caulier\*\*, M.Taglione\*\*, T. Busalb \*\*\* and E. Martin \*\*\*\*

After a feasibility study for the NDT (Non Destructive Testing) of Pelton turbine with hard coating, EDF decided to go ahead with an industrialized version of the Photo-Thermal Camera (PTC) developed by Framatome-Intercontrôle. The PTC is a portable laser thermography system. Before, a demonstration of performance was led in order to determine:

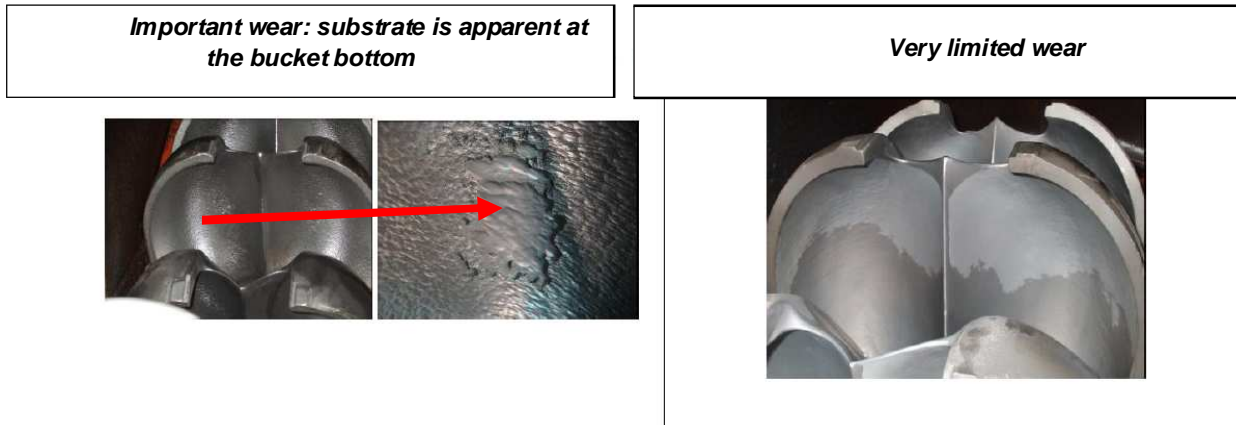
**Fig. 1:** comparison of wear state of the two types of coating tested (left: standard wear right: HVOF)

New wheels coated using the HVOF procedure were fitted to a turbine in some "pilot" plants. The feedback from 10,000 hours' operation has already indicated a drastic improvement in the state of wear of the coatings and allows strong supposition that there could be a gain of a further 2 years of useful life compared with traditional coatings, see figure 1:

- HVOF-coated buckets have a very smooth surface with hardly any wear marks ;
- the coating is still present in practically all functional areas with little loss of thickness.

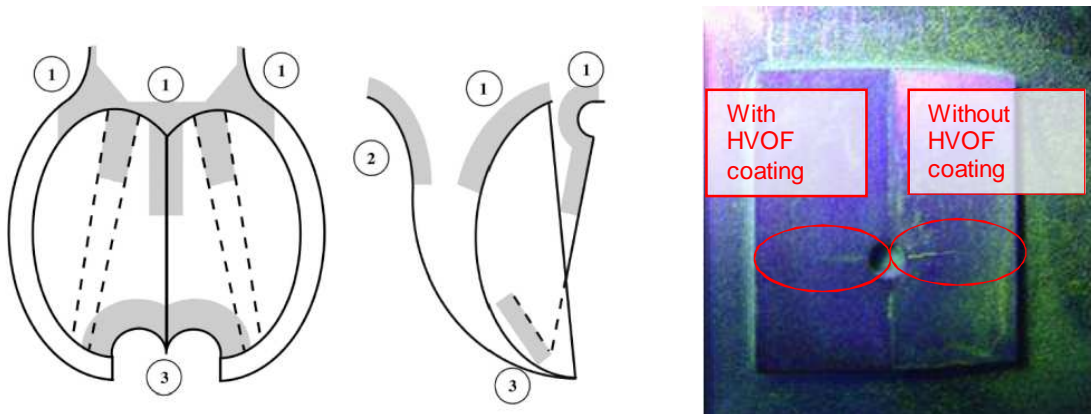
**Fig. 2:** areas sensitive to cracking in Pelton buckets (left) - Effect of the presence of the HVOF coating on the detection sensitivity of the NDT by MPI (right)

NDT by magnetic particle testing (MPI) carried out by the EDF maintenance teams is based on the search for the indication of a crack, caused by a phenomenon of magnetic AC flux leakage from the bucket that has been magnetised and sprayed with a developer containing fine ferro-magnetic particles. The HVOF anti-wear coating acts as a barrier against the phenomenon of flux leakage, see figure 2. The main consequence of this is a strong reduction in the sensitivity of detection, which is unacceptable in areas subject to high strain from fatigue. Failure to detect a crack several millimetres long during a periodic inspection could in fact lead to breakage and ejection of a bucket in service, which is unacceptable in terms of risk to property and people.

Subsequently, the inspection system was brought into a realistic environment to perform an inspection of two HVOF coated Pelton turbine at a hydro power station in the French Alps. This allowed the evaluation of the potential environmental interactions during an inspection in a real hydropower plant, and provided data about realistic implementation of this inspection in terms of positioning, control rate and safety. The positioning of the camera for inspecting the areas described on Fig. 2: requires a wide working range because of the various geometries that are at stake.

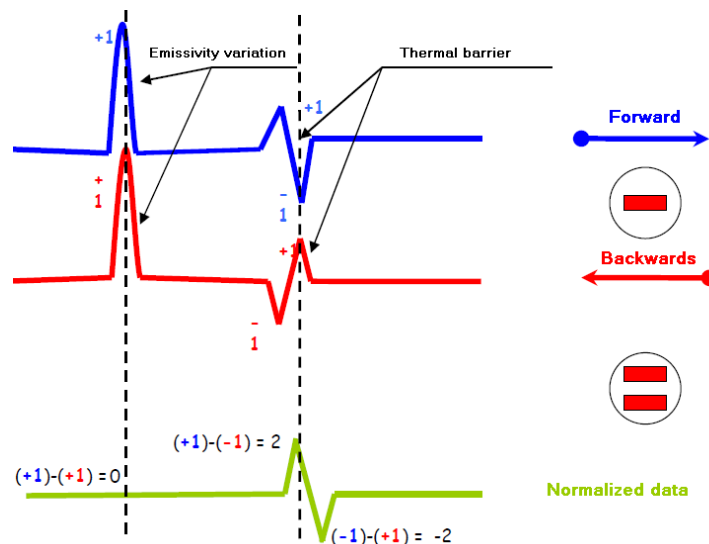
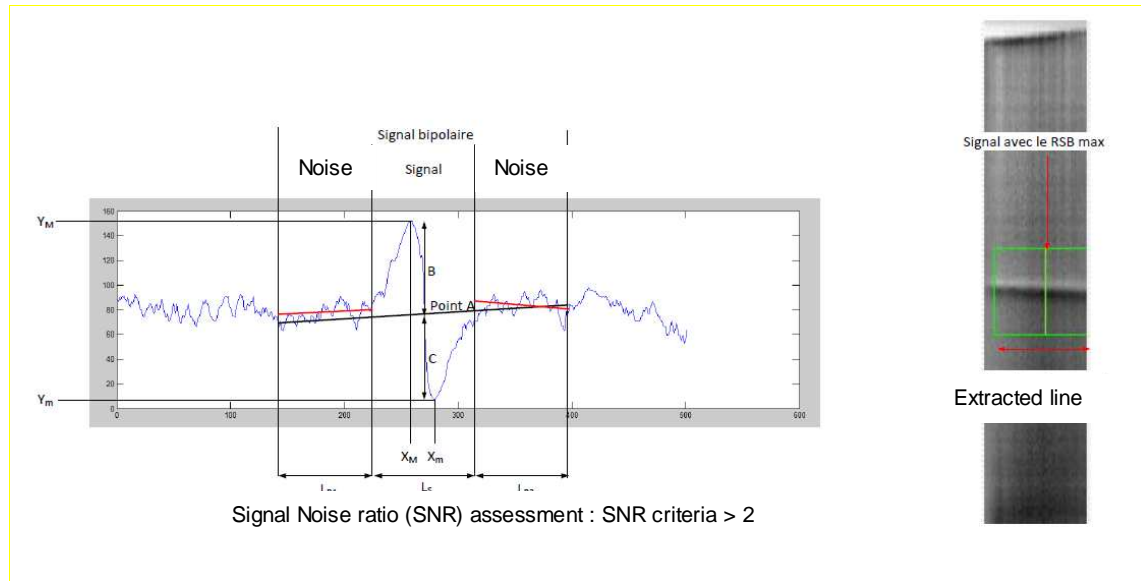
**Fig. 3:** photothermal camera normalization principle – bipolar signal features

The emissivity of the part inspected should not affect the thermography inspection. However, emissivity varies significantly according to different factors. One way to correct for its influence is scanning the part inspected two times: forward and backward. The impact of emissivity on the acquired images will be the same for both the forward and the backward images; however, the signal due to the disturbances in heat propagation will be reversed. A subtraction of the forward and the backward images will cancel out the emissivity signal, leaving only the image information due to the perturbation of the heat flux. Analysis of data acquired this way is straightforward.

One bucket of this turbine contained a real fatigue crack under a 350 μm thick HVOF coating. The PTC was placed in front of the wheel as can be seen on Figure 10, and both areas were inspected in blind-test conditions from this position at a 750 mm distance. The results obtained and shown on Figure 10 clearly indicate an indication which matches the established criteria for the crack classification (see figure 3):

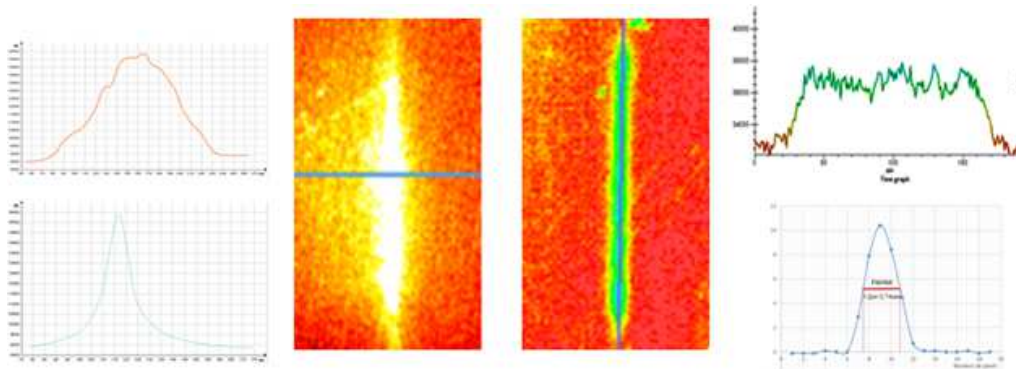
**Fig.4:** longitudinal and transversal profiles of the 2 beams (prototype and new PTC).

One of the improvements of the new developed PTC concerns the improvement of the laser beam geometry. A new beam generation system, using new types of optical lenses permits to project a more regular laser beam. The figure 4 below show the comparison between the previous and new PTC laser beam. The new PTC system was also improved in terms of weight (reduced by a factor 3), dimensions (reduced by a factor 3), and ergonomics (only one software for the calibration, acquisition and processing). The figure 5 below show the new PTC during the inspection of a mockup with an electro-eroded defect beneath the 300 micrometer HVOF coating.

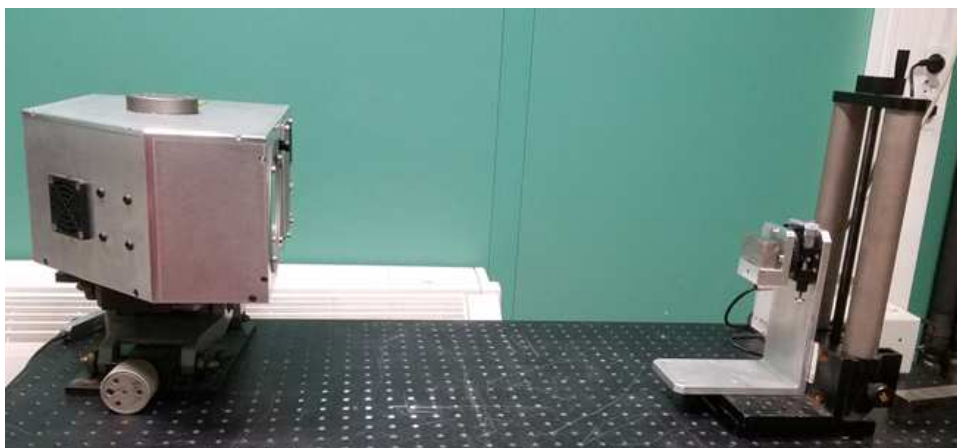
**Fig.5:** test bench (CPA box and PP/AP06 mockup on a gripper)

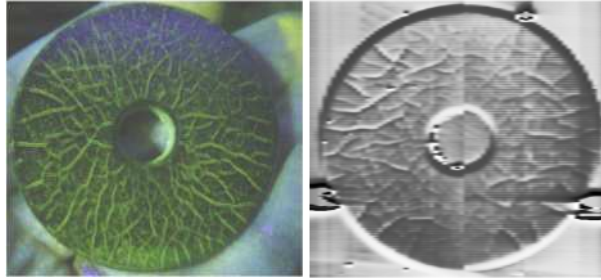
**Fig.6:** comparison of MPI (left) vs. PTC prototype (right) – images of block nr 1 according to EN ISO 9934-2 MPI standard

The comparison of thermographic inspection using the PTC prototype and magnetic particle testing can be realized using the calibration samples from the existing EDF procedure. This calibration sample is designed according to EN 9934-2. It includes surface breaking fatigue cracks, as can be seen on Fig.6.

Using laser thermography, we can see that the crack networks can be detected the same way they are with magnetic particle testing. This concurs with the experience of Framatome-Intercontrôle has with this technique, which shows that its sensitivity is in the same range as MT for both surface breaking and underlying cracks on steel components.

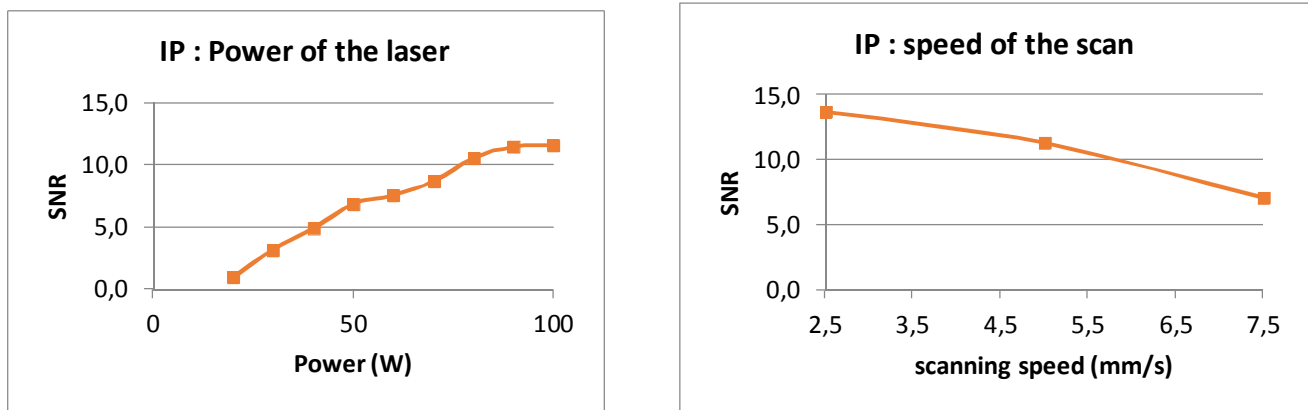
**Fig. 7:** influential parameter – power of the laser – Signal to Noise Ratio on the references flaw in a nickel alloy plate.

- Integration time ( $\mu\text{s}$ ),
- Laser line length (mm),
- Laser Power (W), see figure 7,
- Laser Energy distribution,
- optical focal length (mm),
- Distance of the laser to the surface object (mm),
- Scanning speed (mm/s), see figure 7,
- Repeatability...

All the tests were made in laboratory conditions on mock-up containing surface breaking reference flaws (length 5 mm, depth 2 mm), and with mock-ups representative of the HVOF coating.

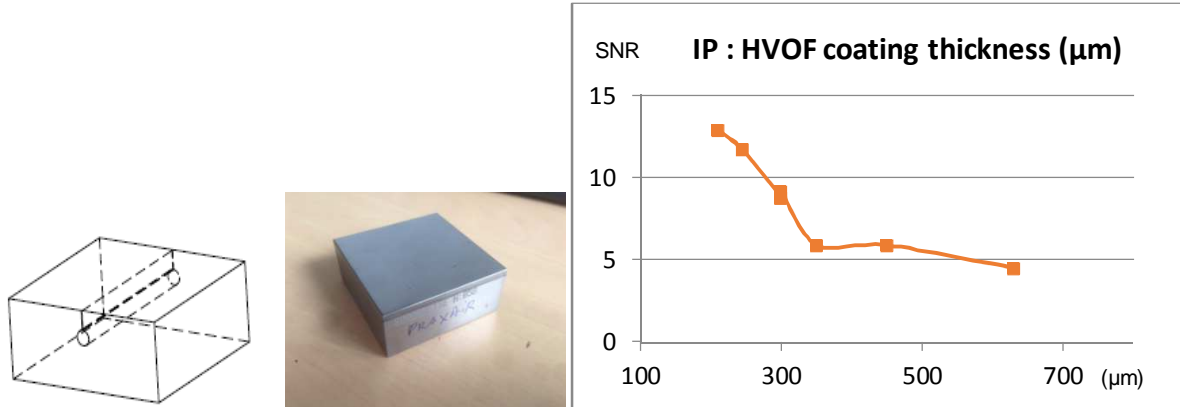
**Fig. 8:** influential parameter – HVOF Coating Thickness – SNR assessment on reference defect

- thickness of the HVOF coating (variation range from 200 to 1000  $\mu\text{m}$  : a set of 8 small mock-ups was especially manufactured for this purpose, each mock-up made of CrNi17-4 martensitic stainless steel contain a reference defect under the surface of the coating, see figure 8,

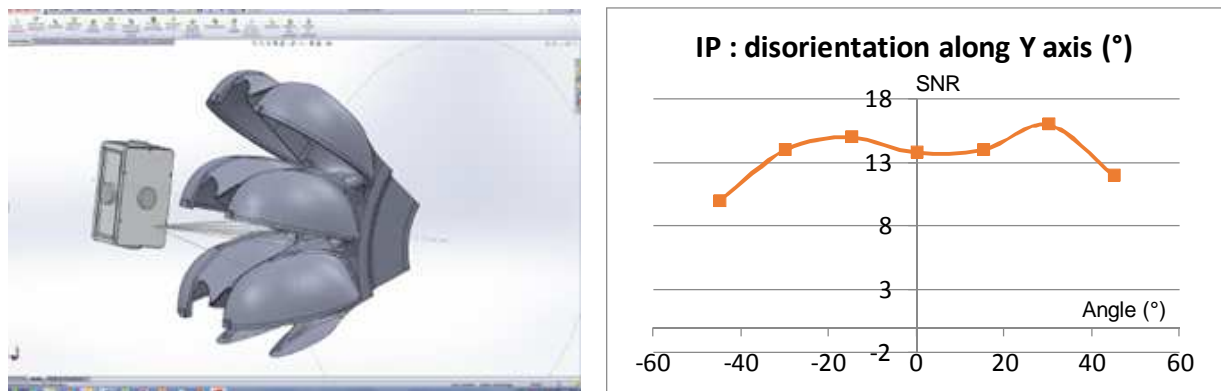
**Fig. 9:** influential parameter – HVOF Coating Thickness – SNR assessment on reference defect

- angular disorientation of the PTC axis vs normal surface/ defect orientation : the variation range of the three space angles (along X,Y and Z axis) was defined with the help of a 3D CAD model of a Pelton turbine bucket and the test was lead on a mock-up to define the acceptable variation range of these essential parameters, see figure 9,

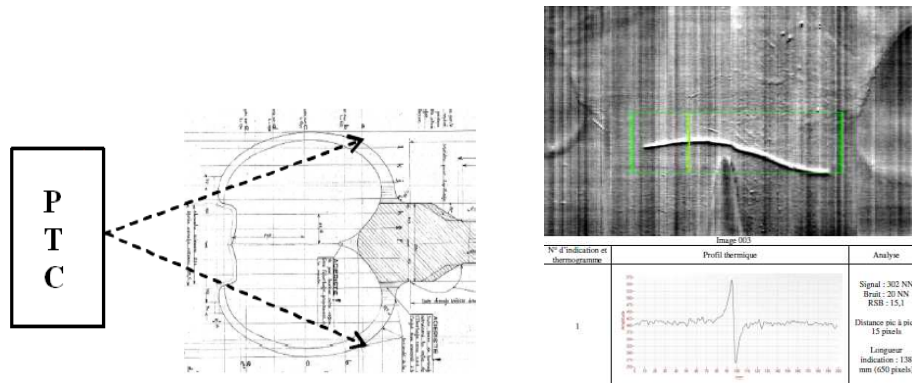
**Fig. 10:** test of the PTC procedure on a real component including a real fatigue crack to be recorded

- signal to Noise ratio > 2;
- bipolar signal (positive/negative according the scan direction);
- peak-to-peak distance;
- length of the indication > 3 mm.

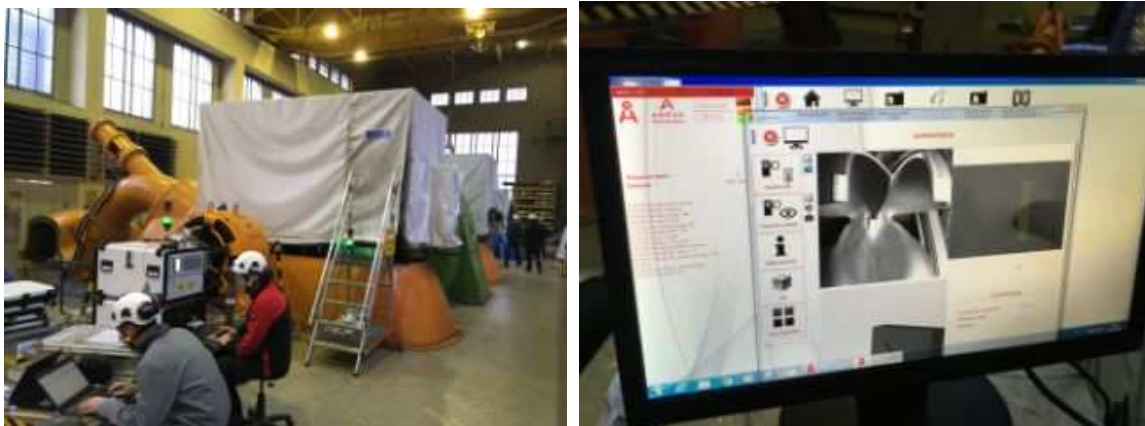
**Fig. 11:** the PTC system under laser protection tarp during Pelton onsite inspection - Periodical check of the system before inspection with ATHENA software interface

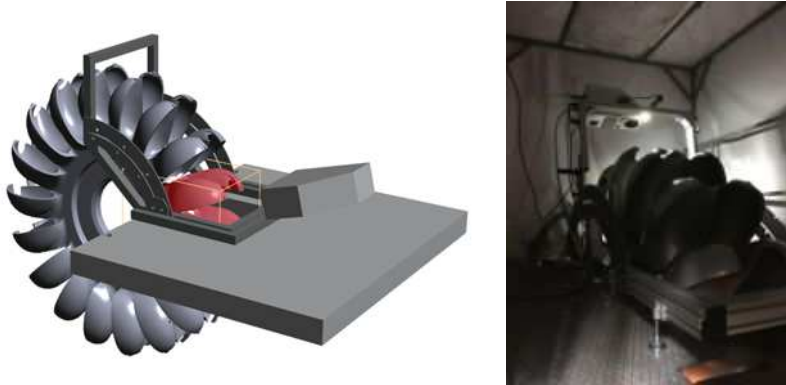
**Fig. 12:** PTC with dedicated carrier for the on-site inspection

A specific carrier of the PTC – see figure 12 - has been developed and shows following benefices:

- repeatable positioning of the PTC for all bucket examination, that guarantees mastered conditions of examination for each bucket inspected – e.g. distance and orientation of the PTC axis ;
- minimization of the manual rotation of the turbine to inspect all the 18 buckets.

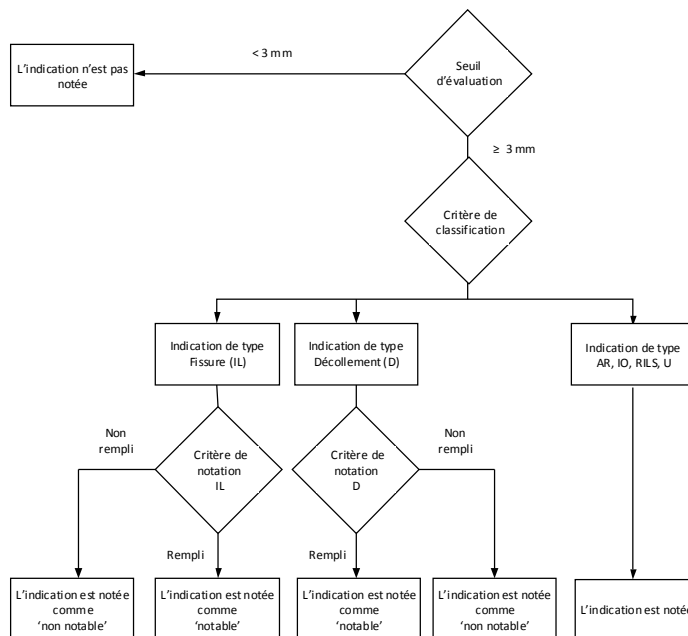
The PTC inspection allowed to give the status regarding the fitness of service for these two wheels after the allowed inspection duration time. All inspected areas of the bucket were inspected and recorded accordingly the procedure. A specific chart flow diagram – see below - was developed in the inspection procedure as a support for the operators regarding the evaluation, classification and registration of the indications from the PTC software.
