Industrial inspection of composites acoustic panels for aircraft components using infrared thermography

by S. Maillard*, B. Bazin*, A. Baillard**, N. Serre**, N. Leconte***, J. Richez****

This paper explains the different steps of the project and how the equipment works.

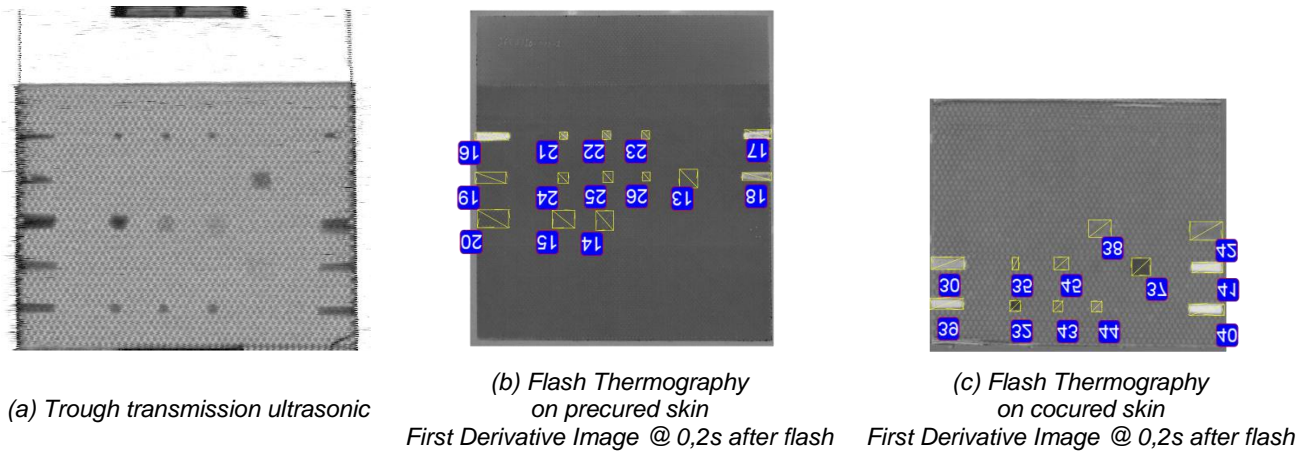
For A320neo IFS application, 11 NDT reference panels and the part have been scanned (IRT then UT) and analysed by inspectors certified Level 2 according to EN4179 in UT and IRT.

Fig. 6. Dual inspection (UT and Flash IRT) on a NDT reference panels with known defects

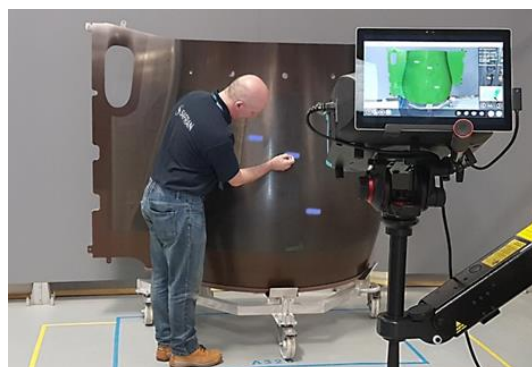
Fig. 10. Thanks to digital thread, indications identified with Flash Thermography are located on the part with augmented reality device
