Active thermography for panel paintings inspection: A comparative study of mid-wave and long-wave Infrared spectral analysis.

by S. Boubanga Tombet*, E. Guyot*, R. Huillery**, T. Calligaro***, V. Detalle***, X. Bai***, and A. Semerok****

Abstract

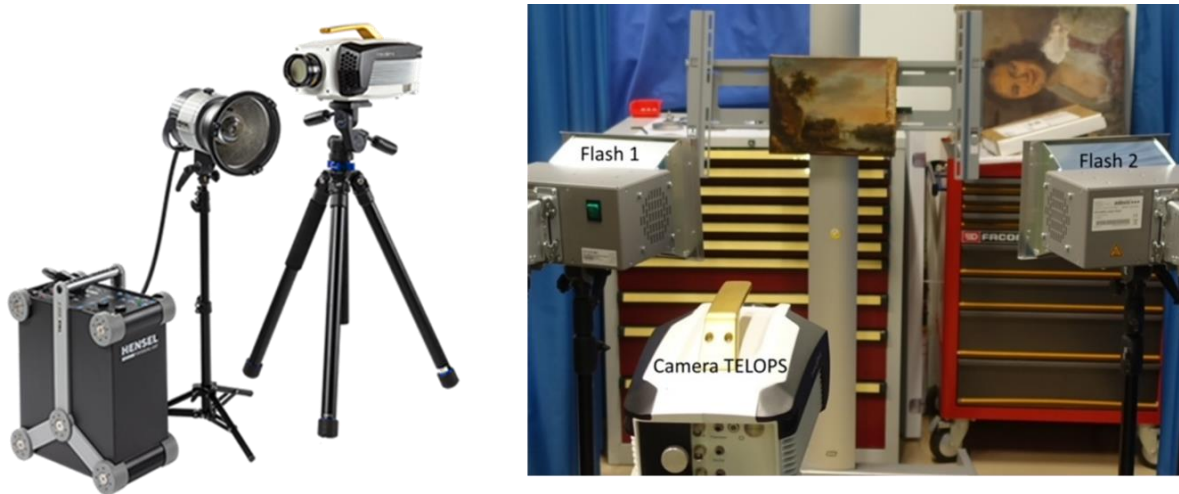
Figure 1. Active thermography set up and experimental configuration including the paintings, TELOPS camera and two flash lamps.

In our studies, an active pulsed thermography system (PTvis setup of EDEVIS GmbH, provided by Thermoconcept) for the specimen analysis was used (**Figure 1**). This system offers non-destructive testing solutions for the evaluation of components or assemblies and subsurface defect detection without damaging the materials. The active thermography solution combines mid- and long-wavelength infrared TELOPS cameras (MWIR or LWIR), deferent external excitation sources solutions and user-friendly post-processing software. External excitation sources such as flash and halogen lamps or lasers are available along with electromagnetic and mechanical sources (inductive coils, ultrasound generators). A wide range of solutions is available from basic systems to compact integrated systems with a variable level of automatization depending on the measurement needs and constraints.

An active thermography setup (**Figure 1**) was used for characterisation of multi-layered structures of panel paintings and analysis of defects caused by aging and environmental effects. Two oil compositions painted on canvas (**Figures 2a-b**) were provided by Centre de Recherche et de Restauration des Musées de France (C2RMF) in the Louvre museum. Pulsed Thermography PTvis setup (EDEVIS GmbH) was applied to provide and inspect a dynamic thermal response, which was recorded by mid- and long wavelength infrared TELOPS cameras. Control, synchronization and data analyses were provided by EDEVIS DisplayImg Professional software provided by Thermoconcept.

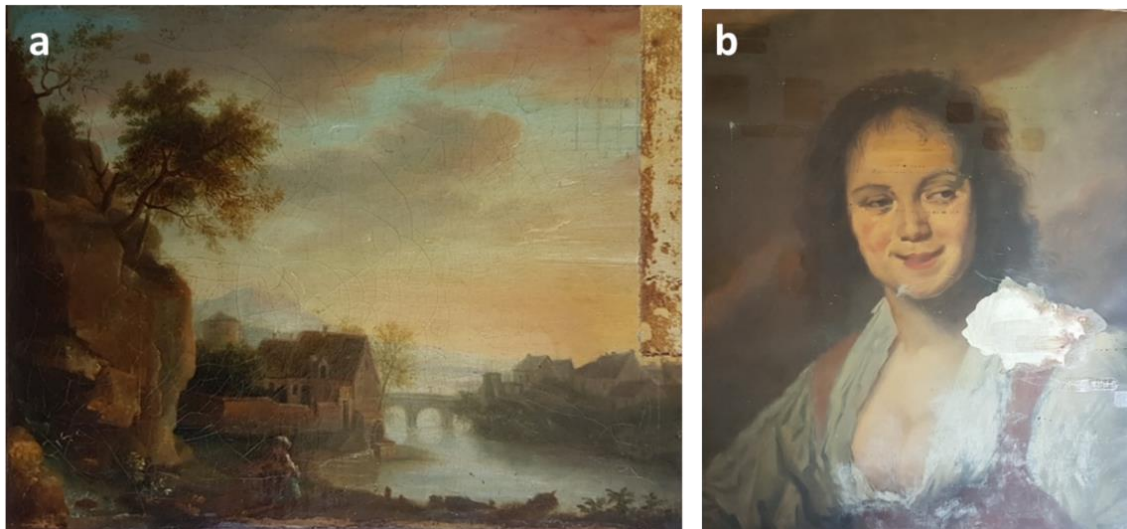
Figure 2. Photographs of the paintings analysed by active pulsed thermography, (a) - XIX century painting (26 cm x 32 cm), XIX century, (b) - replica of Frans Hals *La Bohémienne* (46 cm x 55 cm).

In this work, two panel paintings provided by C2RMF were analysed (**Figures 2a and 2b**). The painting in **Figure 2.a** is about 26 cm \times 32 cm, the XIX century. The top right zone of the painting was peeled off for the previous analysis (not discussed in this paper). The painting in **Figure 2.b** is about 46 cm \times 55 cm and represents a replica (46 cm \times 55 cm) of Frans Hals, “*La Bohémienne*”, (1628-1630). Some zones on this painting were also intentionally peeled off for the previous analysis (not discussed in this paper).

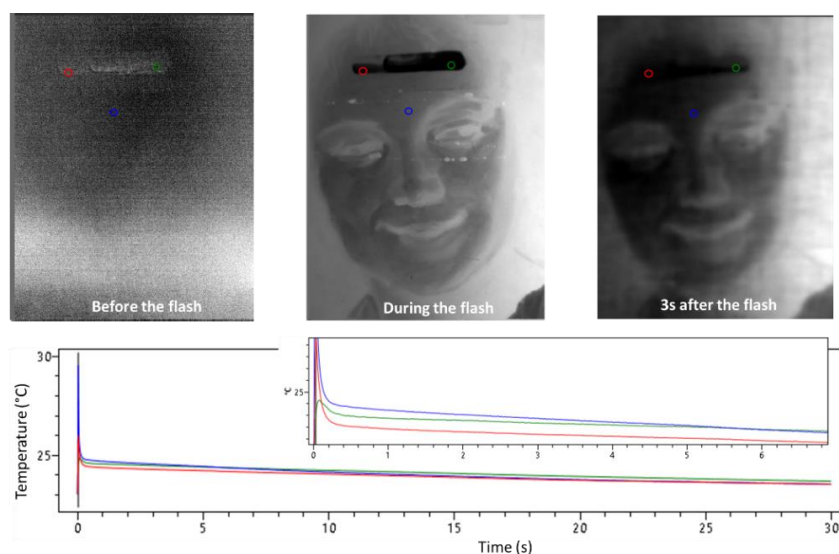
Figure 3. Temperature map of the replica “*La Bohémienne*” recorded before, during and after the flash lamp excitation (upper panels) at 1m distance between the camera and the painting, and Transient temperature curve of the three zones of different thickness (indicated by red, blue, green circles) with a zoom from 0 to 7 sec (lower panel).

The replica of Frans Hals “*La Bohémienne*” painting (see **Figure 2b**) was under Pulsed Thermography experiments performed in reflection mode. The panel painting sample with the three zones with different painting thickness (indicated as red, green, and blue circles in **Figure 3**) was submitted to the thermal pulse generated by the flash lamp, which resulted in non-stationary heat flow in the sample. Then, during the cooling process, the thermal infrared radiation emitted by the replica “*La Bohémienne*” painting was recorded by the IR camera as a function of time. The distance between the camera and the panel painting was one meter in this case. Both the flash excitation and the temperature profiles of the three zones of different painting thickness were measured before, during and after the flash lamp excitation (**Figure 3**, the lower panel). Continuous non-periodical signal decays can be seen after the temperature increase generated by the flash. The cooling dynamics in the three zones was different, which shows the different heat propagation properties in the zones with different thermomechanical properties and thickness.

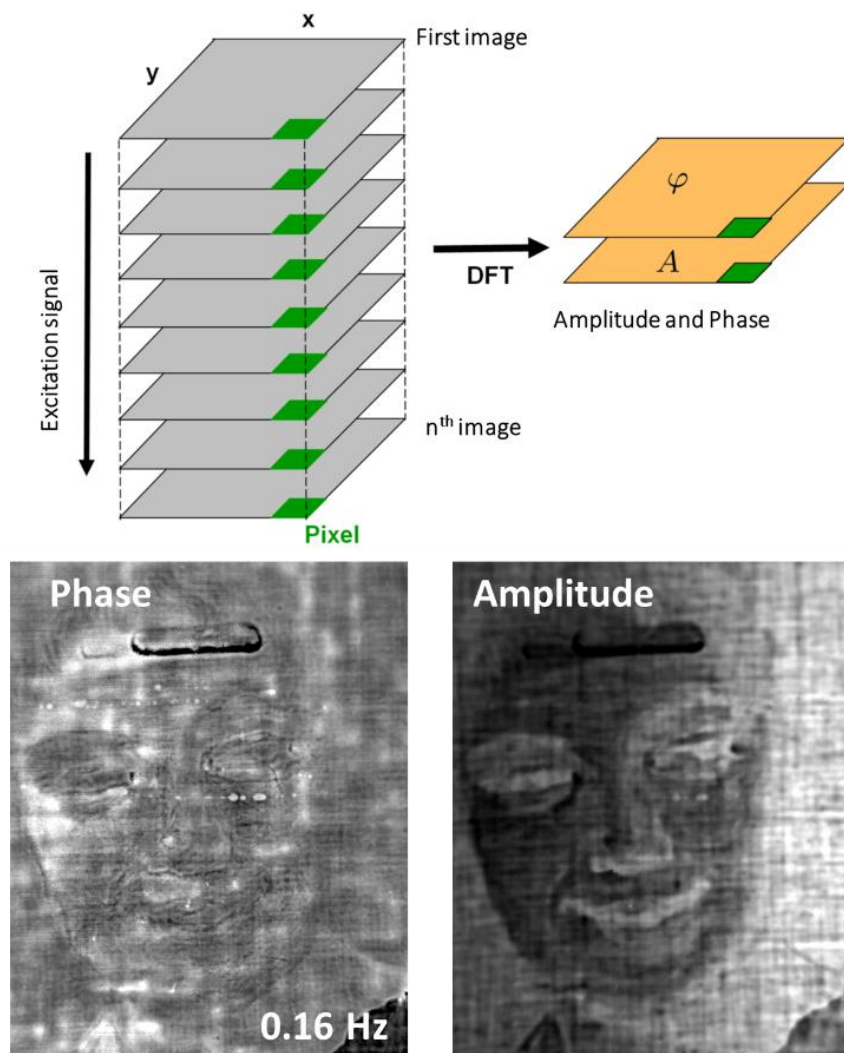
Figure 4. Workflow of the Pulse-phase-thermography used by DisplayMg Professional software. The example of phase and amplitude images computed by the software for $\nu = 0.16$ Hz for a distance between the painting and the camera of one meter.

The data analysis of pulsed thermography obtained with the replica “*La Bohémienne*” was made with the EDEVIS DisplayMg Professional software (provided by Thermoconcept). This software provides an optimum workflow, while offering a wide range of powerful functions to analyse and post-process images and image sequences. The Discrete Fourier transform (DFT) was used to compute the amplitude and the phase images. **Figure 4** (lower panel) presents the example of phase and amplitude data obtained from the measurements of the replica “*La Bohémienne*”. For pulsed thermography analysis, the phase data are of particular interest because they are less affected by environmental reflections, emissivity variations, non-uniform heating, surface geometry and orientation if compared to raw thermal data. This consideration is of particular importance for a quantitative analysis. From **Figure 4**, one can see that the phase image reveals more details (for example, possible pencil drawings underneath) as compared to the amplitude image.

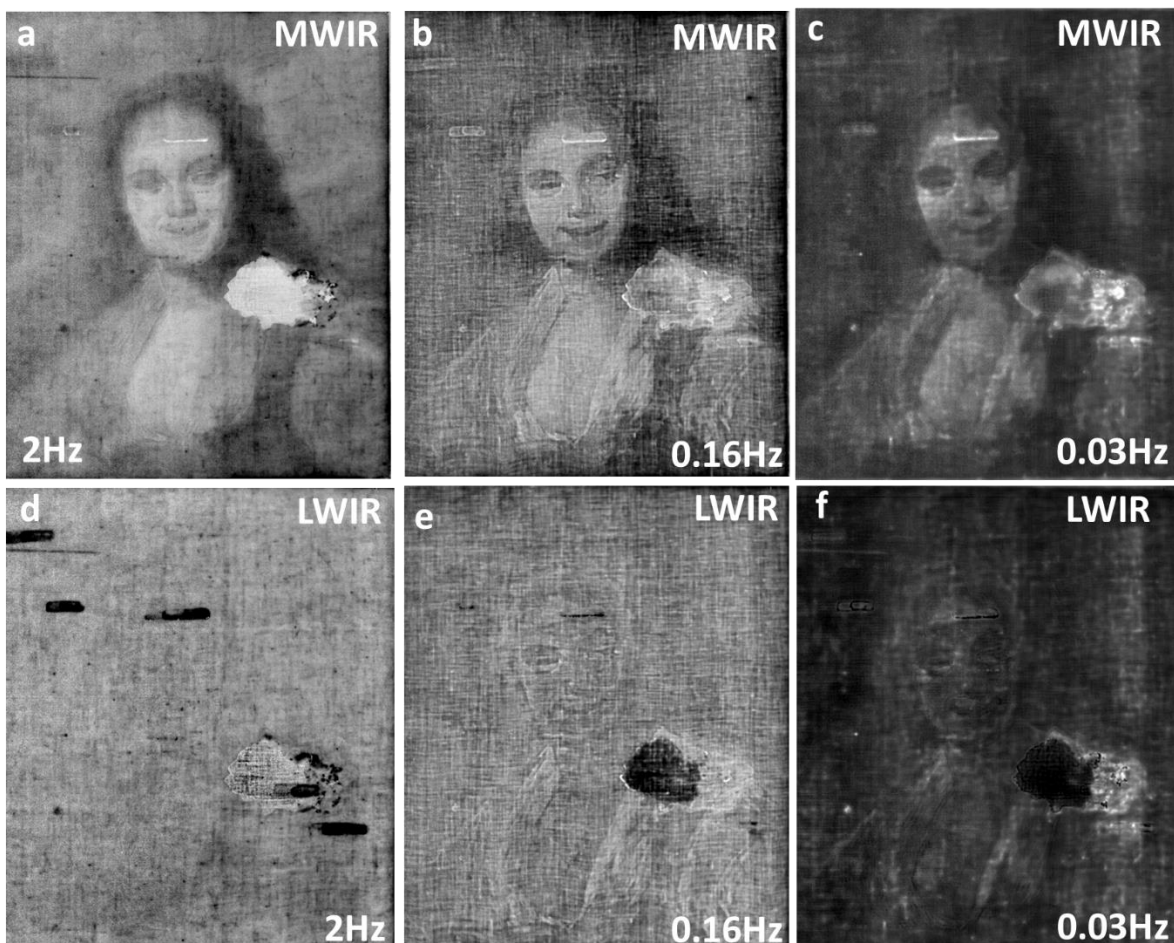
Figure 5. Phase images of the Franz Hals replica obtained with a MWIR camera (a, b, c) and LWIR camera (d, e, f) for different ν (Hz) at a distance camera-painting of 3 m .

Phase images were of a particularly interest since most of the detrimental thermal and optical effects observed in pulse phase thermography could be considerably reduced. **Figures 5.a-f** (for the replica “*La Bohémienne*” painting) and **Figures 6.a-f** (for the XIX century painting) present the Fourier transformation and phase analysis results that were obtained with a MWIR camera (**Figures 5.a-c** and **Figures 6.a-c**) and LWIR camera (**Figures 5.d-f** and **Figures 6.d-f**) at a distance camera-painting of 3 m and 1.7 m respectively. In pulse phase thermography, the deeper layers are seen at low frequencies, while shallow ones are seen at high frequencies.

For the replica painting, **Figure 5b** (MWIR) and **Figure 5e** (LWIR) clearly show the textile support of the canvas. The canvas fibres are observed with the same resolution in both infrared bands, thus demonstrating the potentiality of pulsed infrared thermography to penetrate the paintings from the front side down to a decent depth for *in situ* measurements. It should be noted that the replica “*La Bohémienne*” was more clearly seen on MWIR phase images at all frequencies than that on LWIR ones. The paint layers were intentionally removed in a limited zone to analyse the preparation layer. In this layer, phase images of a stronger contrast were obtained in LWIR than in MWIR. Identical defects were also seen at 2 Hz both in MWIR and LWIR, but the contrast was higher in LWIR. For the XIX century painting, pulse phase thermography imaging also allowed us to identify the canvas in two infrared bands (MWIR and LWIR in **Figure 6b** and **Figure 6e**, respectively). Numerous random dark spots (**Figure 6c** and **Figure 6f**) may be interpreted as a possible presence of glue droplets used to attach the old canvas on the new one. Indeed, previous investigations have shown that the original painting underwent a transposition in early XX century, which is a common practice in restoration process. And this painting is contested undergo this process. The pulse phase thermography imaging of this painting has revealed that the painting pigments are seen more clearly in MWIR phase images (see **Figure 6a** with a tree painted at the top left). In contrast, the painting pigments in LWIR phase images are practically not visible (see **Figure 6d**, for comparison). Our analysis revealed the presence of a pentimento (**Figures 6.d-e**, on the lower right part with a church steeple shape). The pentimento appears to be less detectable in MWIR images. Other features, such as, underdrawings and pencil marks were also detected during the analysis of the XIX century painting.

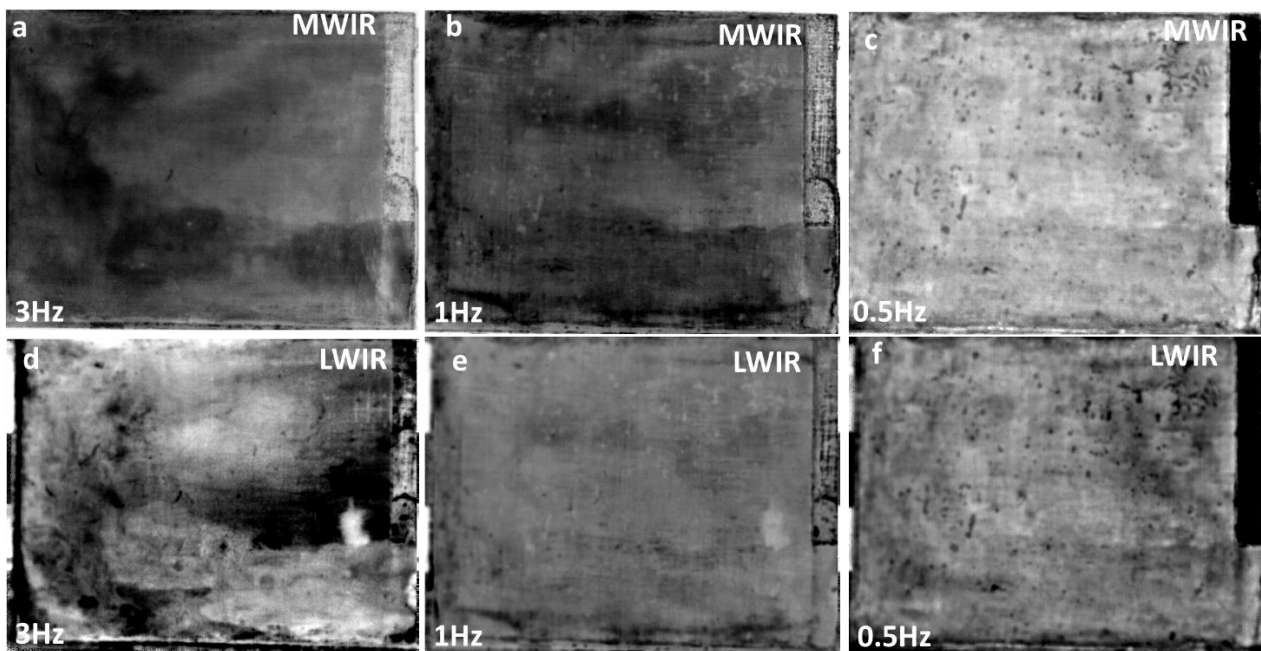
Figure 6. Phase images of the XIX century painting obtained with a MWIR camera (a, b, c) and LWIR camera (d, e, f) for different ν (Hz) at a distance camera-painting of 1.7 m.
