## Detection of Micro-cracks in Metal Elements by Laser Excited Thermography

by W. Swiderski\*

### Abstract

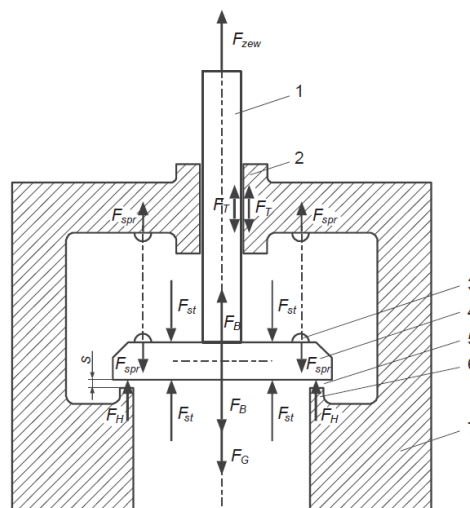
**Fig. 1:** The forces acting on the valve components:  $F_{zew}$  – external force acting on movable elements,  $F_{spr}$  – restoring force of a spring,  $F_T$  – friction force between the valve stem and guide,  $F_B$  – inertial force of moving elements,  $F_H$  – hydrodynamic force in the gap,  $F_{st}$  – force of the stream of liquid,  $F_G$  – earth pull,  $s_{max}$  – valve lift; 1 – stem, 2 – guide, 3 – spring, 4 – valve head, 5 – plate – valve seat gap, 6 – valve seat, 7 – valve housing [2]

During use, the valves in an internal combustion engine are subject to wear and damage which impairs the quality of their functioning. Valves are functional units necessary for the implementation of engine operating processes; the quality of the device's functioning depends on the quality of valve operation. Maintaining and increasing the quality of valve operation is reduced to detecting or identifying damage to valve components and eliminating these damages by repairing or replacing damaged components. In practice, identification of valve damage is difficult due to the lack of appropriate identification methodology. This lack results mainly from the large variety of valve construction solutions and the various areas of applications and loads. Figure 1 shows the forces acting on a valve during engine operation [2].

During valve operation, the following forces operate on the closing element:

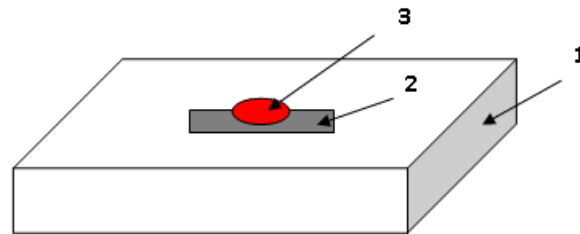
**Fig. 2:** Model of testing sample: 1 – sample, 2 – microcrack, 3 – heating area.

In order to determine the possibility of detecting microcracks using thermography with laser stimulation, a model with dimensions 30x30x3 mm was made from steel in which there were microcracks with a length of 10 mm, width 0.05 mm, and depth 2 mm (Fig. 2). This model was tested using ThermoCalc-6L™ software [4]. ThermoCalc™ - 6L offers the solution to a 3D Cartesian-coordinate transient heat conduction problem for a parallelepiped-shaped body that may contain up parallelepiped-shaped defects. The body is heated or cooled down on the front surface with an external 'heat' pulse. The front-surface heat flux is assumed to be uniform or Gaussian-distributed in space. The heat flux center can be located at any point on a front surface. Along with the external thermal stimulation on the front surface, both the front and rear surface are cooled down according to Newton's law.

The thermal parameters of steel and the air filling the microcracks are given in Table 1. During the modeling of thermal processes occurring on the surface of the sample model, the surface was heated by a pulsed heat stream with a density of 1.2 kW / m<sup>2</sup>. The stream was stimulated by heating with a 5 mm diameter laser beam. The center of the stream was directed to the microcracks. Table 2 presents the selected results of the temperature difference on the surface between the micro-cracking and the outside during the heating and cooling phase of the sample.

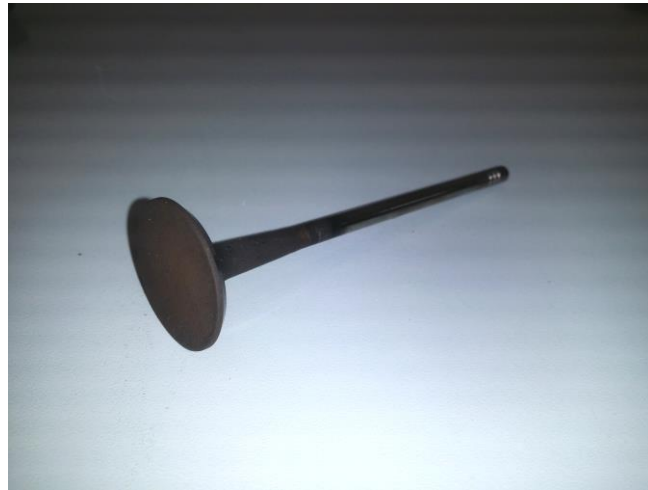
**Fig. 3:** Photograph of the valve

In Figure 3., a photograph of an internal combustion engine valve is shown. A test was also performed using a microscope with a magnification of 40x image microcracks. This is shown in Figure 4, on which the microcracks are clearly visible perpendicular to the surface of the valve head from the side of its working surface. Micro-cracking is also visible on the side of the valve head, as shown in Figure 5.

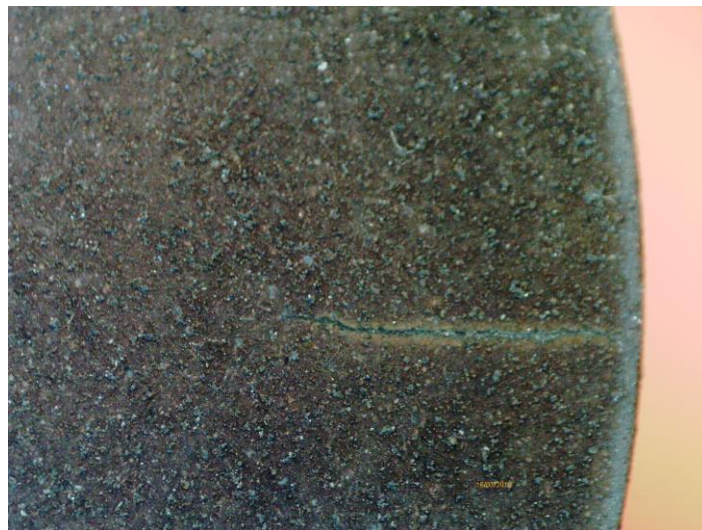
**Fig. 4:** Photograph of a valve head with visible microcracking - magnification 40x

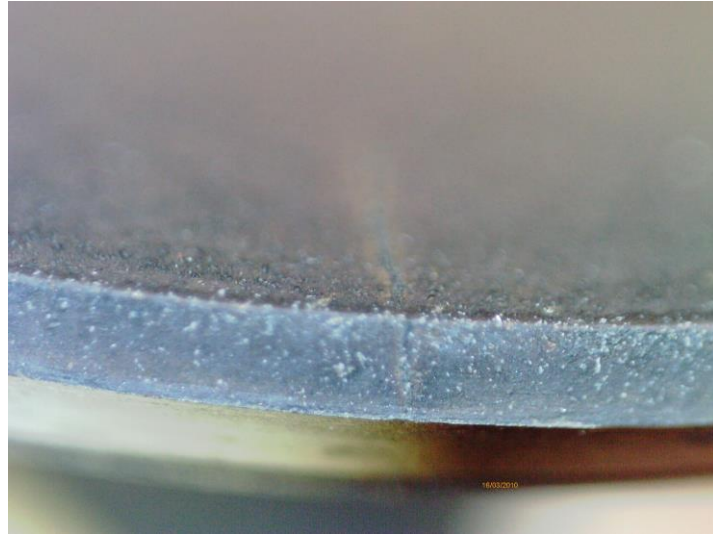
**Fig. 5:** Photo taken at the side of the valve head with visible microcracking - magnification 40x

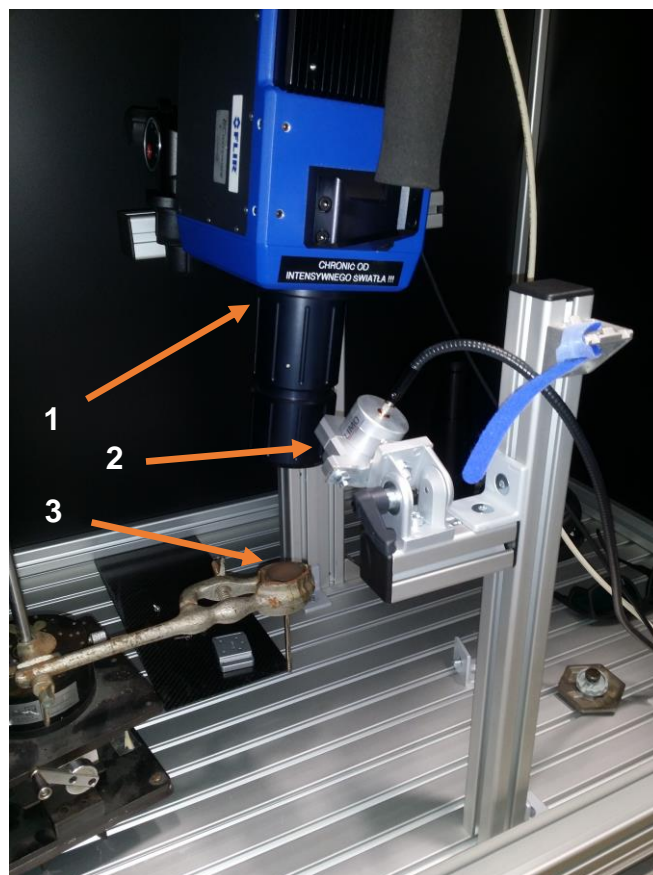
**Fig. 6:** Set up: 1- thermal camera, 2 – laser, 3 - valve.

Fig. 6 presents the measurement stand. Due to laser radiation, the measurement was made in a sealed chamber.

In the experimental tests, a semiconductor laser with a wavelength of 808 nm and a maximum power of 32 W was used for thermal stimulation. Changes of temperature field on the surface of the test sample were recorded with a thermal camera, FLIR 7600 SC, with a microscopic lens. The surface of the tested valve taken from a car engine was

pulsed with a laser for 2 seconds, the diameter of the laser beam incident on the tested surface was 5 mm. The time of recording of the changes in the temperature field caused by heating with a laser beam was 5 seconds.

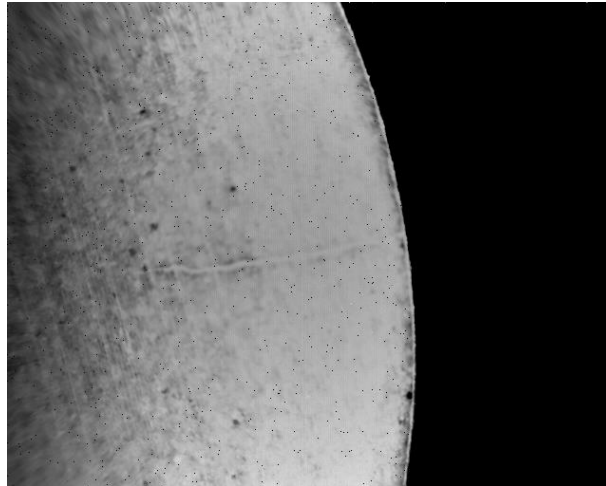
**Fig. 7:** The best source thermogram of a valve head microcrack made perpendicular to its working surface

Fig.7 shows a source thermogram made perpendicular to the working surface of the valve head with visible microcrack, the shape and dimensions of which confirm the photograph taken under the microscope with clearly visible microcracking. The microcrack on the side of the valve head is shown in the thermogram in Fig.8. It is also clearly visible.

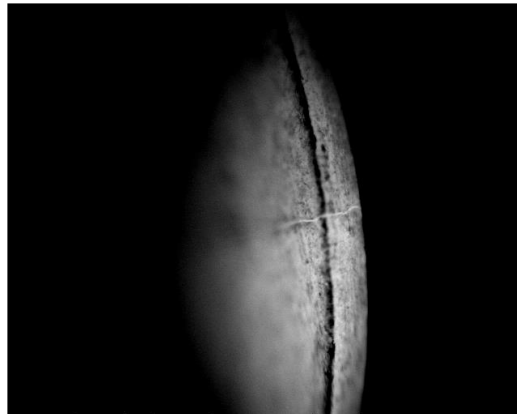
**Fig. 8:** The best source thermogram of a microcrack made on the side of the valve head

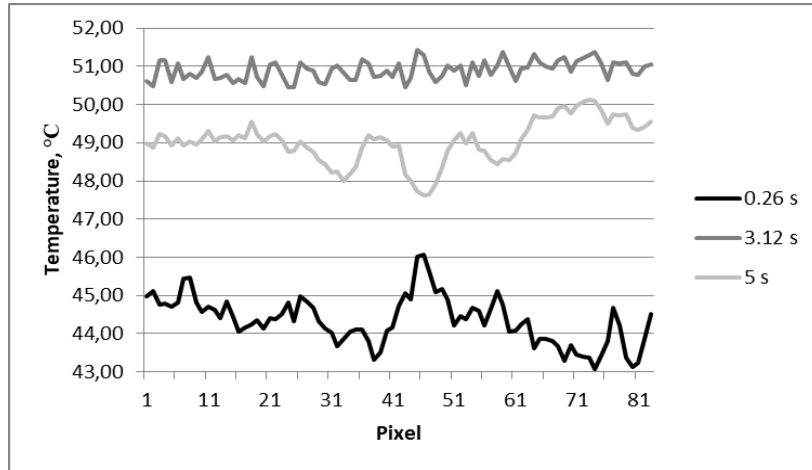
**Fig. 9:** Courses of temperature changes on the test surface of the valve.

Fig. 9 shows the profiles of temperature changes over selected characteristic times, such as the results of numerical calculations presented in Table 1, on the surface of the valve head. As the experimental course of changes shows, the temperature differences over the microcracks (46 pixel in the graphs) coincide with the results of numerical calculations.

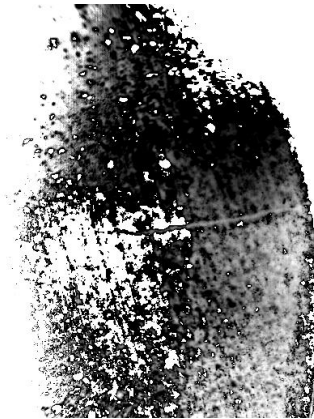
**Fig. 10:** Phase image of microcrack

Figures 10 and 11 present the results obtained as a result of the analysis of phase and amplitude changes recorded during the test. The phase image of the microcrack is better visible than on the best source thermogram. Also visible when comparing figures 7 and 9. The amplitude image does not improve the microcracks image; however, there are visible irregularities on the surface of the valve head (Fig.11), which can also be seen in the microscope image (Fig. 4).

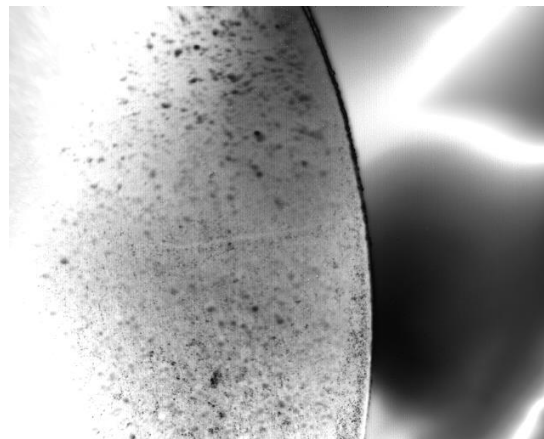
**Fig. 11:** Amplitude image of microcrack
