Detection and Evaluation of Degradation in Electric Wire Connection using Infrared Thermography

by Kotaro Yamakoshi*, Naoyuki Kumagai**, Hirotsugu Inoue***, Hirofumi Yamada*, Yutaka Kasai*

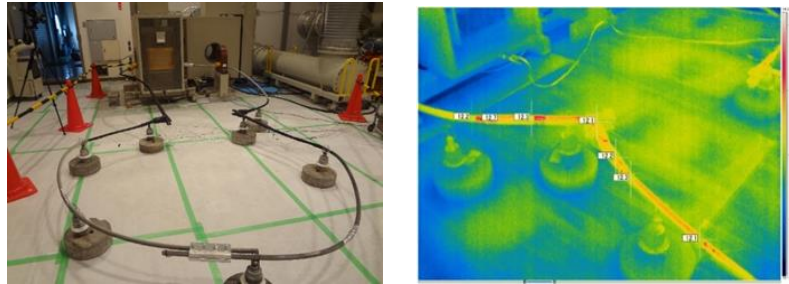
Figure 1: Test body connected in series with the current load test device. A thermocouple was attached to the connection part (Left). Thermography image of the connection part (right)

The relationship between the calorific value and the load current was determined by laboratory test. The power transmission member as shown in figure 1 was connected to the current load test device and the heat generation in the member was measured with changing the current load. The surface temperature of the connecting pipe was measured with infrared thermography and thermocouple. The correlation between current value, resistance value and temperature were examined. As a result, temperature rise according to Joule heat generation was recognized at each measurement location. In addition, it was found that the spatial gradient of the calorific value varies depending on the measurement location.

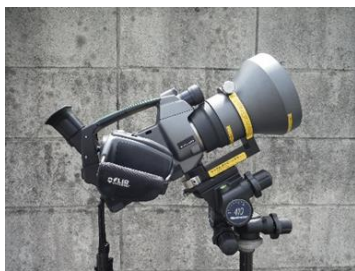
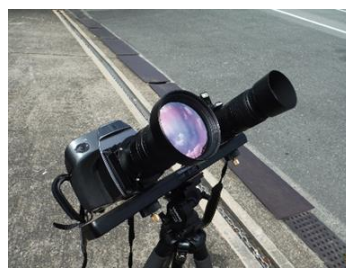
FLIR SC660+7°lens

Nippon Avionics 500EX+3.3°lens
Figure 2: Measurement apparatus

evaluation of the equipment) was also evaluated because these are important factors affecting the temperature measurement. It was found that the emissivity is highest at the electric wire main line as shown in Table 1 and hence that the measurement should be conducted at the electric wire main line. For the spatial resolution, the slit response was measured for two products of Nippon Avionics and FLIR. The value at which the output becomes 90% is determined as substantial spatial resolution.
