Thermal Analysis of an Installation Fault Concerning a Ripple Control Transformer

by Vassilios Chatziathanasiou, Georgios T. Andreou, Olga Gkaitatzi, Ozlem Otuzbir, and Dimitrios P. Labridis

Aristotle University of Thessaloniki, Thessaloniki, Greece

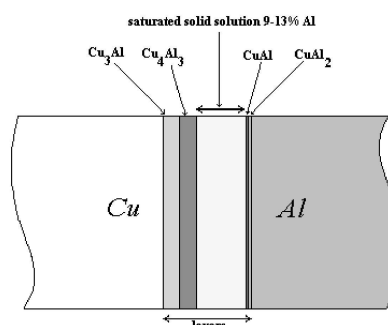
The development of IMC however can seriously impair the overall electrical stability and mechanical properties of bimetallic joints. The increased thickness of the IMC layer will produce a higher electrical resistance, leading to a higher heat generation in the case of current flowing through the joint [1]. Moreover, significant IMC growth can make the joint interface brittle, impairing thus its mechanical properties and leading to a potential mechanical failure.

Fig. 3. Schematic diagram of the IMC produced in an Al/Cu joint
