IRT survey for the quality control of FRP reinforced r.c. structures

by P. Corvaglia*, A. Largo*

Abstract

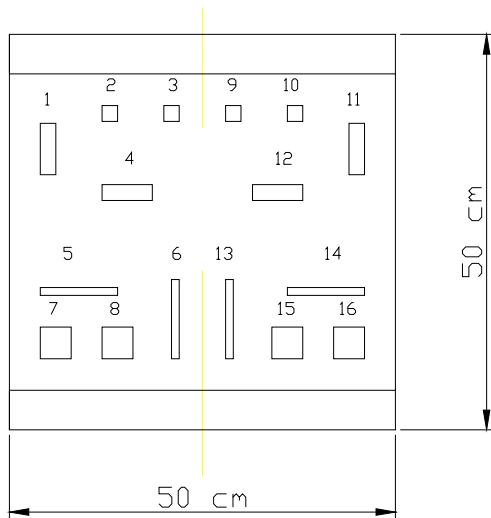
Two types of defects with different dimensions were imposed (see Fig. 1):

- delaminations (by the interposition of two bonded Teflon foils)
 - defects n° 5 and n° 6 (100 mm x 10 mm);
 - defects n° 1 and n° 4 (65 mm x 20 mm);
 - defects n° 7 and n° 8 (40 mm x 40 mm);
 - defects n° 2 and n° 3 (20 mm x 20 mm);

- lack – of – bonding of the FRP (by a simple Teflon foil)
 - defects n° 13 and 14 (100 mm x 10 mm);
 - defects n° 11 and 12 (65 mm x 20 mm);
 - defects n° 15 and 16 (40 mm x 40 mm);
 - defects n° 9 and 10 (20 mm x 20 mm).

Fig. 1 Imposed known defects

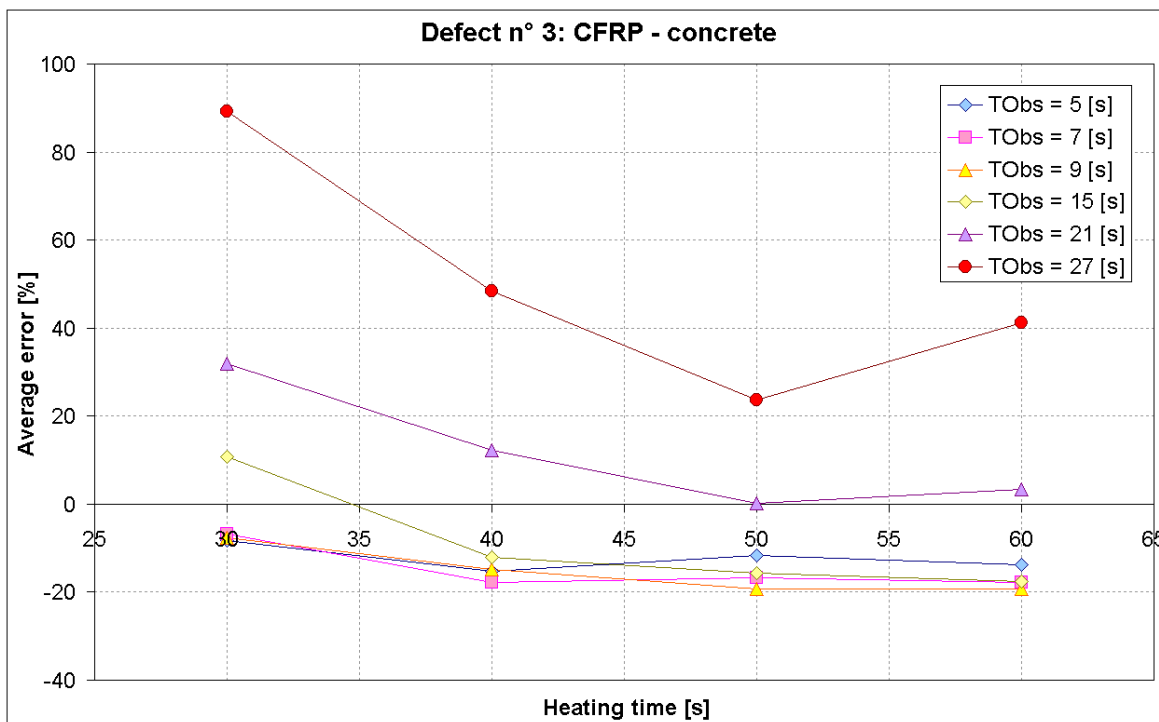
Fig. 4 Percentage error in the assessment of defect n.3 for different experimental set-ups

1. the error (defined as the ratio between the difference of the estimated and the real number of pixels relative to a defective area, and the real number of pixels relative to the same defective area) increases with increasing TObs;

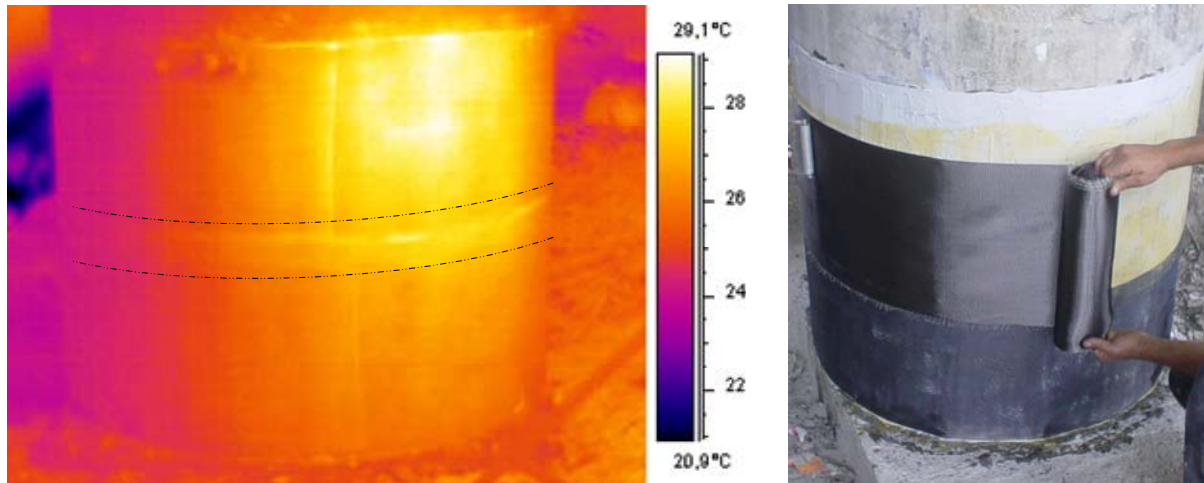
The first type (in white square in Fig. 7) is caused by the longitudinal joining of two CFRP sheet. When applying multiple plies of FRP sheets for columns wrapping, or when two strips need to be joined longitudinally, it is necessary to create an overlapping of at least 20 cm. Overlapping is not necessary for the width of the fabric because the different strips of fabric can simply be applied one next to the other. Nevertheless, for the presented case study, the strategy of overlapping the two CFRP strips, along the width, for 3 cm, was adopted (this is also evidenced in Fig. 8). According to the IRT survey results, it can be concluded that this kind of approach can cause a “step effect” resulting in a lot of air inclusion all along the column diameter. However, these kind of defects are very often characterized by a low aspect ratio and can be easily repaired using low – pressure epoxy injection.

Fig. 8 CFRP strip transversal overlapping
