## Inspection of the Leakage for the Closure Plug of Heavy Water Reactor using Infrared Thermography in Nuclear On-site Application

by S. G. Lee\* and W. T. Kim\*\*†

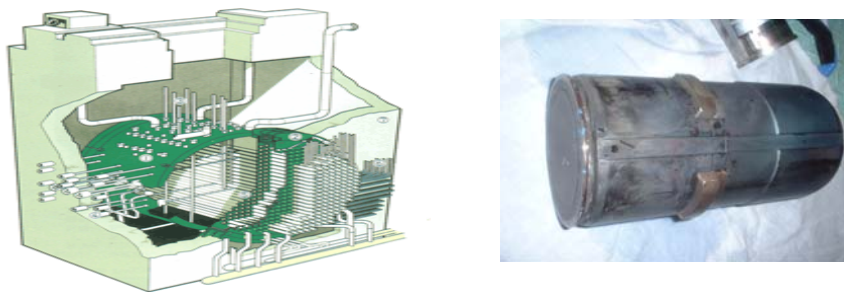
Fig. 1 Structure and closure plug considered in the study

(a) Structure of heavy water reactor (b) Photography of closure plug

As further study, following Fig. 1 shows the the leakage detection system of the closure plug at heavy water reactor in nuclear plant. In case of testing method using CCTV camera, the precision degree of the testing is considerably low. At present, in order to measure the leakage of heavy water at the closure plug during on-site operation of nuclear reactor, there are two testing methods; one is using the CCTV camera and another one is using the fuelling machine, it consumes much time for the testing and, above all, it brings about the increase cause of the tritium concentration in testing period. Therefore, even though these two methods have been used as detection ones, each of them has fatally own constraints. Also,

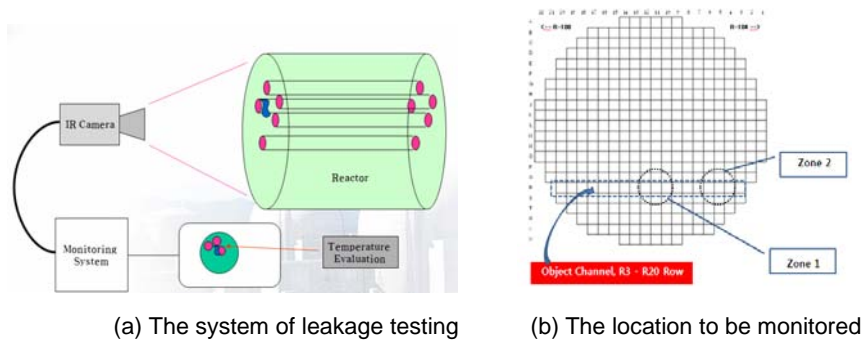
**Fig. 2** Schematic diagram of experimental apparatus

In order to monitor the temperature distributions coincided with the leakage of heavy water led out of the closure plug for each fuel channels, the temperature contours including hot spots acquired by infrared measuring technique was analyzed. Fig. 2 (a) show the experimental set-up for the condition monitoring in the heavy water reactors and Fig. 2 (b) shows the location of detection to be diagnosed from infrared thermography.
