Induction Active Thermography as an alternative to Magnetic Particle Inspection

Patrick BOUTEILLE*, Grégory LEGROS*, Samuel MAILLARD*, Julien CADITH*, Jean Luc BODNAR**

* CETIM – NDT Division, 52, avenue Félix Louat – 60300 SENLIS – France

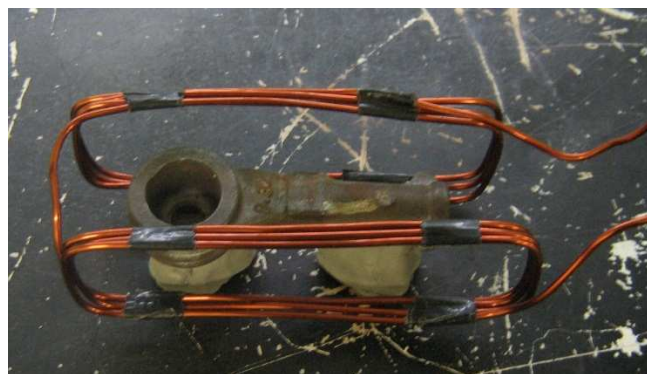
Figure 7: Inductor used for the study

The system is comprised of three parts. The first part corresponds to the excitation source. This is an inductor supplied by a control electronic system. The inductor is adapted to the inspection of the ball joint and composed of two rectangular coils made up of 3 turns of copper wire. They are 150 mm long and 50 mm wide. The coils are positioned on both sides of the analysed specimen and 45 mm apart. This configuration gives easy access to the ball joint, for example to turn it by 90 degrees to allow the analysis of its entire surface (Figure 7).

The current is supplied by a generator adjusted to deliver a current equal to 35 amperes for 70 ms (square pulse excitation).
