Thermal Imaging for Monitoring Rolling Element Bearings

by R. Schulz^{1,2}, S. Verstockt³, J. Vermeiren⁴, M. Loccufier², K. Stockman¹ and S. Van Hoecke^{1,3}

Abstract

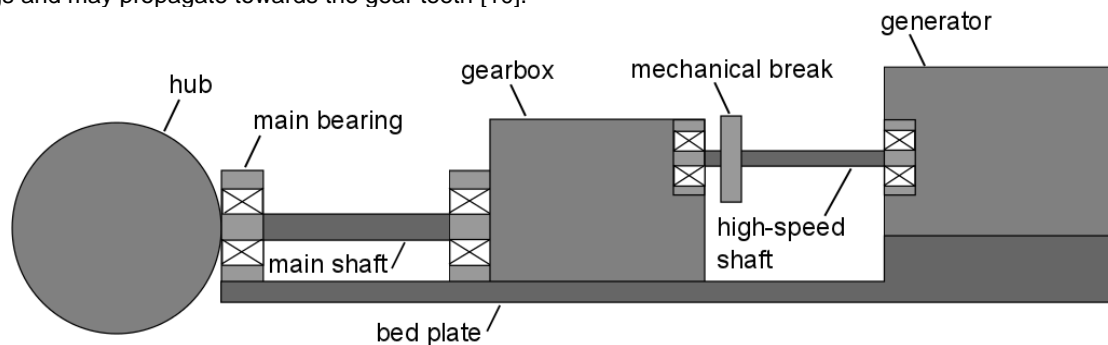
Fig. 1. Scheme of a wind turbine drive train with gearbox

In Figure 1, the main components of a gearbox-based wind turbine drive train are shown schematically. Because of their tribological nature, wind turbine drive train components such as gears and bearings are affected by friction and wear [5, 6]. The consequences include vibrations, acoustic emissions and heat which can be monitored by different sensor-based techniques. Faults in the drive trains are the main cause for downtime [7, 8]. Bearing faults belong to the major issues in reliability of wind turbine drive trains, as the bearings must deal with cyclic and transient loading as well as with alignment issues [9]. Furthermore, the majority of wind turbine gearbox faults appear to initiate in the bearings and may propagate towards the gear teeth [10].

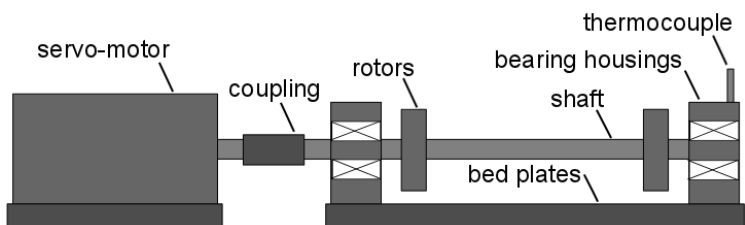
Fig. 2. Scheme of the test setup

A test setup, as schematically shown in Figure 2 is used for monitoring FAG 22205-E1-K spherical roller bearings¹. As shown in Figure 4, these bearings consist of cylindrical rollers which manage high axial forces oscillating in both directions as well as radial forces. They are particularly designed to handle heavy loads such as in wind turbines. The close osculation between rollers and raceways supports uniform stress distribution. As it is usually the case in industrial applications such as wind turbine drive trains, the bearings are completely covered and sealed.

In this particular setup, the bearings have been mounted within FAG SNV052-F-L plummer block housings². The shaft is solid Cf53, made of hardened and ground steel, and has a diameter of 20 mm with a h6 tolerance rate.

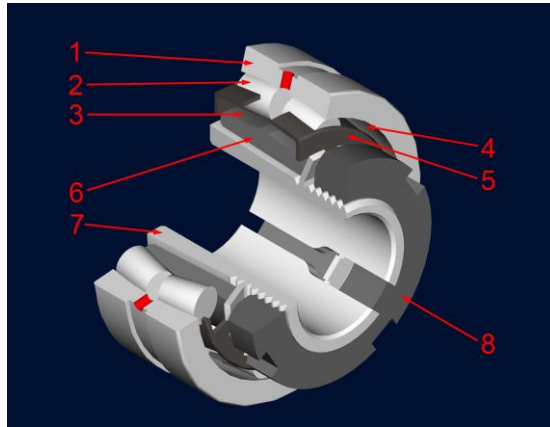
Fig. 4. 3D scheme of spherical roller bearing

bearing parts	
1	outer ring
2	rolling element
3	inner raceway
4	outer raceway
5	cage
6	inner ring
7	adapter sleeve
8	groove nut

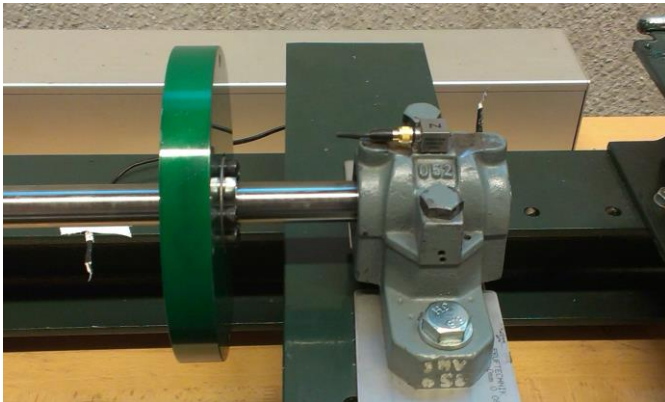
Fig. 5. Bearing housing and shaft from the side

All bearings have been monitored from different point of views. The analysis in this paper focusses on the camera location sideways of the setup which allows to monitor both bearing housing and shaft as shown in Figures 5 and 6. This point of view is expected to be most promising to monitor the effects of outer raceway faults as well as inner raceway faults. Figure 6 shows the thermal image taken from the side of the housing for the healthy bearing after a measurement period of sixty minutes.

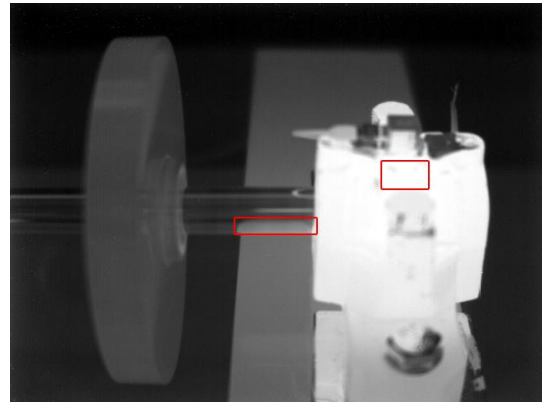
Fig. 6. Thermal image of bearing housing and shaft with regions of interest

Because both bearing housing and shaft show different temperature characteristics and noise effects such as reflections, regions of interests have been selected and further analyzed. Both two-dimensional and three-dimensional surface plots have been analyzed to determine the actual thermal characteristics of both healthy and faulty bearings as well as noise, and consequently support the choice of meaningful regions of interest. The upper housing is closest to the outer ring because of lower material thickness and is therefore selected as first region of interest. The bottom part of the shaft next to the bearing housing is expected to show heat increase based on both natural impacts such as shaft bending as well as bearing faults, and therefore selected as second region of interest.

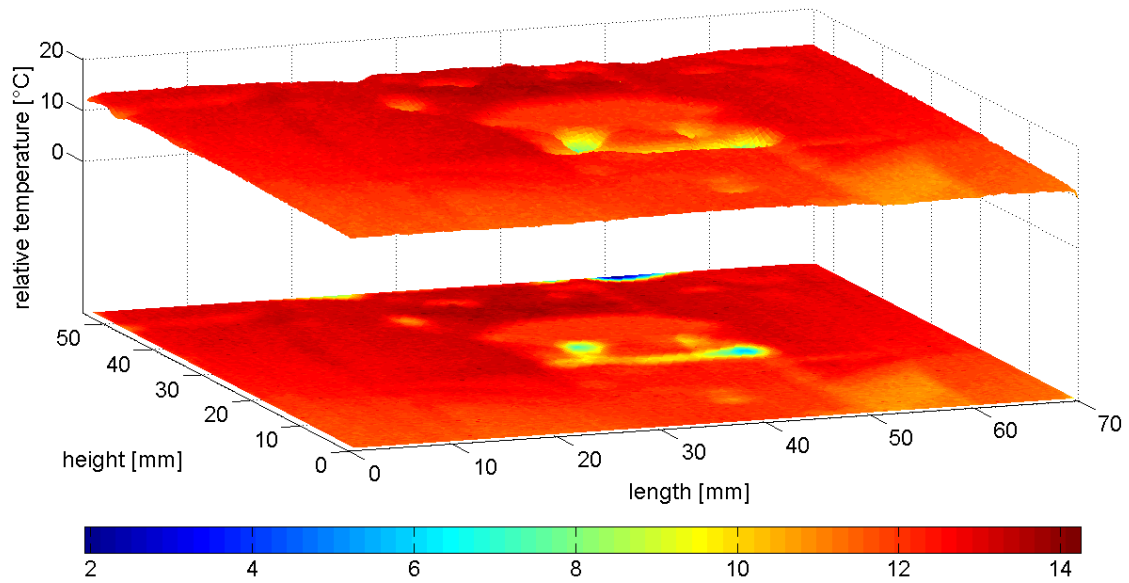
Fig. 7. Three-dimensional surface plot of the housing for the healthy bearing

As shown in Figure 7, the non-uniform surface of the bearing housing leads to different temperature characteristics. The material of the upper housing is thinner and leads to faster heat-increase than for the bottom part. The screw in the upper center of the housing as well as the polished surface on top of the housing cause distinct drops in the measurements, making these regions unsuitable for further analysis. The central upper region of the housing is closest to the outer bearing ring because of thinner material and shows the highest temperatures. Therefore, this region is chosen for further analysis.

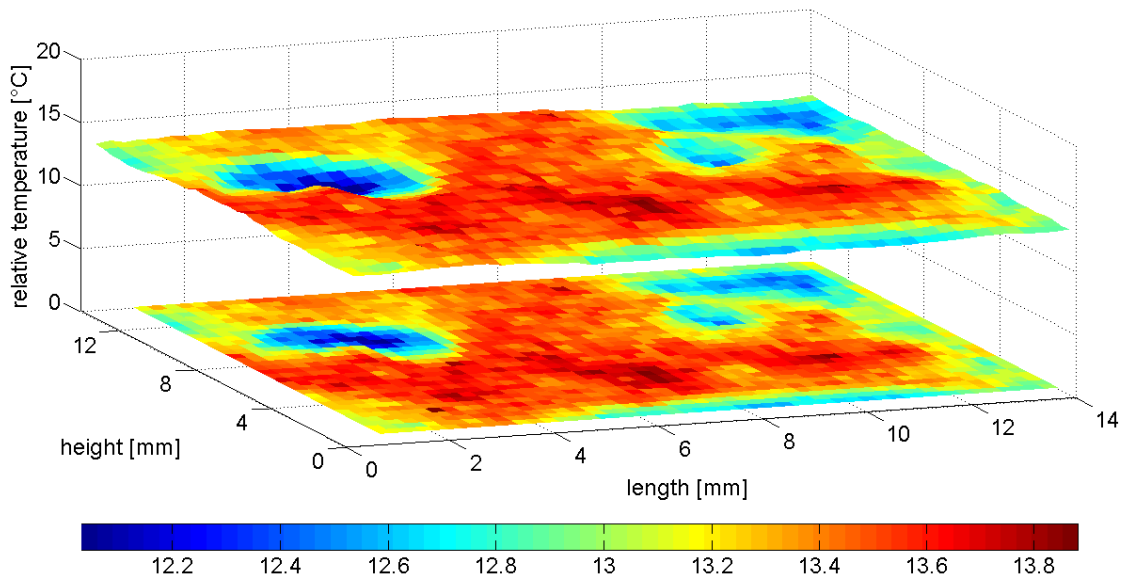
Fig. 8. Housing region of interest for healthy bearing

The region of interest is shown for the healthy bearing in Figure 8 and for the bearing with inner raceway fault in Figure 9. As both images show noise caused by reflection of light, the thermal measurements need to be analysed carefully. For the inner raceway fault, higher temperatures are monitored as well as a stronger heat propagation across the surface which is indicated by the more uniform color representation.

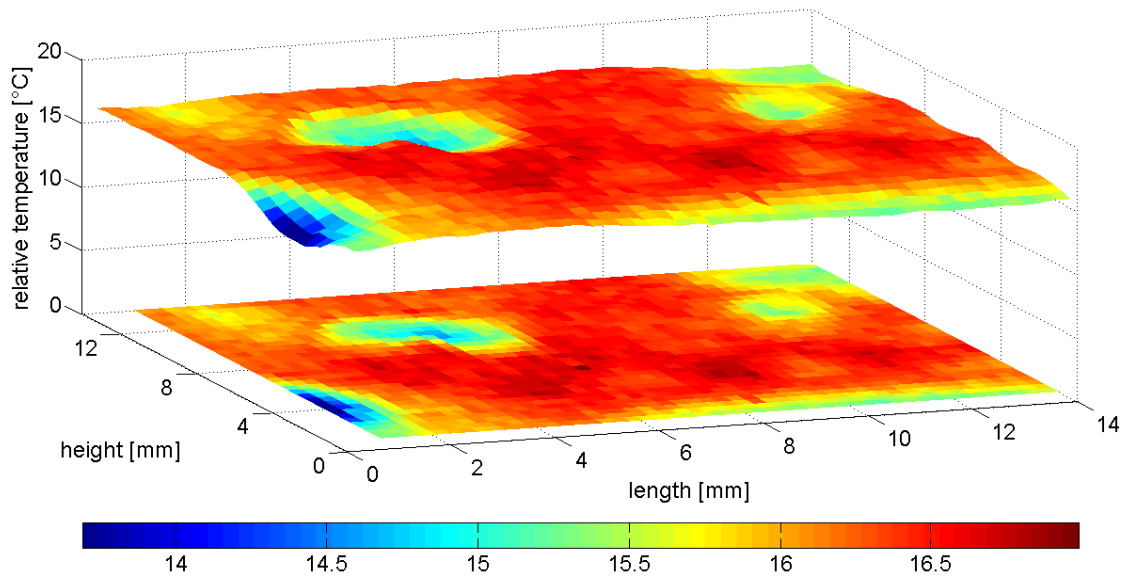
Fig. 9. Housing region of interest for bearing with inner raceway fault

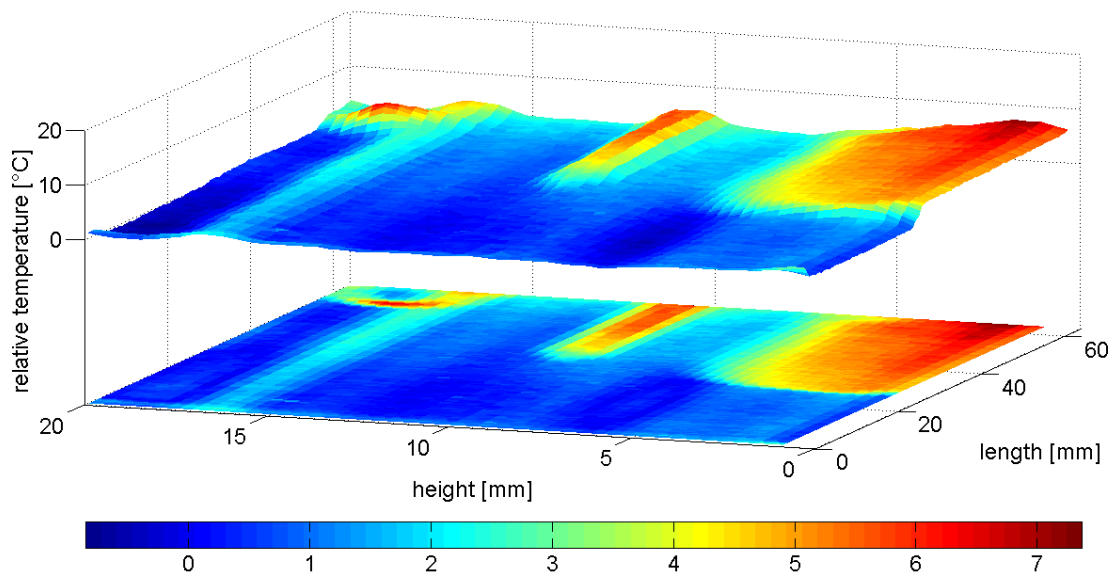
Fig. 10. Three-dimensional surface plot of shaft from side view for healthy bearing

The second region of interest is located at the shaft. Increased temperatures have been monitored in the bottom right shaft next to the bearing housing. This impact becomes more distinct in the surface plots in Figures 10 and 11 which represent the complete shaft part between bearing housing and mass rotor for both healthy and faulty bearing.

The shaft shows distinct heat increase next to the bearing housing for both healthy and faulty bearings. As the housing is sealed and the rotation of the shaft seems to cause a cooling effect, this heat increase only occurs for a small region. Central and upper shaft show lower temperatures and in fact no distinguishable heat increase for both healthy and faulty bearings. The peaks in the upper shaft are caused by reflection of light. It was monitored that the locations of the reflections on the shaft are not fixed but slightly oscillating up- and downwards. Because of these characteristics, further analysis of the shaft focusses on the heat increase in the bottom part next to the housing.

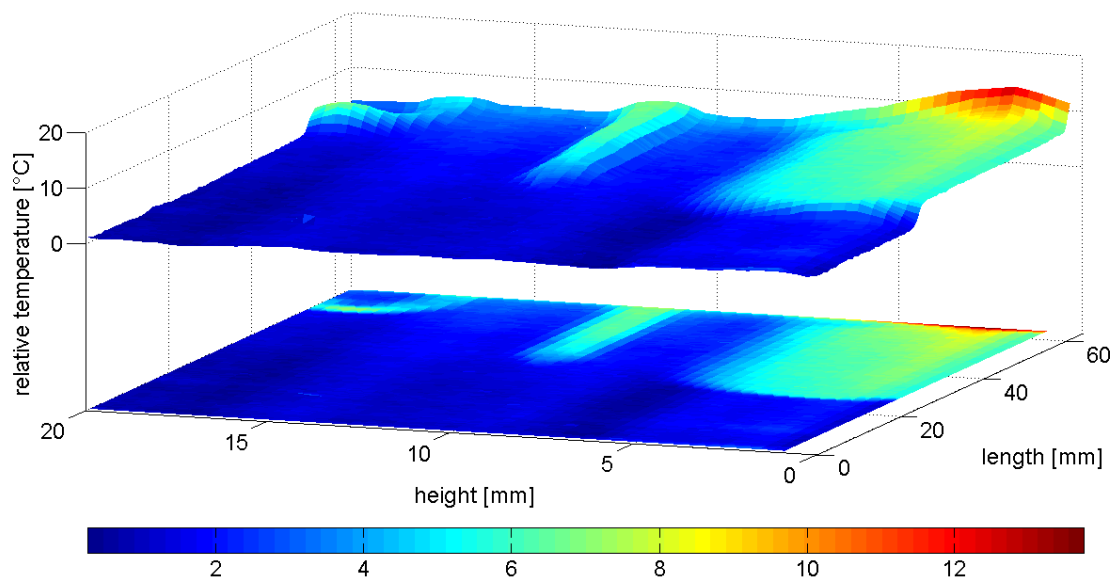
Fig. 11. Three-dimensional surface plot of shaft from side view for bearing with inner raceway fault

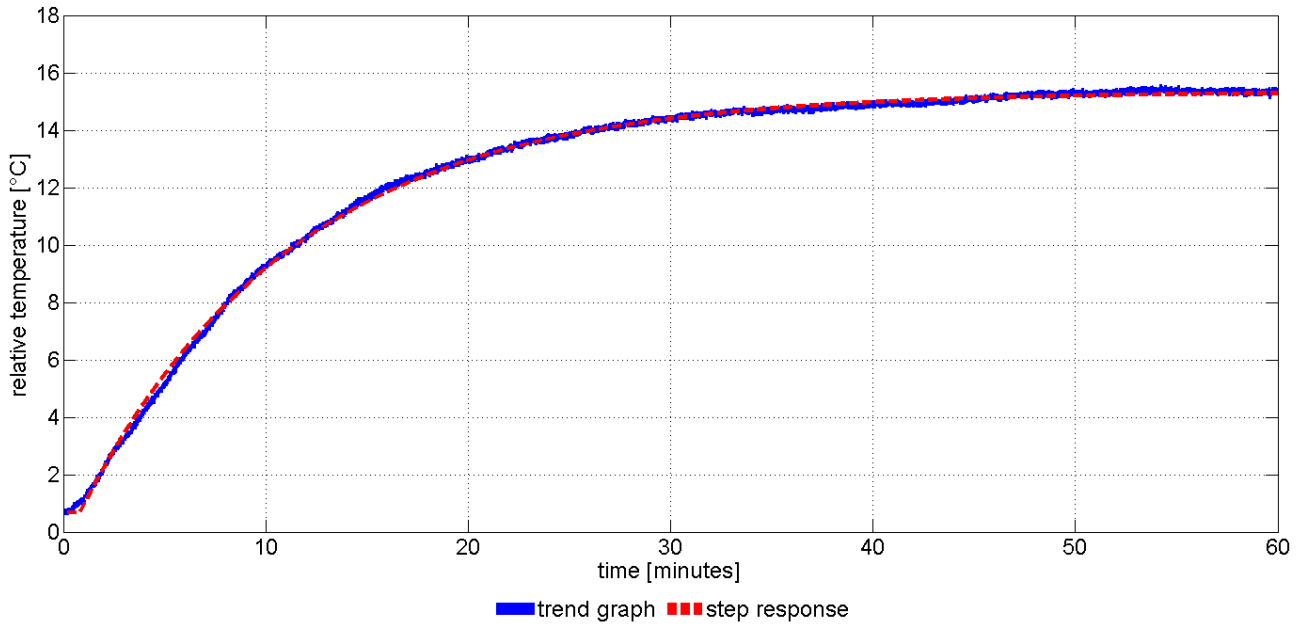
Fig. 12. Relative temperature trend and step response of the housing for healthy bearing

Figures 12 and 13 show the average relative temperature increases and step responses for the central point of the region of interest on the housing, independent of the ambient temperature. Whereas the thermocouples have shown only little differences in the ambient temperature, the temperatures of the housing clearly differ for the different bearings. In particular, the temperatures for the inner raceway fault increase faster than for the healthy bearing.

Whereas the inner raceway fault shows a first-order behavior straight from the beginning, the healthy bearing shows more a second-order behavior. The second-order behavior is approximated by a first-order model with dead time. The dead time defines the initial time required by the trend to show first-order behavior. In particular, a dead time of 48 seconds is determined for the healthy bearing.

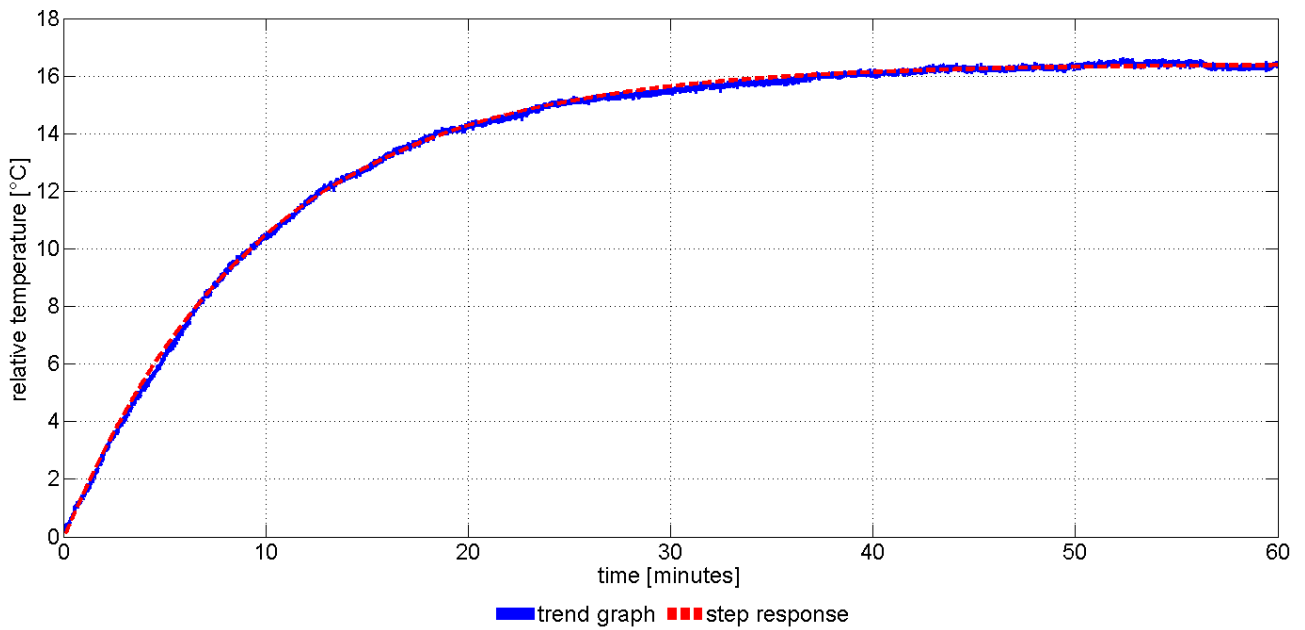
Fig. 13. Relative temperature trend and step response of the housing for bearing with inner raceway fault
