## The infrared measurements of damages of laser-processed carbon fiber reinforced plastics

by M. Muramatsu\*, Y. Harada\*, T. Suzuki and H. Niino

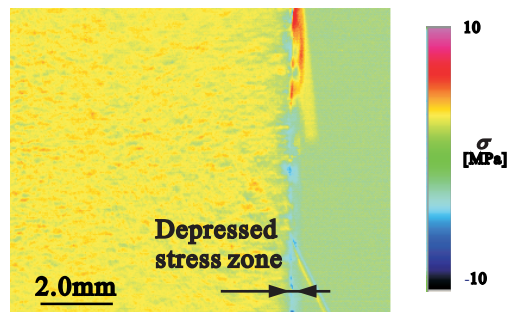
Fig. 1. Stress distributions of CFRPs processed by fiber laser by infrared measurement

Figure 1 shows the stress distribution of CFRP processed by the fiber laser. We also obtained X-ray images of CFRP from the directions 1 and 2 shown in figure 2. Figures 3 (a) and (b) are the observed images from direction 1 and 2, respectively. The both figures were obtained at the edge area of CFRP specimen. In figure 1, it can be seen that the numerous of fibers were exposed from the specimen at the cutting edge. Such exposed fibers were observed at the edge of the specimen in the figure 3 (b). Additionally, delaminations and debondings were seen inside CFRP in figure 3 (b). In figure 1, the depressed stress zone was observed at the edge of the specimen. The length of the zone area was 1.0-2.0mm. In figure 3 (a), the HAZ whose width was about 0.5mm was found. The size of the area whose stress was depressed corresponded to the size of the HAZ in the X-ray images. Comparison of the stress distribution in figure 1 and

X-ray images in figure 3 provides the following supposition: The epoxy resin in the cutting edge and the neighboring area was evaporated during the laser processing. Such evaporation led to the delaminations and debondings in CFRP, which made the area unable to bear the load. The depressed stress zone at the cutting edge area is considered to have induced the depressed strength [3].

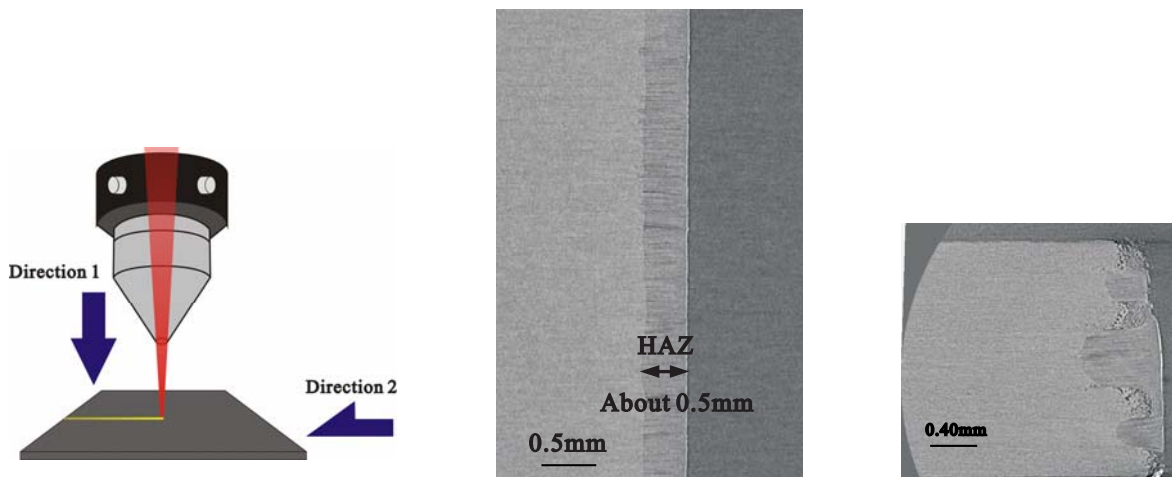
Fig. 2. Schematic illustration of observation directions toward laser processed CFRP

Fig. 3. X-ray images of CFRP processed by fiber laser
