The use of infrared thermography for defects detection on reinforced concrete bridges

by H. Cannard*, M. Mahrez*, T. Perrin*, V. Muzet*, D. Prybyla*, F.Brachelet**

Abstract

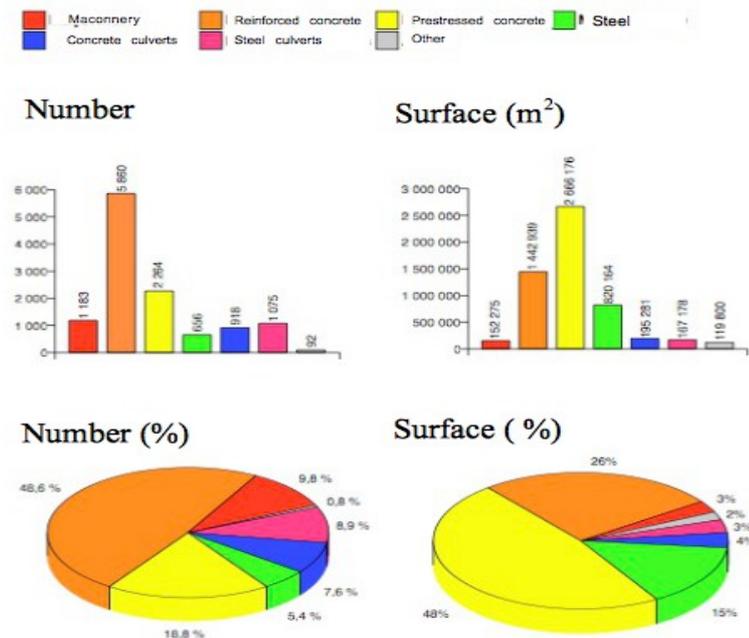
Fig. 1 : Bridge inventory by category on the French national roads network.

Nowadays, France counts around 200 000 bridges that are in use. On the national roads network, there are approximately 12 000 bridges corresponding to a 5 million meters square area [1]. The majority of these bridges are made with reinforced concrete (48,6%) and in prestressed concrete for 18.6% (Fig. 1). These constructions, dating from the 1970-80, may be subject to some classical pathologies induced by aging, like delamination of the concrete and corrosion of the reinforcing steel.

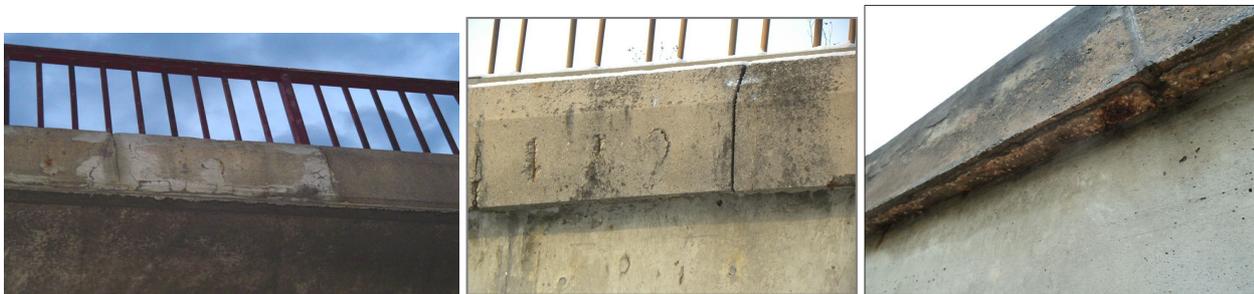
Fig. 2. Samples of steel corrosion and spalling of concrete on concrete cornices

The common defects identified on concrete bridges by visual inspection are delamination of concrete and corrosion of reinforcing steel [5]. On aging bridges, a particularly important point to monitor is the integrity of the concrete covering on the outer surfaces of cornices and on the horizontal surfaces below the deck (Fig. 2). Serious accidents may occur if pieces of concrete fall on the road.

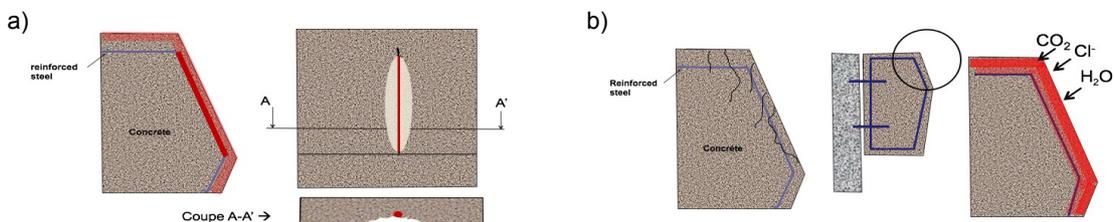
Fig. 3 shows the corrosion process. Aggressive agents like chlorides enter the concrete and modify its chemical properties. The passivation of steel is no longer guaranteed and initiation of corrosion begins. When steel corrodes, the resulting rust occupies a greater volume than the steel and leads to a loss of bond between the steel and the concrete. This expansion creates tensile stresses in the concrete, which can eventually cause cracking, delamination, and spalling. If left unchecked, the integrity and the durability of the structure can be affected.

Fig. 3. Process of steel corrosion and spalling of concrete. a) Penetration of aggressive agents, b) Spalling of concrete and initialization of corrosion

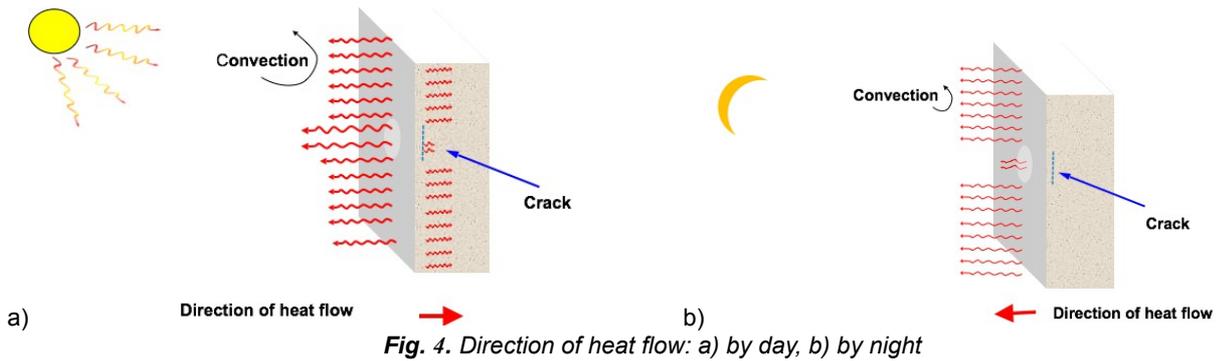
The major goal of this study is to detect the delamination on cornices with infrared thermography. If subjected to the same thermal stimulation, a cornice with defect presents surface temperatures that differ from a cornice without defect. Considering the cornice as a thermal system, the presence of a defect like an air gap introduces a supplementary thermal resistance [6]. Since the thermal conductivity of air is inferior to the thermal conductivity of the concrete and the steel, a thermal gradient can be generated and recorded with an infrared camera. This phenomenon is time dependent and can be helpful to reveal defects. The heat flow depends on the temperature difference and is disrupted as soon as it crosses a beginning of spalling or a cracked area (Fig. 4). For instance after a sunny day, when the bridge is warmer than the surroundings, the defects could appear colder than the surrounded intact area.

Fig. 4. Direction of heat flow: a) by day, b) by night

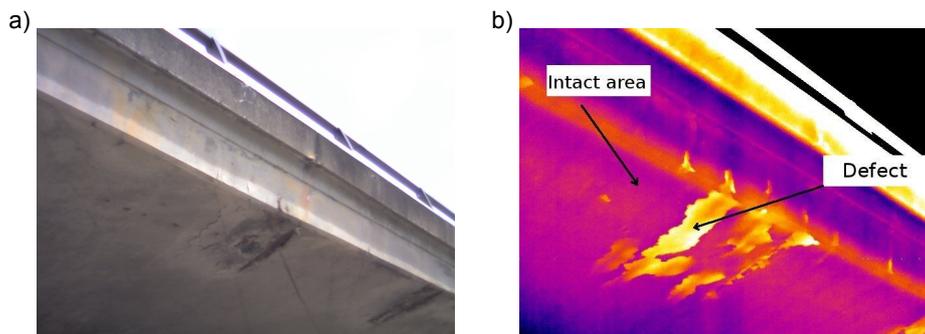
A first test was conducted on a reinforced concrete bridge which had some apparent defects (Fig. 5a). The aim of this first trial was to evaluate the thermal images quality under natural solicitation for different meteorological conditions. The experiment has shown that it was possible to detect the bridge defects under natural environmental stimulation [8], the defects appearing warmer than the intact surrounding area (Fig. 5b).

Fig. 5. Images in the visible spectrum (a) and in the infrared spectrum (b) of a concrete bridge deck.

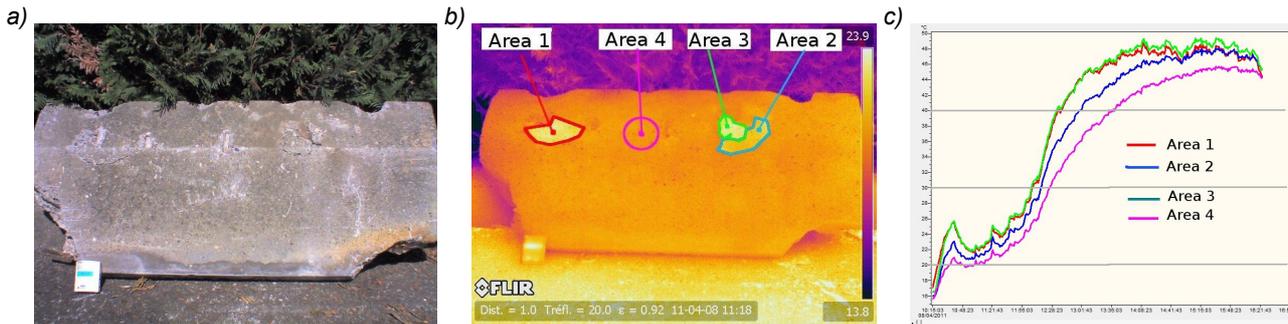
The second experiment was conducted outdoor on a sample of a bridge cornice subjected to natural stimulation. The sample presented four interesting areas:

- area 1 : release of burst of concrete remaining in place,
- area 2 : partial detachment of a burst,
- area 3 : total separation of a burst,
- area 4 : intact part of reinforced concrete (reference).

Fig. 6. Image of the sample of a bridge (a), infrared image with the 4 tested areas (b), mean temperature as a function of time for the 4 tested areas (c).

The temperature evolution of the sample was recorded during one day for the four defined areas. All the defects were detected (Fig. 6b). During the sunshine period, the temperature difference between the intact part and the area with the defects was greater than 1K and could reach 7K, which is higher than the thermal sensitivity of the infrared camera (NETD =30mK).

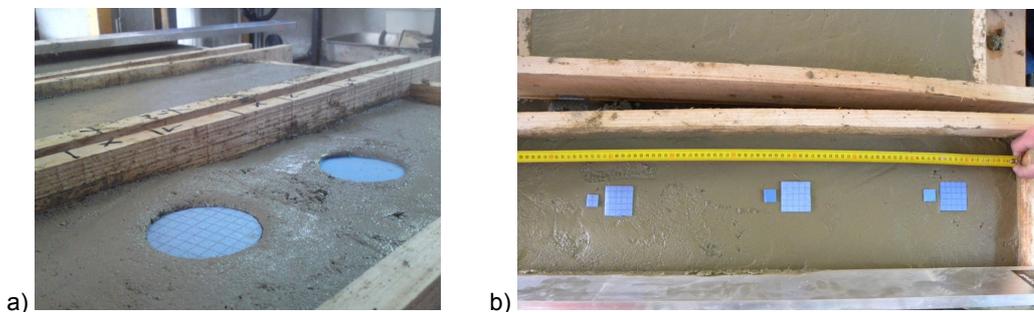
To simulate delamination defect of concrete, test slabs were realised with known defects. These specimens have been made with cement mortar (thermal conductivity = $1.60 \text{ W m}^{-1}\text{C}$). In each blocks, three defects were created with polystyrene foam (thermal conductivity = $0.04 \text{ W m}^{-1}\text{C}$) and placed at 1, 2 and 4 cm deep from the external surface. These defects, shown in Fig. 7, are circular, rectangular or square shapes.

Fig. 7. Positioning of the defects during the pouring of the specimen: a) circular defects, b) square defects.

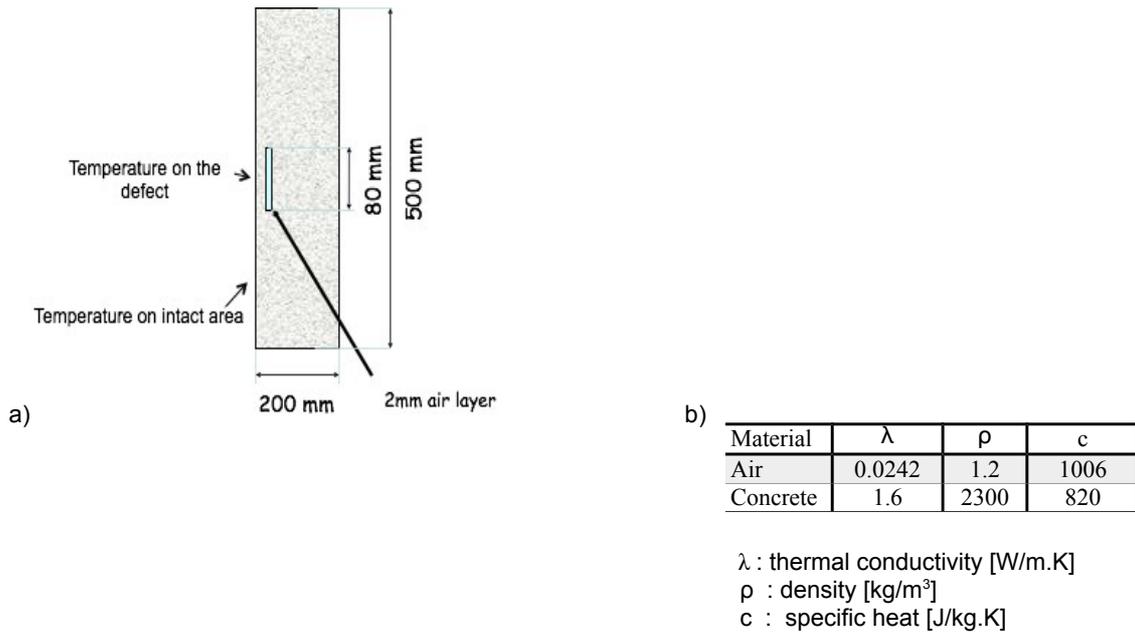
In order to evaluate the thermal evolution of the samples under external conditions, a model has been build. A cornice is modeled by a rectangle of concrete with a size of $50 \times 20 \text{ cm}$. The defect is simulated by an air gap with a size of $0.2 \times 8 \text{ cm}$ at depth of 2 and 4cm as illustrated on Fig. 8a. Thermophysical parameters are shown in table Fig. 8b.

The objective of this simulation is to determine the evolution of the surface temperature gradient. The rear face of the cornice is considered to be at a fixed temperature of $T_{\text{back}}=10^\circ\text{C}$. The exchanges between the front face and the surrounding fluid at $T_{\text{air}}=10^\circ\text{C}$ are represented by a global coefficient of exchange ($h_g=15 \text{ W/m}^2.\text{C}$). Boundary conditions imposed on the sides of the beam are of adiabatic type.

Fig. 8. a) Model of the cornice, b) Thermophysical parameters of the modeling

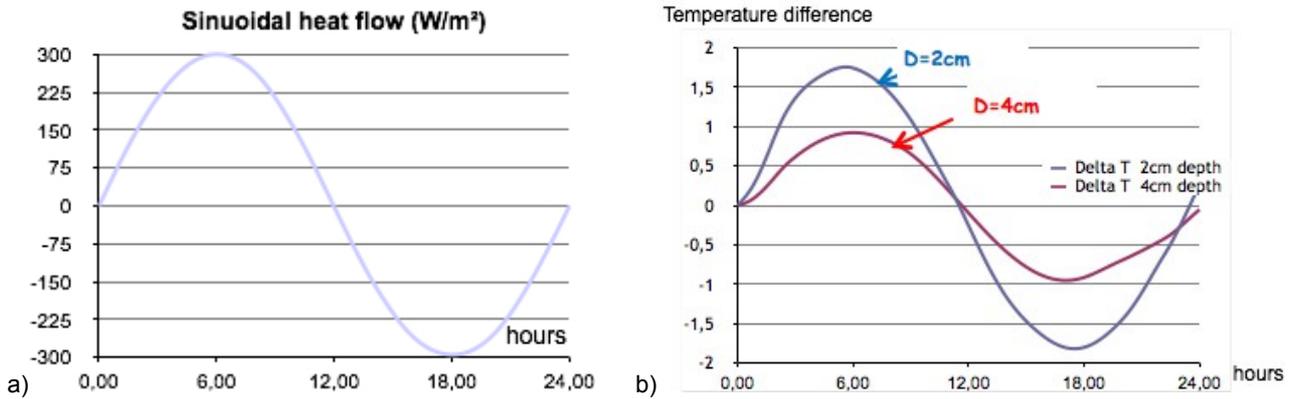
A sinusoidal heat flow of +/-300W/m² is also simulated on 24 hours (Fig. 10a).

Fig. 10b shows the evolution for 24 hours of the temperature difference between a defect area and an intact one. Amplitude of the resultant temperatures is higher than 1.5°C for a defect at a depth of 2cm and is less than 1°C for a deeper defect at 4cm.

These results demonstrate that defects localized at a depth of 4 cm could be detected by infrared thermography. These encouraging results let us think that it is possible to detect the beginning of spalling of cover concrete by an infrared camera, as the concrete cover on aged bridges is roughly 3cm.

Fig. 10. a) Sinusoidal heat flow on 24 hours, b) Difference between the temperature on a defect area and an intact area for defects at 2cm depth (in blue) and 4cm depth (in red).

- the amplitude of the signal must be sufficiently high so that the effect on the surface is detectable ;
- the ratio between the defect size and its proximity to the surface should be large enough to create a thermal contrast ;
- propagation of sinusoidal heat waves is exponentially attenuated as a function of depth (Fig. 10b).

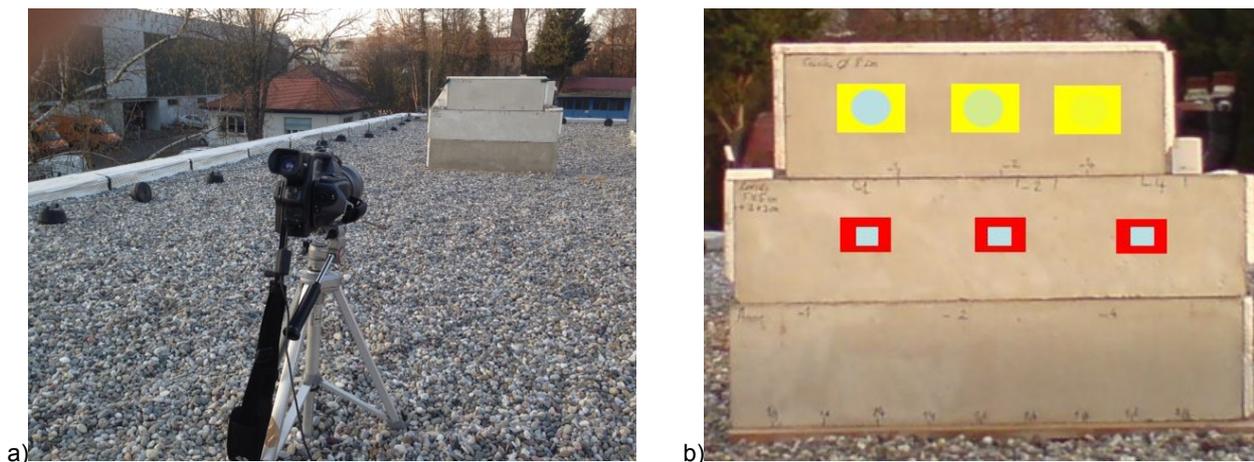
Infrared thermography tests were performed outdoor on the test slabs by passive thermography. The thermal stimulation is made by the climatic environment: solar radiation and convection. The sides have been insulated with foam to reduce heat losses from outskirts. The experimental set up is presented in Fig. 11.

Fig. 11. (a) View of the experimental device, (b) Location of defects are highlighted in blue in the samples.

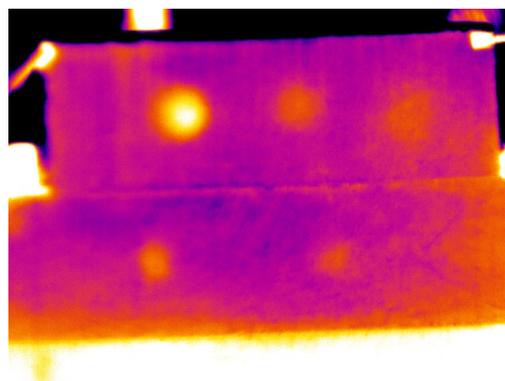
Images were taken every ten seconds by the infrared camera from 7.30am to 6.00pm. An example of an image grabbed by the infrared camera can be seen in Fig. 12. Temperatures differences between defect areas and an intact one have been represented for the 3 defects. The results are presented in the Fig. 13.

Fig. 12. Infrared image of the sample under natural solar stimulation.

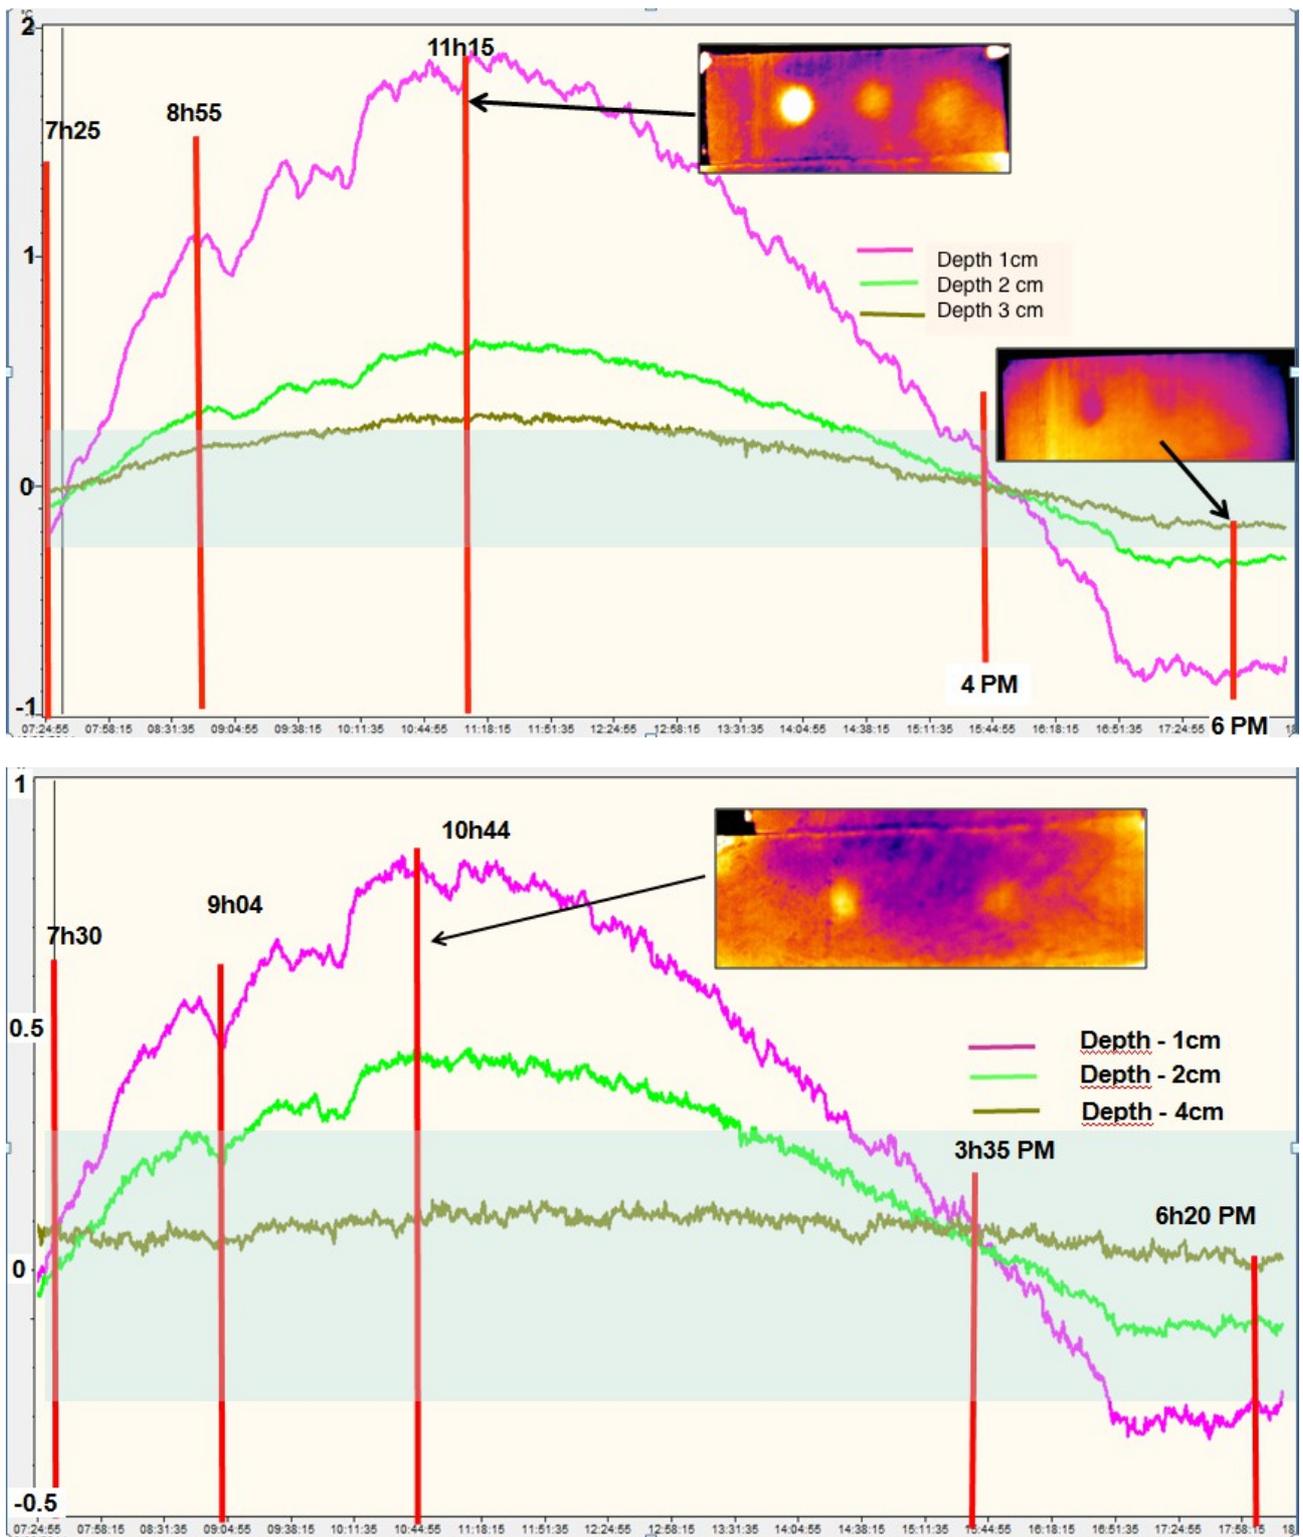
Fig. 13. Temperature differences between areas with defects on three different depths and an intact area: a) Circular defects of 8 cm diameter, b) 5x5 cm squares defects.

While the defects closer to the surface could be quickly identified after the first sunlight exposure, the 4cm depth defect was only detected when the ambient temperature increased. Whatever the depth, defects with a size of 2x2cm,

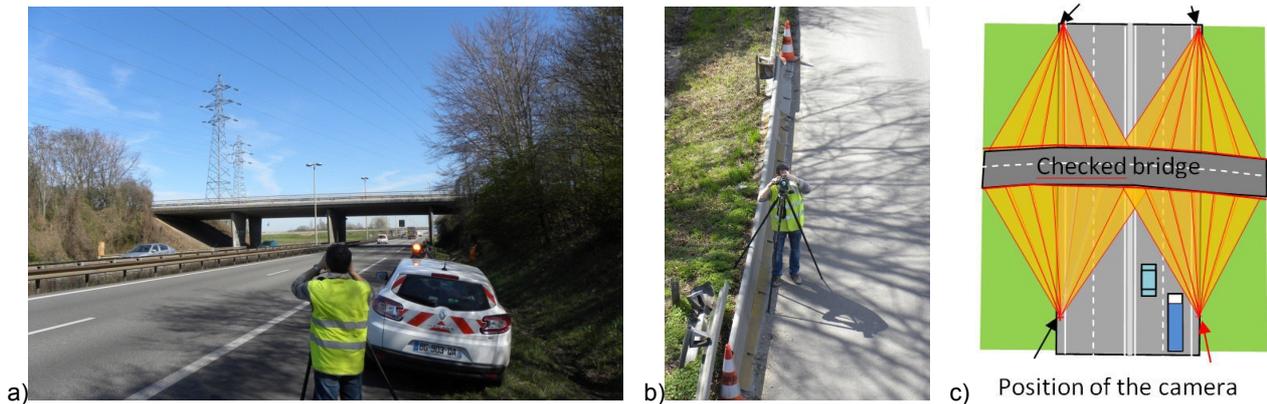
Several experiments were conducted on reinforced concrete bridges in order to identify damaged cornices. To keep the operators safe, the experiments were performed with a camera equipped with a telephoto lens. As it can be seen on the Fig. 14, during the intervention, the road traffic was not stopped.

Fig. 14. Pictures of the camerawork (a and b) and implementation of shooting (c).

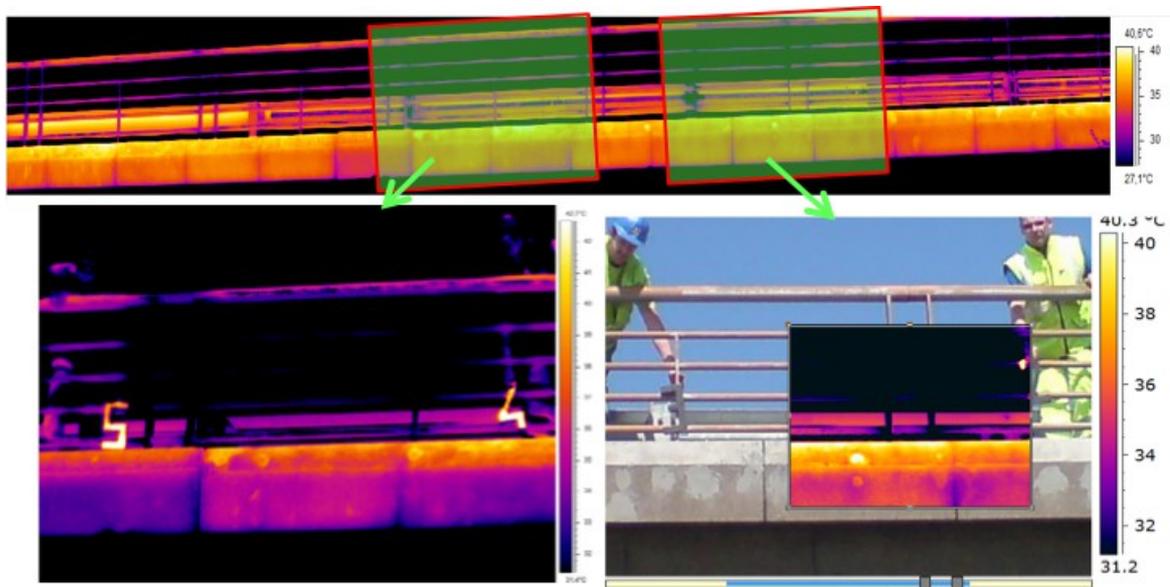
To be able to localize defects, a bridge preparation is needed, for example by the placement of landmarks on the bridge as shown in Fig. 15. These landmarks should appear in infrared and visible spectrum. With this setup, it was possible to make a complete inspection of the cornices of the bridges with 4 installations of the camera. Several defects like delaminations were detected even in case of indirect sun exposure.

Fig. 15. Images of landmark (left) and defect detected in "fusion mode" (right).
