Comparative study of active infrared thermography, laser vibrometry and laser ultrasonic techniques in application to the inspection of graphite/epoxy composite parts

Abstract

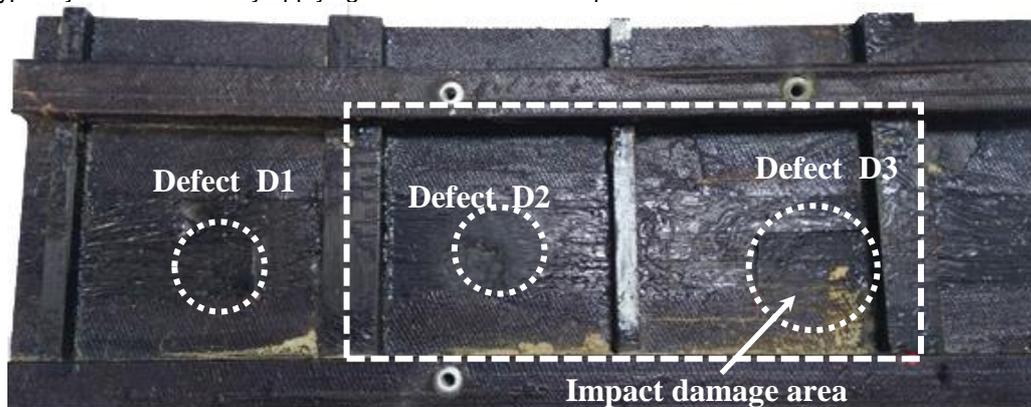
Fig. 1: Test graphite epoxy sample (rear view, defect 1 - through-the-sample (“kissing”) cracks, defect 2 - 40-50% wall thinning, defect 3 - 15 J impact damage, square dashed area was tested by laser ultrasonics)

The 250×100×2.5 mm graphite epoxy test sample shown in figure 1 represented a fragment of a composite cylindrical case used in the aerospace industry. The main panel of a curved shape was strengthened with two types of ribs also made of graphite epoxy and contained three artificially-made defects (specified as 1, 2 and 3 in figure 1): two 12 mm-long thin vertical slits simulating cracks, local wall thinning with 15 mm-diameter material loss from 40 to 50% and 15 J impact damage. Since thinning-like (“corrosion-type”) defects are not typical in real composite parts, this kind of defect was used to show how local variations of main panel thickness and the presence of ribs affect surface temperature. Two other defects, in fact, simulated composite cracking that can occur in both lateral and in-depth directions. The through-the-sample cracks could not be detected visually, therefore, to some extent, they simulated vertical “kissing” cracks which are typically hard to detect by applying common NDT techniques.

The most important information about defects is supplied by analyzing amplitude-frequency characteristics of samples under test. For each of three defects in the test sample from figure 1, we found resonance frequencies at which local vibrations are maximal (see figure 4). At the frequency of 2.275 kHz, the D1 area was characterized by mean vibration velocity of $62 \mu\text{m/s}$ and produced $\text{SNR}=23$ in regard to mean 'non-defect' vibration of $4.05 \mu\text{m/s}$ (see the formula for SNR above). In the D2 area, the intensity of resonance vibrations exceeded those in a non-defect area by 14 times reaching the value of $51 \mu\text{m/s}$ at the frequency of 3.25 kHz: the corresponding SNR value was 21. Respectively, in the D3 area, the mean vibration amplitude was $73 \mu\text{m/s}$ at the frequency of 2,65 kHz (mean 'non-defect' value $6,5 \mu\text{m/s}$) with the maximum $\text{SNR}=22$.

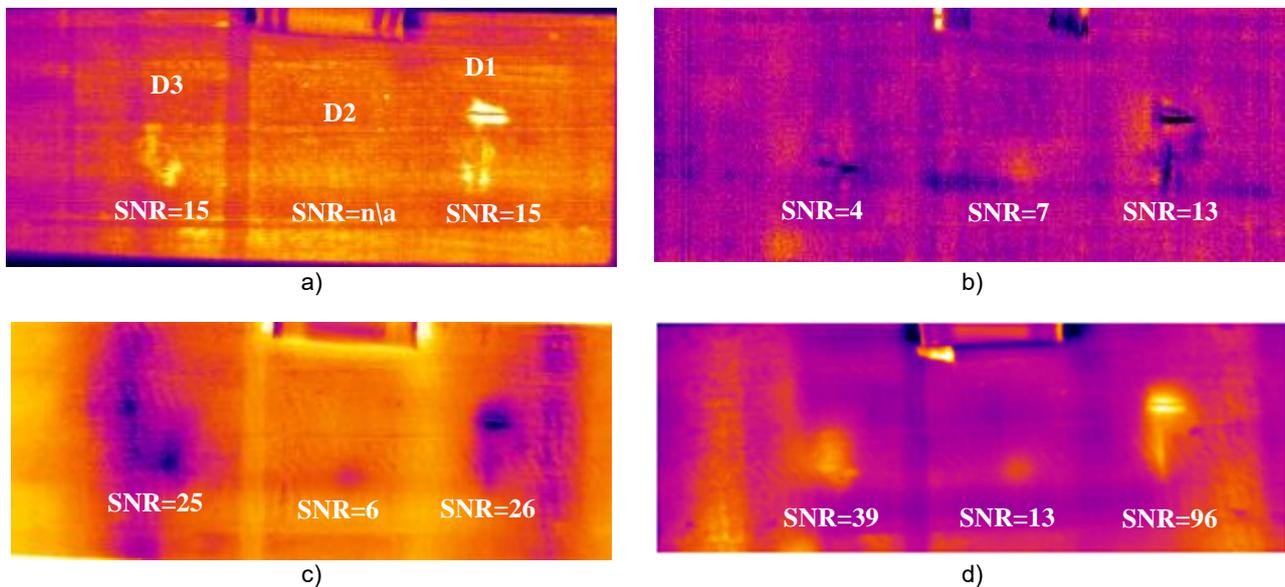
Fig. 2: Test results, optical heating: a-Xenon tube, source image, b-same as a), PCA image; c-halogen lamps, pulsed heating for 10 s; PCA image; d-halogen lamps, frequency 0.07 Hz, PCA image

Flash heating was not powerful enough to ensure a detectable temperature elevation over the area with material loss while two other defects appear clearly in the source image (figure 2a). Applying PCA has allowed to stress the material loss ($SNR=7$) but worsened visibility of two other defects (figure 2b). This is a typical selective feature of the PCA method which concentrates particular types of temperature patterns in particular components. The thermogram in Fig. 2c illustrates why halogen lamps are often used in active thermal NDT devices due to high energy delivered for some seconds of heating (see the results of the pulsed test in figure 2d). However, the highest SNR values for all three defects appeared in the case of low-frequency thermal waves (figure 2d).

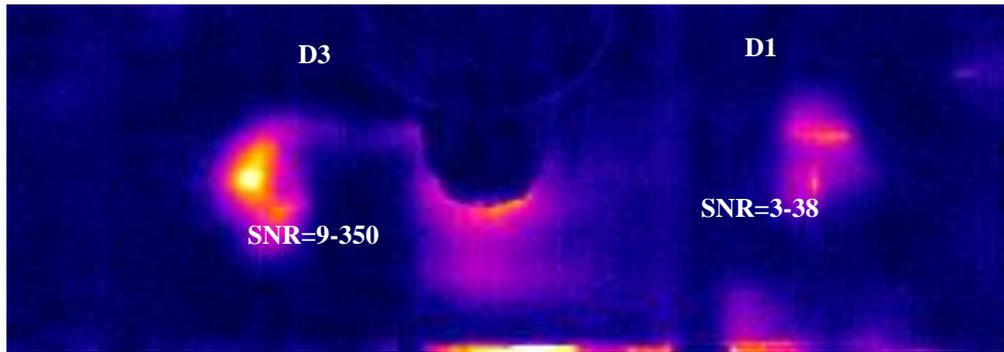
Fig. 3: Temperature distribution on sample surface under ultrasonic stimulation (22 kHz, 300 W electric power, magnetostrictive device in the centre)

Ultrasonic stimulation was performed by using a magnetostrictive device providing continuous (long-pulsed) stimulation with 22 kHz mechanical waves, while the electric power supplied to the magnetostrictive indenter was in the range from 50 to 500 W (see also [2-4]). When the indenter was firmly pressed onto the sample front surface in the sample centre, the defects 1 and 3 have been reliably detected providing fairly high SNR values while the indication of Defect 2 was hidden within the stimulation area (figure 3) it cannot be detected by ultrasonic IR thermography because of a lack of internal friction. High SNR values that are typical for this method of NDT are conditioned by the principle of “dark field” that is characteristic for ultrasonic IR thermography. This means that defect-free areas do not change their temperature as a result of stimulation thus leading to very small values of temperature standard deviation σ_{nd} . The big divergence in the SNR values (see figure 3) are explained by a strong non-linear dependence of temperature signals on position of the stimulation point.

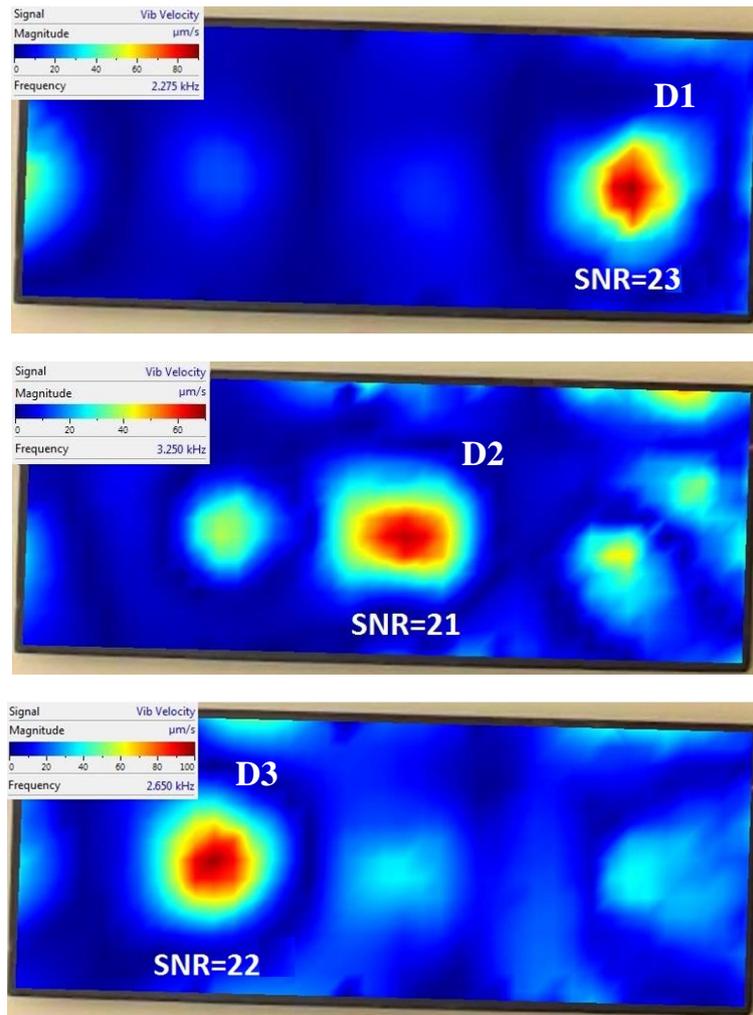
Fig. 4: Local resonance vibrations: D1 – 2.28 kHz (top), D2 – 3.25 kHz (middle), D3 – 2.65 kHz (bottom)

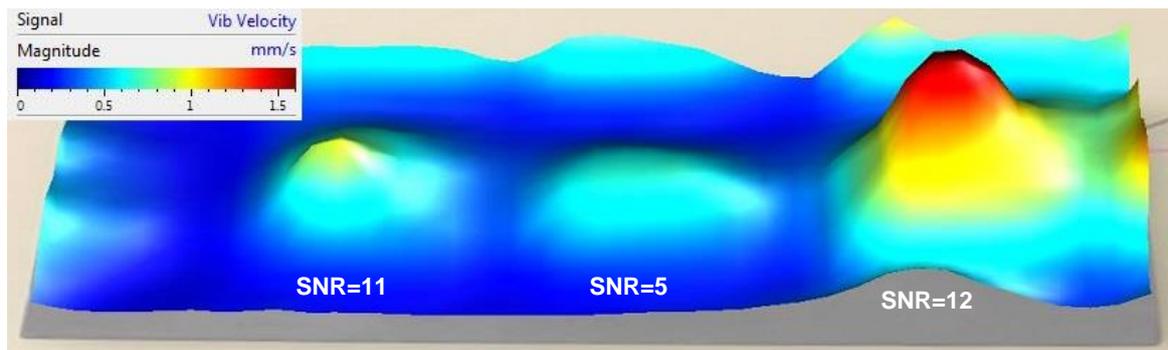
Fig. 5: Total vibration pattern obtained under low-power ultrasonic stimulation by applying SLDV technique (wide frequency range)

Since the resonance frequencies for all defect areas were close, the technique of laser vibrometry allowed obtaining clear defect patterns in the image of total vibrations even if the corresponding SNR values were 2-4 times lower than in the case of resonance stimulation (figure 5, wide frequency range).

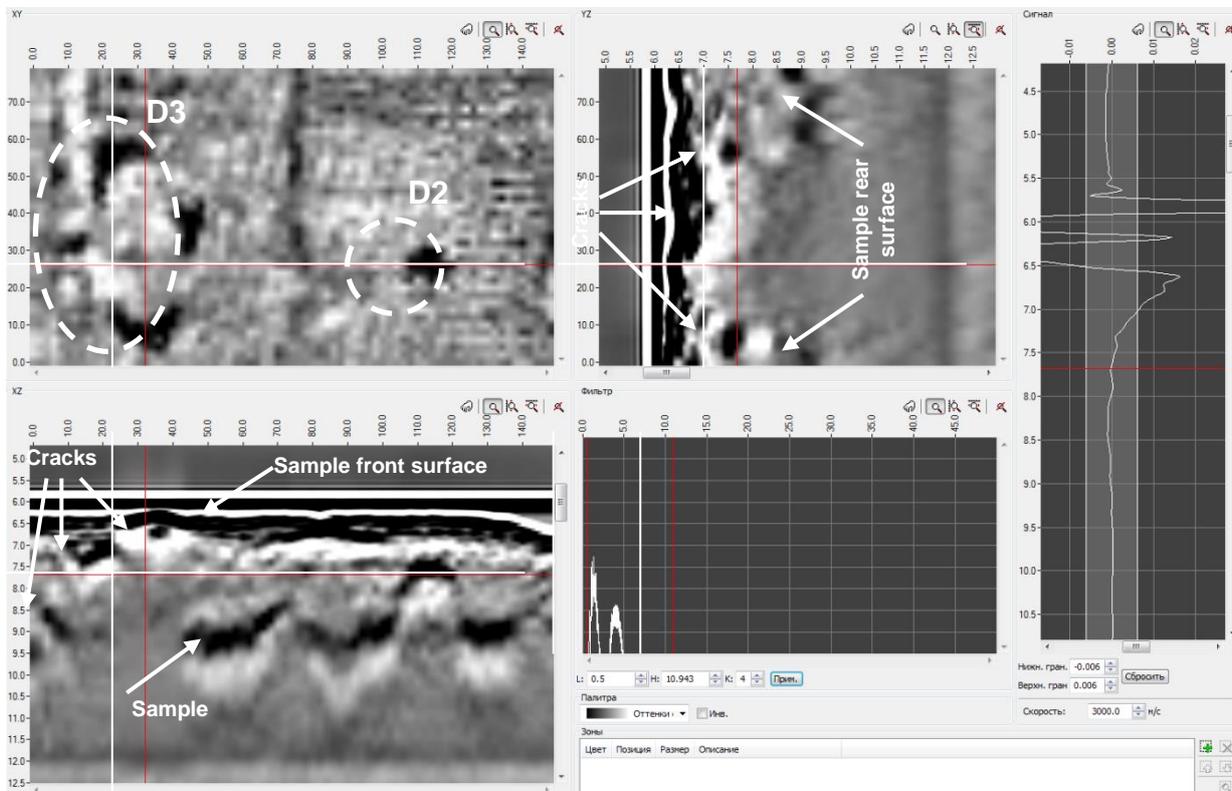
Fig. 6: Example of laser ultrasonic test results (processing program interface)

Figure 6 shows the interface of the computer program used in data processing. The size of the scanned area was 150×80 mm (see figure 1), scanning step - 2 mm. The signals obtained are represented in a 3D form (figure 6); the XY, XZ and YZ planes depict the sample cross-sections (slices) at fixed coordinates Z, Y and X respectively. The X and Y coordinates are fixed by the position of both the vertical and horizontal markers on the XY-plane, and the fixed Z-coordinate is determined by the horizontal marker on the XZ plane. By correspondingly changing position of markers, it is possible to visualize the internal structure of the sample. The Z-coordinate corresponds to a time delay of the acoustic

signal. In fact, by knowing velocity of ultrasonic waves in a test material, one can convert time delays in the in-depth coordinate Z, while grey tone images represent signal amplitudes.

In figure 6, the sample front surface is represented by a white-colour line because here an ultrasonic pulse penetrates the composite from the medium of lower density; respectively, the rear surface appears as a wide dark line. It is clearly seen that the material is essentially inhomogeneous. It is also characteristic, that, in the defect D2 area, the bottom reflection of the ultrasonic waves occurs at the half sample thickness (see the XZ-plane). The area of impact damage (D3) contains plentiful cracks while the rear-surface signals are absent. In fact, acoustic signals cannot penetrate through the damaged area.

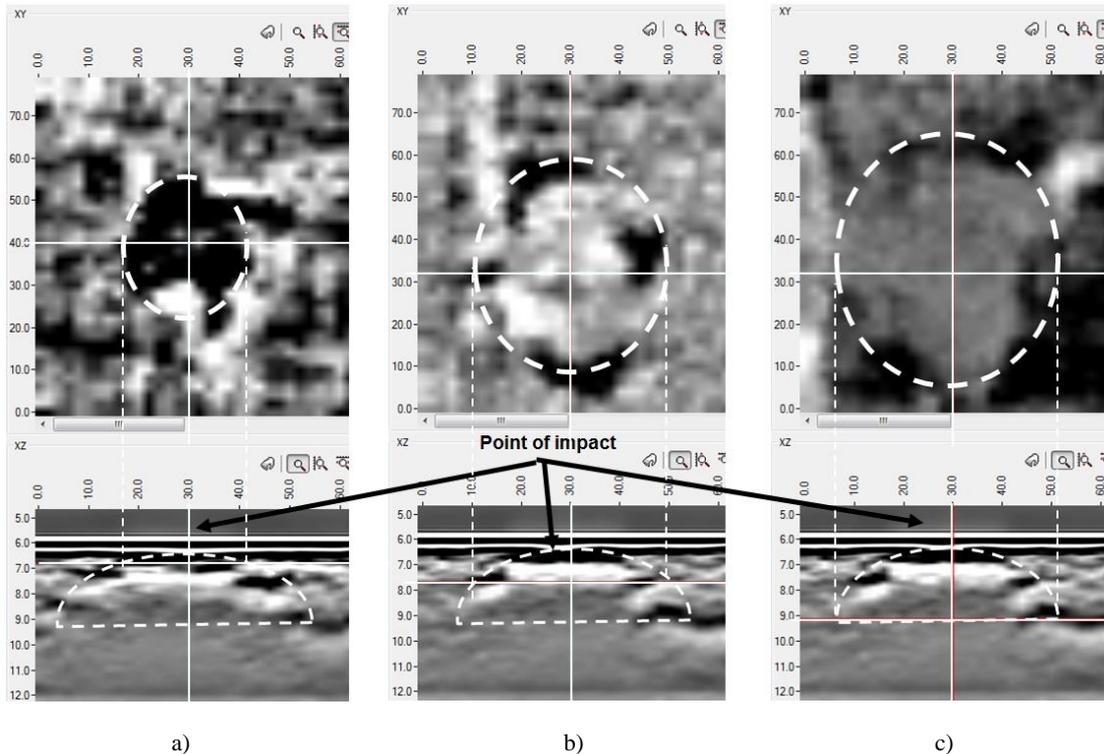
Fig. 7: XZ (top row) and XY (bottom row) slices: a - depth 0.5 mm, b - 1.4 mm, c – 2.9 mm

Figure 7 shows some sets of slices in the area of the defect D3. The XZ-planes correspond to different material depths: approximately 0.5, 1.4 and 2.9 mm. By evaluating these results, one can see that the zone of internal structure damage has the form of an inverted cup with the cup bottom placed on the area of front surface impact. The cracks shown in the XY slices look like concentric circles of which radius increase with depth.
