The continuous thermal imaging of the flood embankment to identify location of the leaks

by B. Bukowska-Belniak*, A. Borecka*, A. Leśniak*

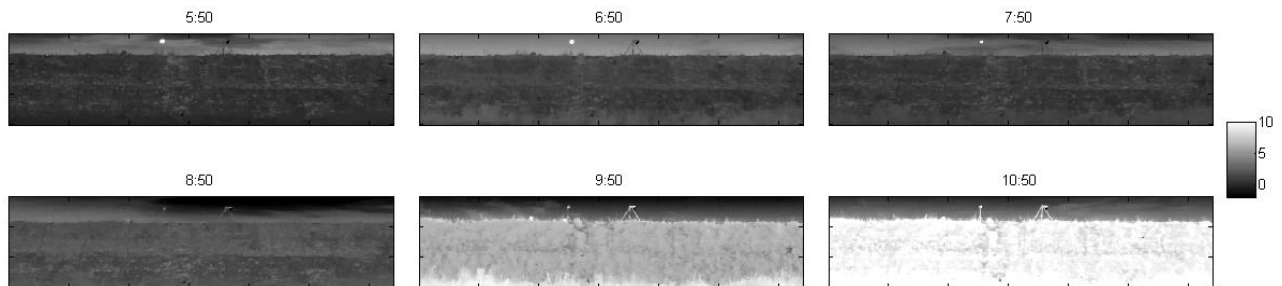
Fig. 1: Thermal images taken in daybreak and morning at 5:50, 6:50, 7:50, 8:50, 9:50 and 10:50 [°C].

The thermographical measurements were carried out during several experiments that were conducted in different seasons and lasts for several days. In November 2016 experiment, during the occurrence of a leak in the NW part of the embankment the stationary thermal image recording was performed with a 5-minute step. Figure 1 presents six images taken by FLIR T620 microbolometer camera. There are no visible places of leaks on the surface of the embankment, despite their occurrence in this area.

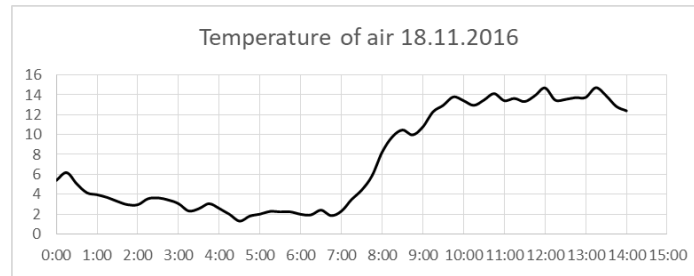
Fig. 2: Temperature of air measured by weather station in °C.

As it was shown in figure 2 there was a rapid rise (12°C) in air temperature between 7:00 and 10:00 in that day. The sun rose at 7:00. After 8:00 the temperature of the embankment began to increase.

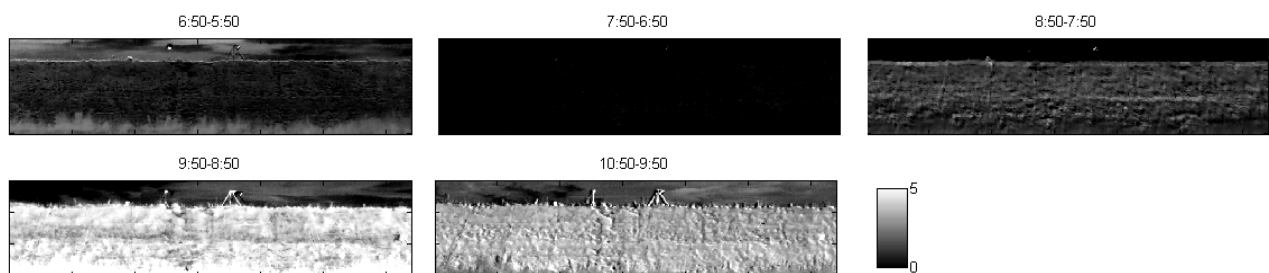
Fig. 3: Differences in temperature in each hour of measurement – subtraction images [°C].

There is expected that when air temperature raises in damp areas of the embankment the temperature increases more slowly than in adjacent, dry areas. After performing the subtraction of the consecutive thermal images, the leak regions became visible as can be seen in Figure 3. A strip shape dark area, 1.6 m above embankment base is visible, where more permeable layer of sands exists (fig.3 9:50-8:50).
