Thermal analysis of impact damage of prepreg composite materials

by P. Bagavac*, L. Krstulović-Opara* and Ž. Domazet*

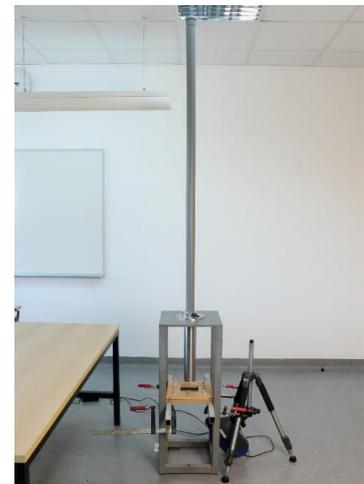
The EN DIN 6038 impactor is used to test material resistance and response when subjected to impact, Fig. 1. The device consists of a supporting construction, tube, thorn and frame for clamping the sample. It is possible to place specimens of different thickness on the frame. A thorn is released from height thus producing a dynamic impact on the surface of specimen. An IR camera is placed underneath the specimen on, i.e. facing the tension side during impact loading. IR camera is capturing temperature distribution throughout the duration of the experiment.

Fig. 1. Experimental setup – EN DIN 6038 impactor

It is possible to vary the height from which the thorn falls to the sample by free fall and the weight of the thorn. In this way, we select the impact energy ($E = m g h$) and the amount of motion ($p = m v$) by which the thorn strikes the surface of the sample. This is a very simple impactor and used to produce the damage on specimens that later on were subjected to NDT.

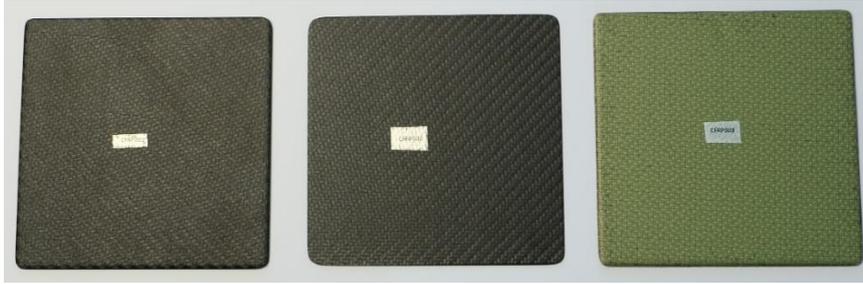
To evaluate the impact behavior of composite structures, 3 different composite materials were tested: CFRP001, CFRP002 and CFRP003 with overall dimensions $150 \times 150 \text{ mm}$, Fig. 2. Specimens were made from RAW006-010319 SHD DF314-C650-HS-3K-1250mm carbon prepreps and matured for 18 hours in autoclave at $75 \text{ }^\circ\text{C}$ and 1.5 bar pressure. Lay-up plan is given at Table 1.

Fig. 2. Specimens: CFRP001, CFRP002 and CFRP003

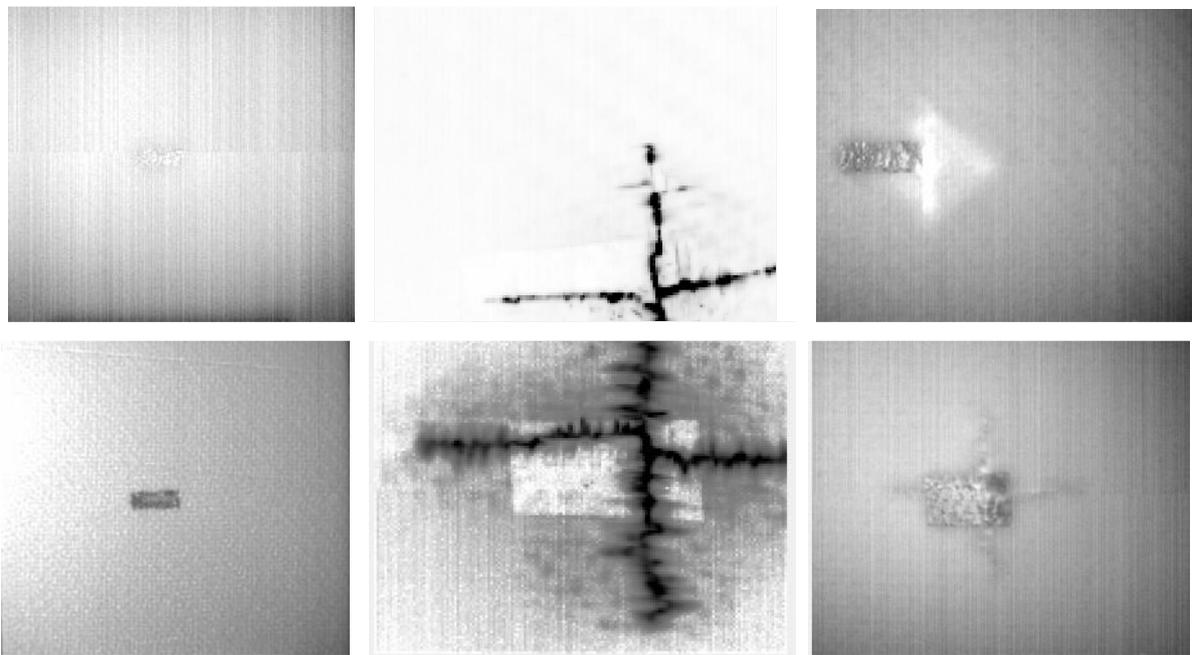
As shown at Fig. 3., the CFRP003 specimen exhibits a more extensive damaged area, as the intralaminar damage in the CFRP003 specimen is more detectable than in the CFRP001 specimen for same geometry and impact parameters.

Fig. 3. Thermal images for specimen CFRP001 and CFRP003 impacted with total energy of 19.68 J: a) before impact, b) during impact and c) after impact
