# Numerical and experimental analysis for flaw detection in composite structures of wind turbine blades using active infrared thermography

## Abstract

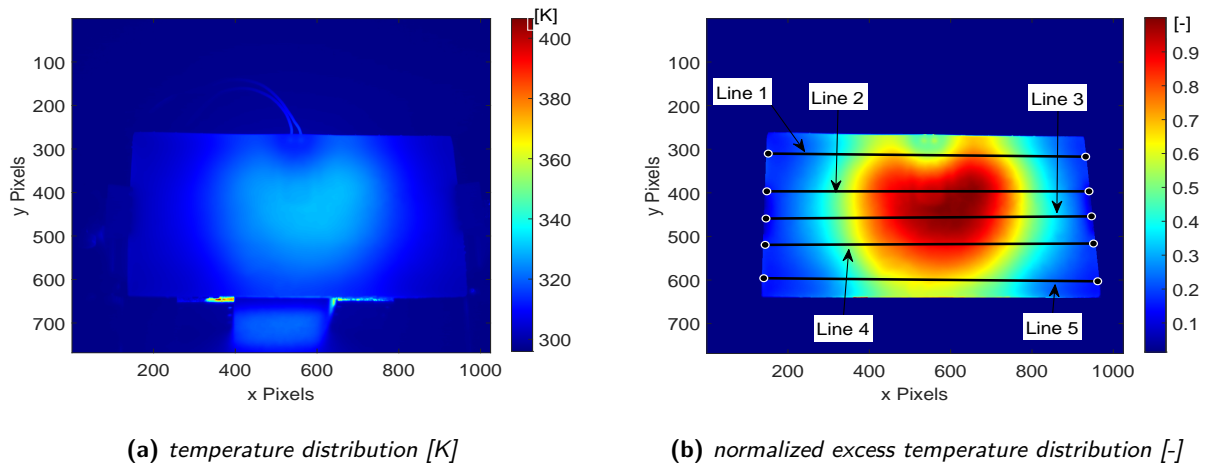
In the configuration of the last scenario analyzed, Fig. 10a shows the thermography for the final heating time, where it can be seen that a region on the right side heated more than on the left side. This must have occurred because the inclusion of PVC made it difficult to transfer heat to the right side of the sample, resulting in the accumulation of heat in the region between the center of the composite and where the defect is located. Analyzing the excess temperature lines in Fig. 11, the 60 s instant shows a significant asymmetry between the two sides of the surface, especially in lines 1 and 2 that pass over the PVC inclusion. The right side presents an accumulation of heat due to the defect making heat transfer difficult. During the entire heating phase (120 s) and beginning of cooling (180 s) the same thermal behavior was observed. Therefore, scenario 4 was also able to present thermal asymmetries for a defective composite material.

Fig. 10. Thermographic images for scenario 4 at the end of heating

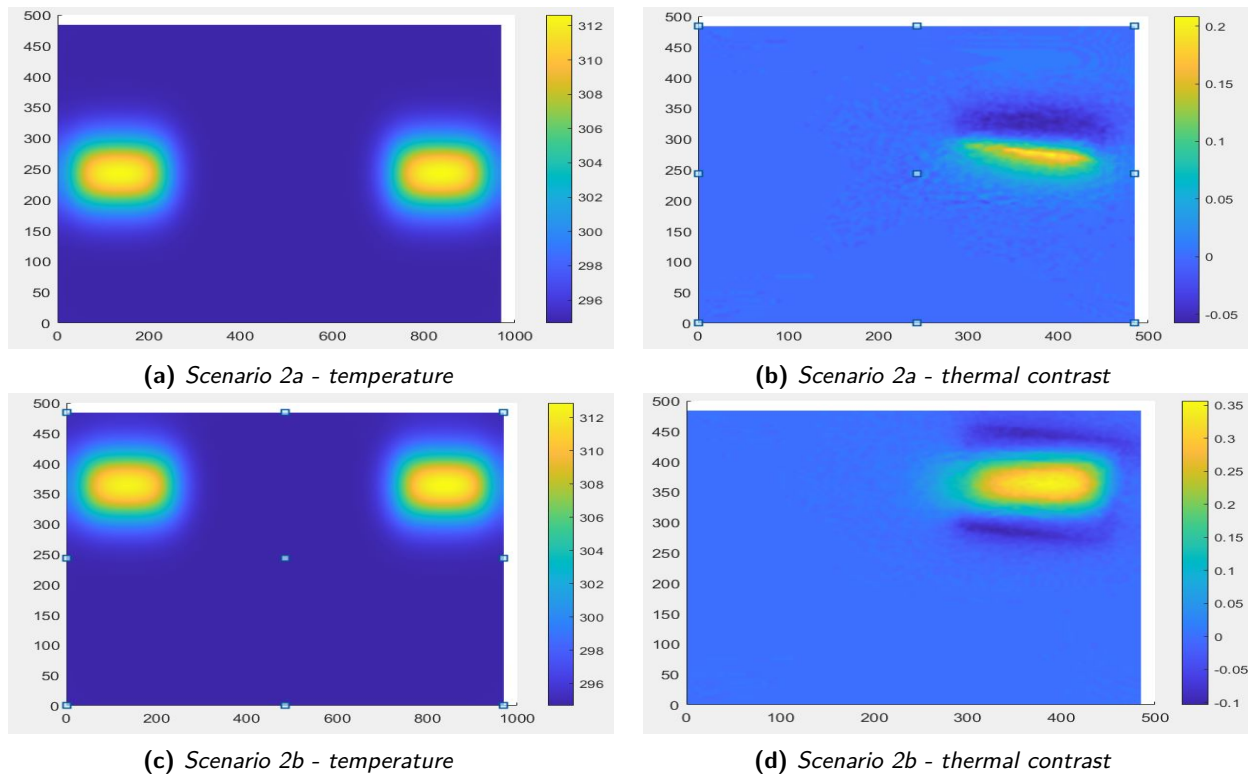
Figure 13 shows the simulated thermal images at the final heating time of 120 s. Figure 13a shows the temperatures on the front surface of scenario 2a, where the image presents a thermal symmetry between the right and left side of the sample. When performing the subtraction between the right and left half of the thermal image, Fig. 13b shows the thermal contrast of this scenario, where it is possible to observe a small region of low temperature at the defect location and a region of high temperature below the defect. Figures 13c and 13d show the temperature distribution and thermal contrast for the simulation in scenario 2b. In this case, the reconstruction of the defect is of great interest, as the heat generated finds it more difficult to dissipate due to the presence of PVC, thus creating an image with low temperature contours that characterize the defect.

Fig. 13. Numerical thermal images at 120 s [K]

greater capacity to heat the composite, also increasing the possibility of reducing the distance between the heat source and the defect. Numerical analysis showed that if the heater and inclusion are overlapping, the defect reconstruction can be considered of great interest.
