A preliminary study on pipe wall thinning of metallic underground utilities using in-pipe infrared thermography

by Samuel Yu*, Marco Kin Pan Ho, Wallace Wai-lok Lai, Janet Fung Chu Sham, Ho Chun You**

*Department of Land Surveying and Geo-informatics, The Hong Kong Polytechnic University, Hong Kong, samuel-yu.yu@connect.polyu.hk

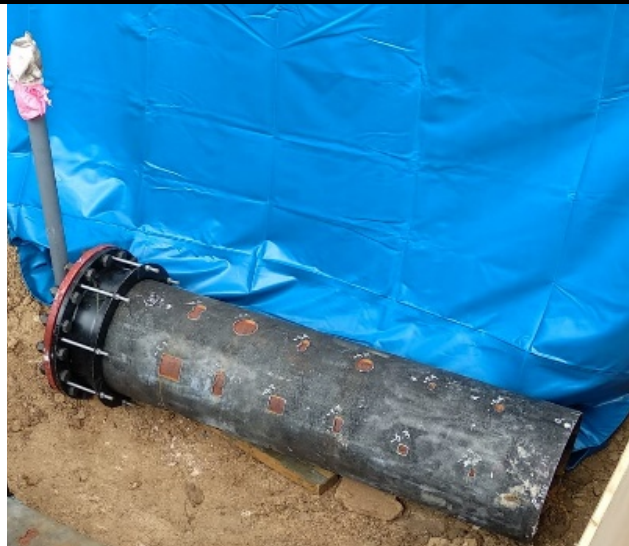
Fig. 1: Pipe sample with milled defects on the pipe exterior before buried attached with a flange connected to a riser pipe with shut off valve at the left of the pipe.

Fig. 1 shows the pipe used for this study before burying underground. One end of the pipe was plugged and attached to a riser which the hot air was transported into the pipe. The other end of the pipe was the entrance for the robotic tractor entering the pipeline for inspection. Each pipe was machine-milled with 36 flat-bottom holes on the pipe exterior. These holes had varying lateral size (25 mm, 50 mm, 75 mm) and residual thicknesses to imitate pit corrosion on a metallic pipe and were distributed on the pipe randomly into 6 rings in which each ring have 6 defects distributed in 6 directions - 12 o'clock, 2 o'clock, 4 o'clock, 6 o'clock, 8 o'clock and 10 o'clock with 12 o'clock in the zenith direction and 6 o'clock in the nadir direction. Each ring of defects, which represents the distance of that group of thinned area from the pipe entrance which Ring 1 is the closest to the entrance for the robot and Ring 6 is the furthest, was separated by approximately 208 mm to ensure the effect of diffusion in the longitudinal (z) direction is not affecting each other (Fig. 2). The design details on the pipe exterior for 400 mm pipe are listed in Table 2. The schematic drawings of the designed defects on both pipes are shown in Fig. 2. The defect notation (e.g. R6-75-l-4.0) is interpreted as the following:

In this study, active thermography was applied. A heat blower was set to 50 °C and was applied to the pipe as the source of heat. The heat blower was attached to the shut off valve at the end of the riser pipe as shown in Fig. 1., and the heating time has set to be 2 min.

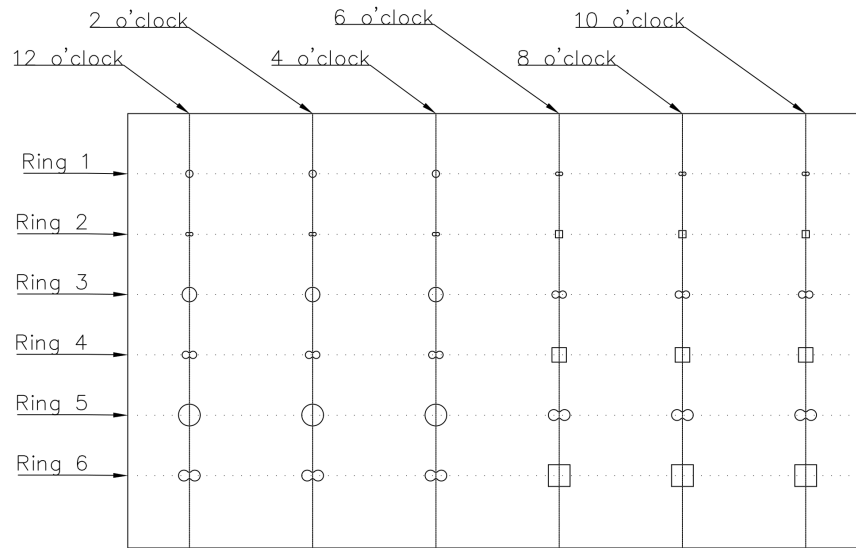
- R1/2/3/4/5/6 – represents the ring number the defect locates;
- 25/50/75 – represents the lateral size of the defects in millimetre (mm);
- l/C/S – represents the defects in Peanut-shaped (l), Circle (C) or Square (S)
- 1.0-5.0 – represents the residual thickness of the defects measured by ultrasound probe

Fig. 2: Schematic drawings of the design defects on an unwrapped sheet

Angular Direction	Distance from entrance (mm)					
	208	416.7	625	833.3	1041	1250
12 o'clock	R1-25-C-2.1	R2-25-I-2.6	R3-50-C-3.5	R4-50-I-2.1	R5-75-C-2.2	R6-75-I-4.0
2 o'clock	R1-25-C-2.8	R2-25-I-4.0	R3-50-C-2.0	R4-50-I-2.7	R5-75-C-3.6	R6-75-I-1.7
4 o'clock	R1-25-C-4.0	R2-25-I-2.0	R3-50-C-2.8	R4-50-I-3.6	R5-75-C-2.0	R6-75-I-3.0
6 o'clock	R1-25-I-2.3	R2-25-S-3.1	R3-50-I-4.4	R4-50-S-2.1	R5-75-I-2.7	R6-75-S-4.0
8 o'clock	R1-25-I-2.7	R2-25-S-4.0	R3-50-I-2.0	R4-50-S-2.6	R5-75-I-4.0	R6-75-S-2.0
10 o'clock	R1-25-I-4.0	R2-25-S-1.8	R3-50-I-3.1	R4-50-S-4.0	R5-75-I-1.7	R6-75-S-2.6

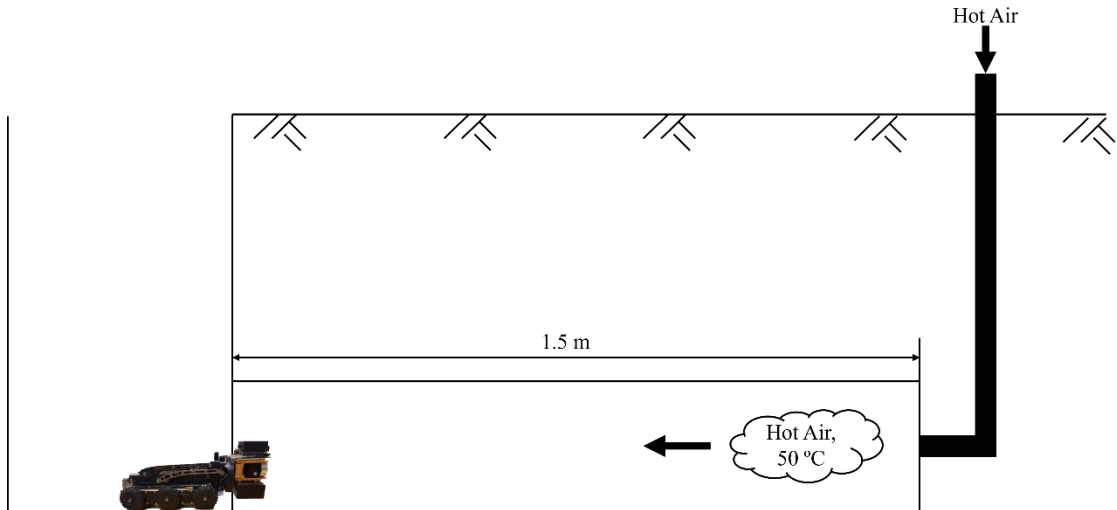
Fig. 3: Schematic diagram of on-site setup for active thermography

A heat blower was used for transport heat energy into the pipe (at $t = 0$ s). The change in temperature of the pipe interior surface was monitored by a long-wave infrared camera (7–14 μm) with a 640×512 pixel microbolometer at a frame rate of 9 Hz for 2 minutes after the heat blower started operating. The infrared camera is attached on a commercial class close circuit television (CCTV) robot. Due to the smaller pipe size compared to Sham, et al. [12], the infrared camera was not able to focus on to the crown on the pipe. Therefore, instead of having the infrared camera pointing perpendicular to

the crown of the pipe, a tunnel-view approach was adopted. Such approach also increases the inspection efficiency as the thermographic results of the whole pipe could be captured in one run. Since the length of the pipe specimen is only 1.5 m, the CCTV robot was staying still near the entrance of the pipe specimen for the whole 4 min from heating to cooling. The full set up of the test is shown in Fig. 3. The instrument specifications and parameters used for the acquisition of the thermogram are provided in Table 3.

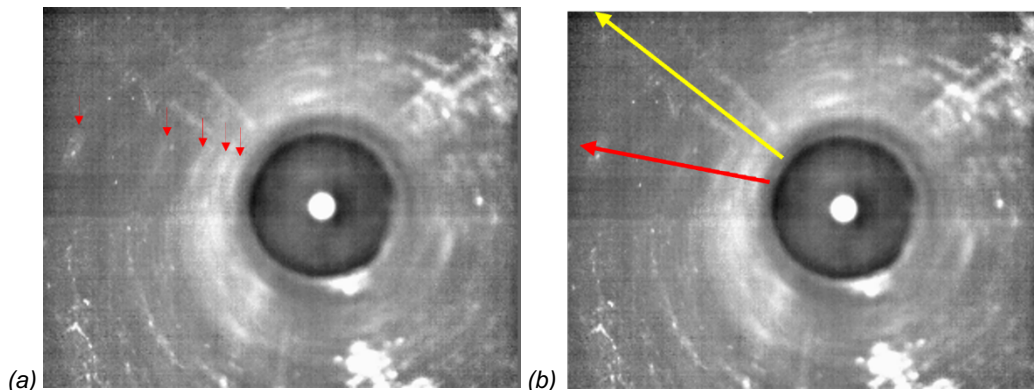
Fig. 4 is a thermogram in grey scale with the highest signal-to-noise ratio during the heating period with the white circle in the middle showing the hot air blown from the above ground and the black / grey circle being the attached flanged at the end of the pipe. Generally, the pixels that were high in temperature (white in colour) were considered as thermal anomalies which possibly mean defects. To distinguish interior defects from exterior corrosion, the blurry boundary characteristic of subsurface defects was used. Pipe interior defects such as soil deposits, encrustations, scales, and surface cracks usually having a sharp edge while thinned area could be treated as a subsurface defect usually having a blurry edge as thermal energy diffuse in three-dimension when traveling within the metallic medium.

Fig. 4: (a) Thermogram at $t = 118$ s with a grayscale temperature bar ranging from 23.0 °C (black) to 24.7 °C (white) with red arrow indicating the thinned area in 10 o'clock angular direction; (b) Thermogram at $t = 118$ s with red and yellow arrow indicating the thinned area at 10 o'clock from ring 6 to ring 2 and the reference sound area respectively

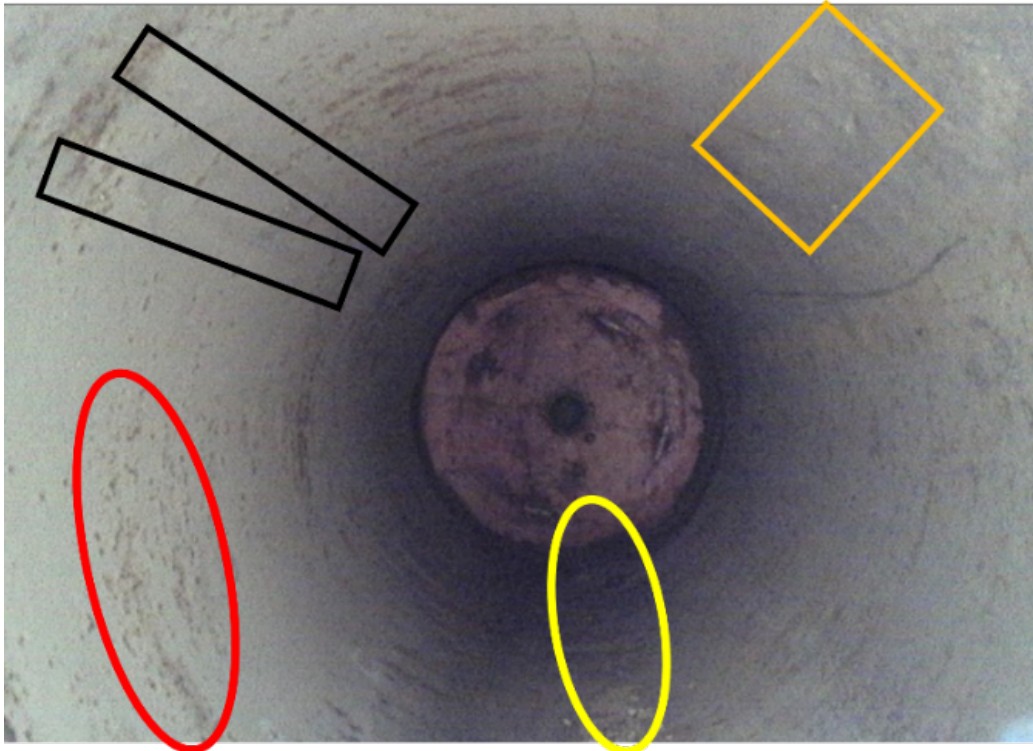
Fig. 5: Interior condition of the pipe specimen from optical image with annotated markings of possible surface features: Red oval: Scales, Yellow oval: Deposits, Black Rectangle: Welding Feature, Orange Rectangle: Surface Wear.

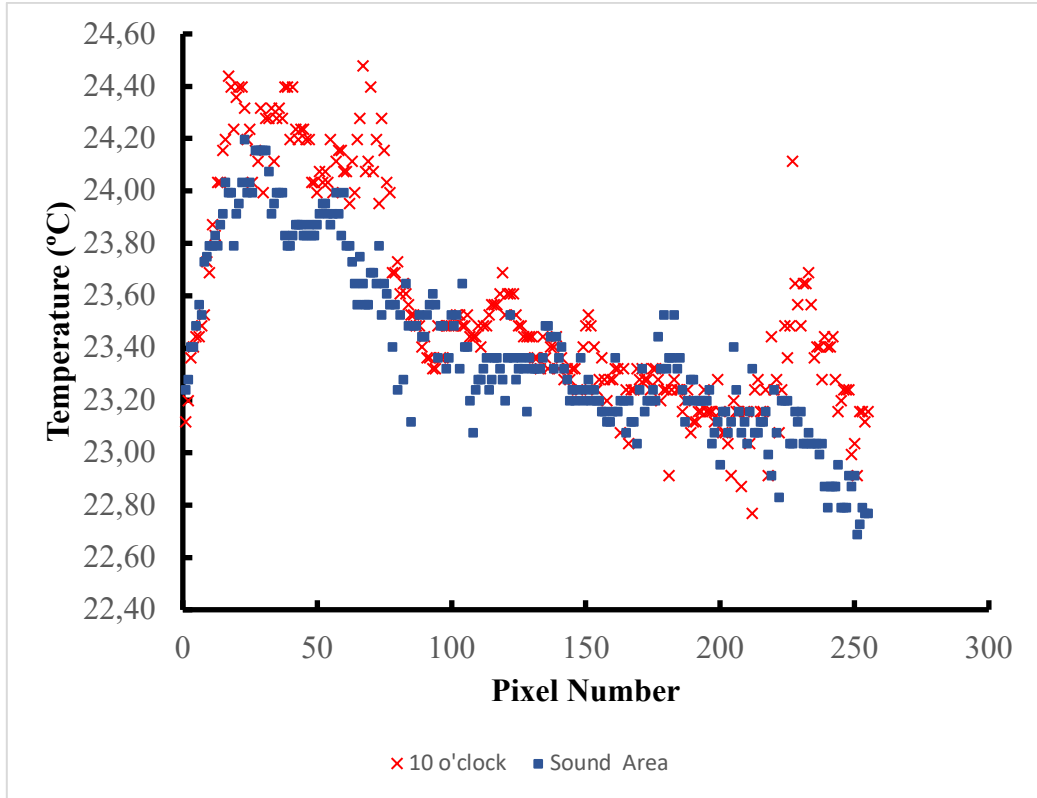
A thermal profile, shown in Fig. 6, from a chosen angular direction (10 o'clock) was plotted together with a thermal profile of sound area. The thermal profile in the angular direction of 10 o'clock was represented in red cross where the sound area was represented in blue square. In this thermal profile, it shows a general phenomenon of the further away from hot air source, the lower the temperature of the pipe wall it is. This is due to the nature of hot air dissipating when travelling through the pipe. Also, from Fig. 4, it is obvious that the left side of the pipe (from 12 – 7 o'clock) is generally hotter than the right side of the pipe. This may be due to the turbulence flow within the pipeline after exiting the small riser pipe into the pipe specimen. Thus, further studies on the heating process are recommended including possible pre-heating procedures or different thermal excitation source to solve the above-mentioned issue. Nevertheless, it is still observable that the thinned area can show a temperature difference of 0.5 °C compared with sound area.

Fig. 6: Temperature Profile of the red cross and blue squares representing defective area and sound area respectively with 255 pixels extracted from Fig. 4

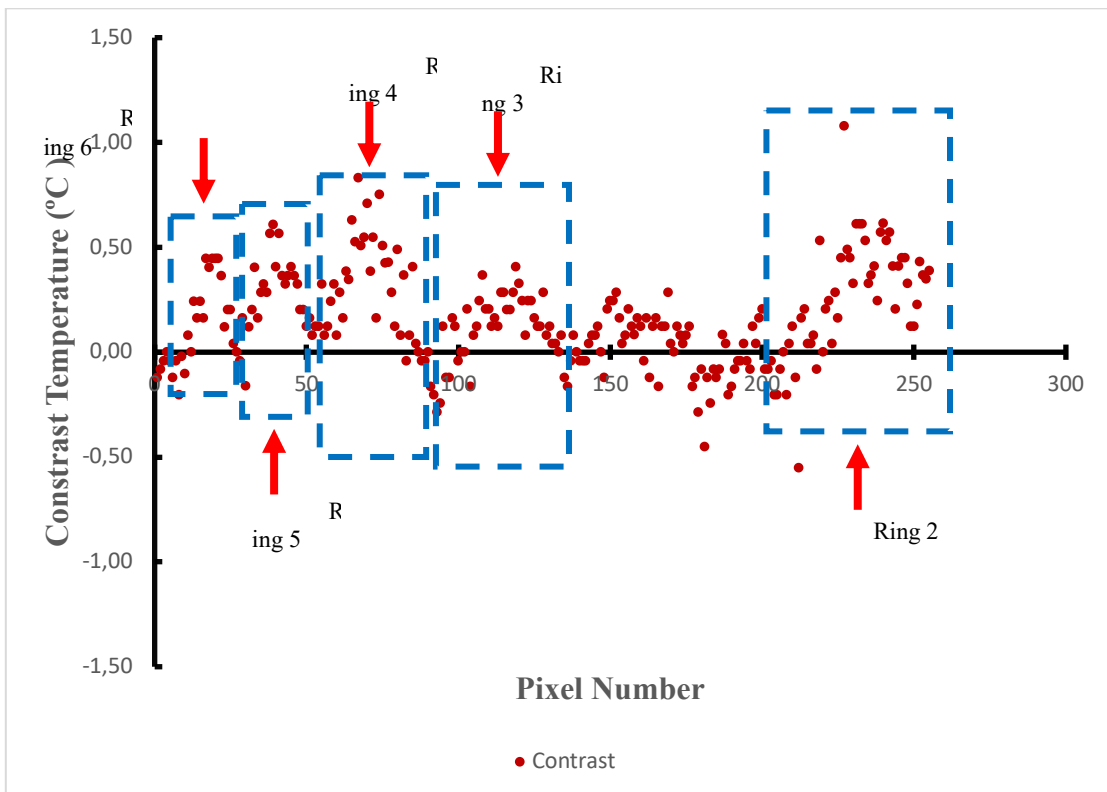
Fig. 7: Contrast of the temperature profiles from Fig. 6 corresponding to R6-75-S-2.6, R5-75-I-1.7, R4-50-S-4.0, R3-50-I-3.1 and R2-25-S-1.8 from left to right listed in row 10 o'clock listed in Table 2
