## Composite Thermal Nondestructive Evaluation Research at NASA Langley

by Joseph N. Zalameda\*, William P. Winfree\*, K. Elliott Cramer\*, Peter D. Juarez\*, Elizabeth D. Gregory\*,  
and Joshua Brown\*\*

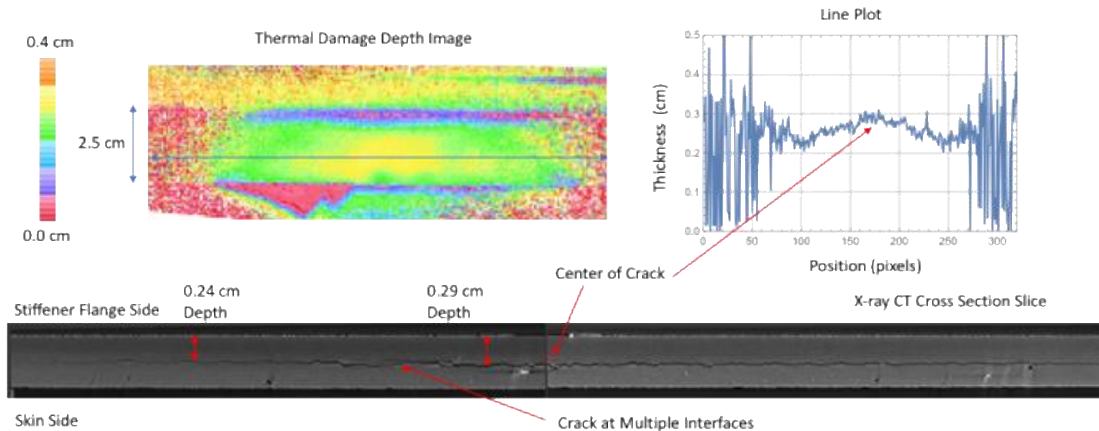
Fig. 1: Thermally detected damage depth with comparison to X-ray CT.

from quasi-static loading with good agreement to X-ray CT measured damage depth. By fitting a one-dimensional thermal model to the data pixel by pixel, the thermal data can be reduced to a thickness image revealing the damage depth. In the area of rapid inspection, a dual collaborative robot line scan thermography system was developed. This technology is a rapid large area inspection technique that follows the three-dimensional geometry of the structure. An example aircraft fuselage inspection is shown in figure 2, where the thermal inspection is mapped onto the aircraft's 3-dimensional geometry.

In both quasi-static and fatigue loaded composite structures, passive thermography has been successfully used to detect and control damage onset and growth. Shown in figure 1 is the thermal imaging of damage depth

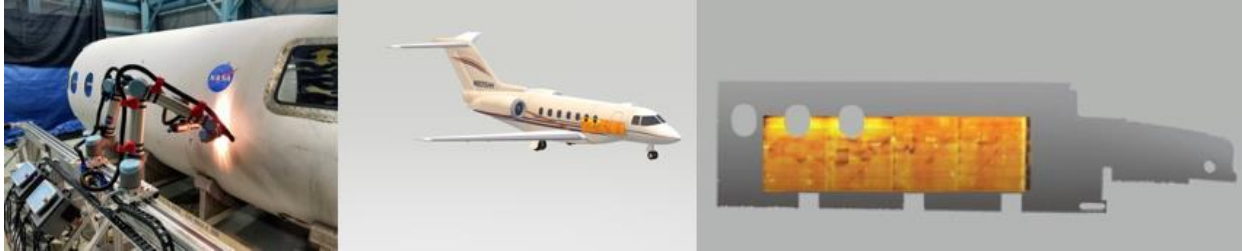
Fig. 2: Dual collaborative robot thermal line scan inspection of aircraft fuselage.
