Thermographic diagnostics for detecting malfunctions in TV

by A. Stoynova, B. Bonev

Technical University of Sofia, 8, Kl. Ohridski str., Sofia, Bulgaria, ava@ecad.tu-sofia.bg

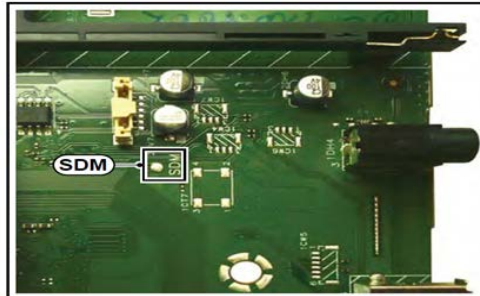
Fig. 2. Control point SDM

The TV can be booted up in SDM mode in two ways: with remote control test of button combination or with connecting a SDM control point to GND, shown on Fig.2.

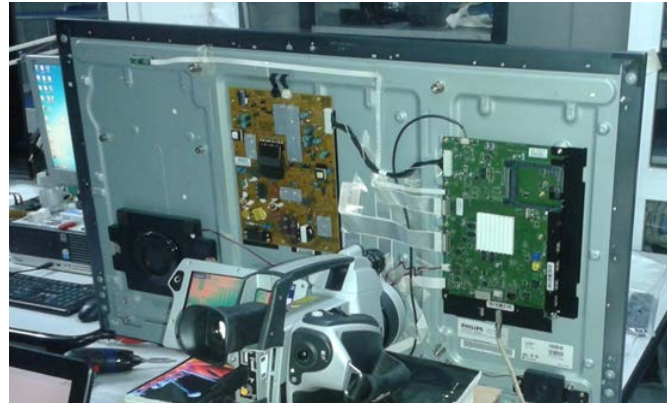
Fig. 3. Photo of the experimental setup

Fig. 3 shows thermography study at the diagnosis of the defective TVs. The infrared camera captures TV main board and more specifically CPU area. The ambient temperature, relative humidity and the distance between IR camera's lens and tested PCB are measured in order to compensate their impact on temperature measurement accuracy.

Infrared camera FLIR TermaCAM SC640 is used for thermal measurement (45° lens). The IR camera is connected via IEEE1394 interface. Infrared image processing are performed with software ResearchIR and self-developed software for thermal histograms analysis.

Photo of the experimental setup is shown on Fig. 3.

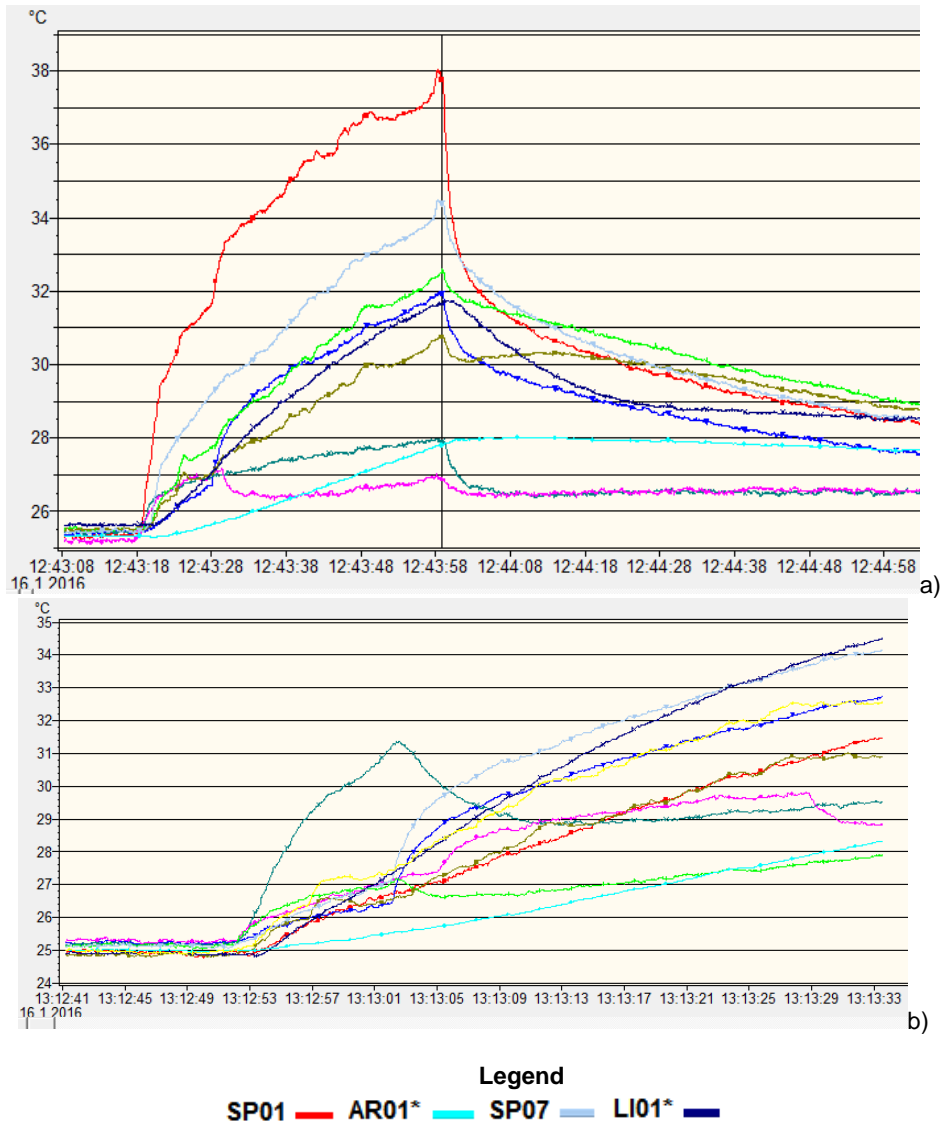
The temperature-time diagrams of the marked points, area and line are shown in Fig. 5. The cursor displays the time of standby mode turning off. The diagram shows a non-specific heating at point SP01 (red colour) - DC/DC convertor 7UU1. His chart reaches the highest value compared to the other areas studied. 48 seconds after turning on the TVs, the temperature at this point reaches 38 °C, while the CPU temperature at this point is 31 °C. It can be assumed that the problem of the TV is due to a DC / DC converter 7UU1 defect or related components. From the comparative thermographic analysis made between the defective and the reference TVs, we have undoubtedly come to the conclusion that the problem is due to a defect in the DC / DC converter 7UU1.

Fig. 5 shows temperature distribution over time for different marked elements. The legend is given only for commented in the paper components. On Fig. 5a is shown temperature distribution for 15s after turning on standby mode. We monitor temperature change on the following marked elements: SP01 - DC / DC converter 7UU1; AR01 - CPU 7J00. The temperature time diagrams of the marked areas are shown in Fig. 5b and Fig.5b. At 13:12:41 h the TVs is switched on in standby mode, and 12 seconds later at 13:12:53 h, a "power on" signal is output from the remote control

Fig. 5. Temperature distribution for marked areas in Fig. 4: a) defective TVs and b) reference TVs

and the TVs is switched to normal operating mode. We are interested in the first 12 seconds when the TV is in standby mode and the temperature value at SP01 DC / DC converter 7UU1. It is seen that the temperature is equal to 26.7 °C and does not change over time.

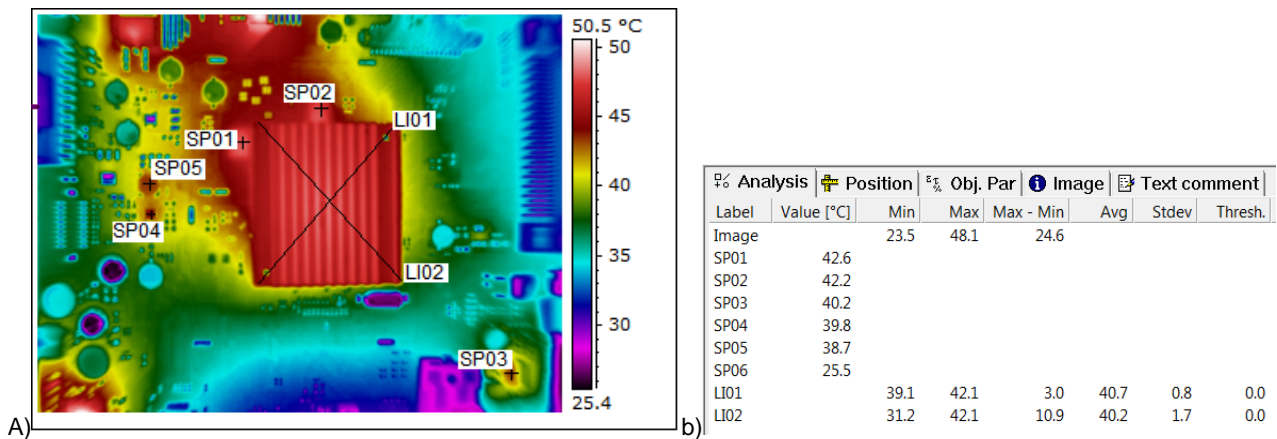
On Fig.6a, b (LI01 and LI02) the thermogram and the temperature values in steady state mode are shown, respectively. On Fig.6c, d temperature distribution over time is shown during the transient period after turning on standby. Four minutes after turning on a steady state mode an equilibrium have been reached. The average temperature of the heat sink is stabilized to 41.2 °C. The temperature distribution is evenly across the heat sink area and no problem areas are detected. For this case it can be concluded that the processor is working normally (Fig.6c - see LI01 and LI02). After turning on HD (High-Definition) mode the surface temperature on the heat sink starts to rise and after 5 min it reach stabilization to about 56°C (Fig. 6d - see LI01 and LI02). On the Fig.6 legend is shown only for commented elements of the Main Board.

Fig. 6 a, b Thermogram on Main Board in steady state mode with given temperature for marked areas

- Point SP01 - DDR U4003 - maximum temperature °C;
- Point SP02 - DDR U4002 - maximum temperature °C;
- Point SP03 - Stabilizer U7006 - maximum temperature °C;
- Point SP04 - DC / DC U7004 - maximum temperature °C;
- Point SP05 - Induction L 7101 - maximum temperature °C;
- Maximum temperature distribution on line LI02 - processor heat sink MT5366.

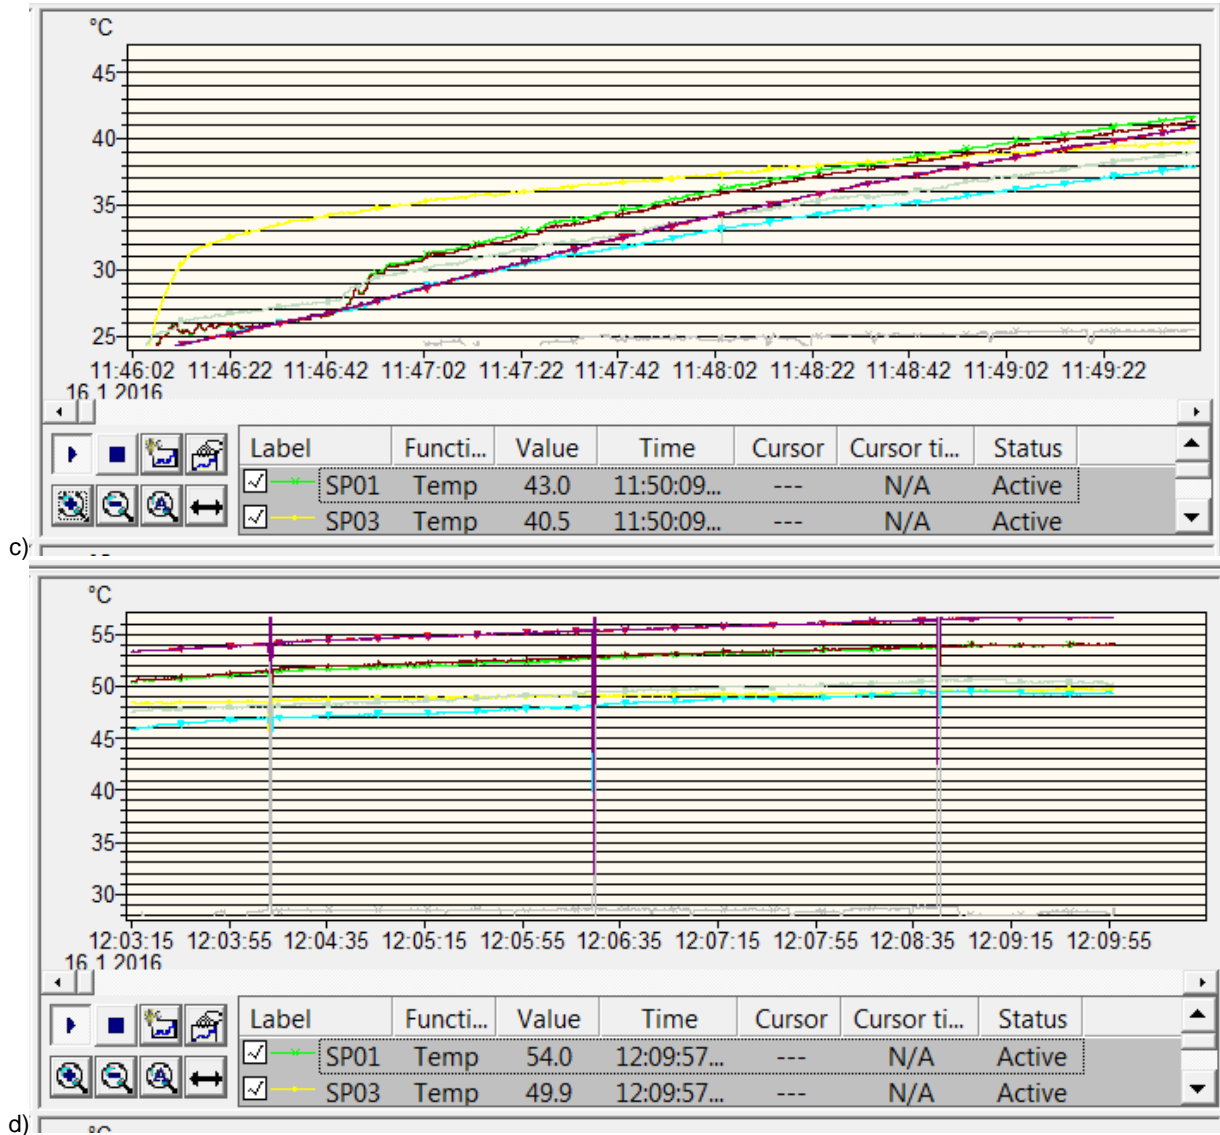
Legend
 SP01 SP02 SP03 SP04 SP05 LI01 LI02
 Fig. 6 c, d. Temperature distributions – c) stby power; d) HD power

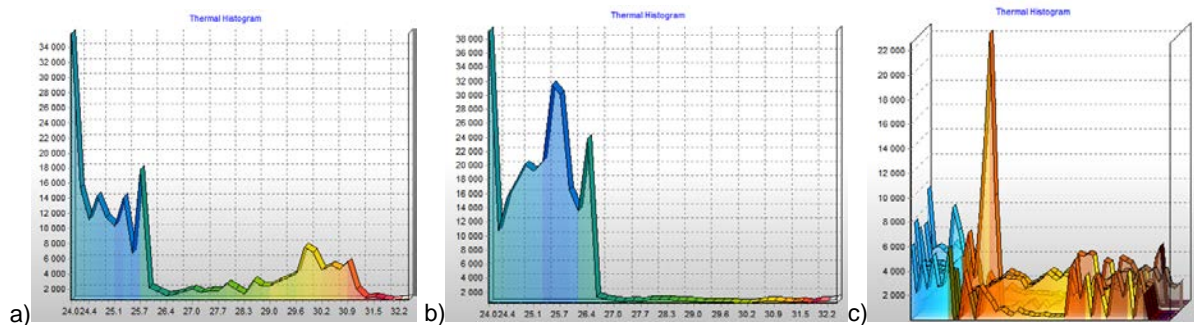
For example, when the problem is in the DC / DC converter 7UU1, the temperature histograms from Fig.7a and Fig.7b are compared. Fig.7c shows the temperature histograms for the converter for the sequence of 5 thermograms after switching on the TVs. The appearance of the peak after the third minute is indicative for the presence of malfunction in the DC/DC converter.

Fig. 7. Thermal histograms' of DC / DC converter 7UU1: a) with failure; b) without failure; c) with malfunction

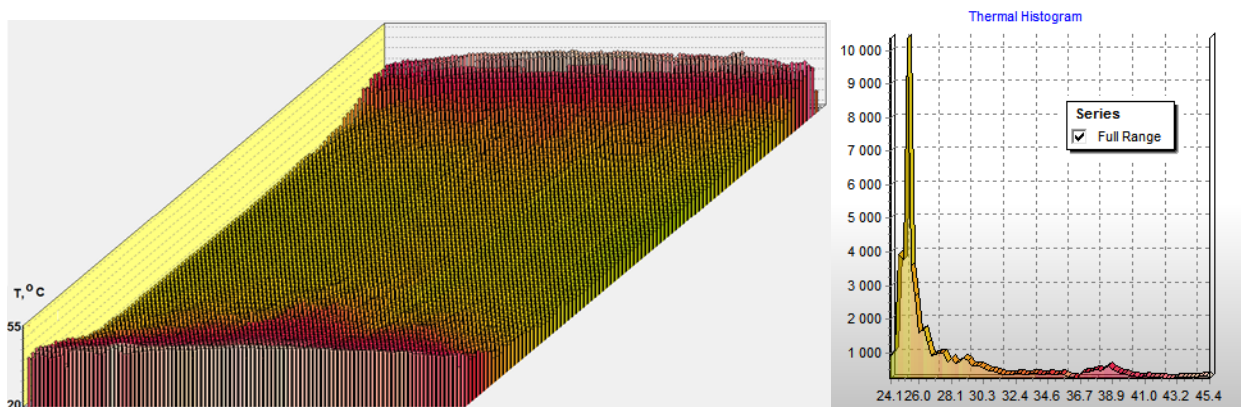
Fig. 9 shows the 3D temperature distribution (front display & cell surface) and the thermal histogram of the LCD. The highest measured temperature (about 45°C) at steady state mode on the TFT LCD is on the Bracket surface.

Fig.9. 3D thermal view and thermal histogram of TFT LCD at steady state
